**ACCESSORY SIDE ROCKER TRIM INSTALLATION INSPECTION INSTRUCTIONS**

**Service Alert No.: SA-022/22**

2023 CX-50

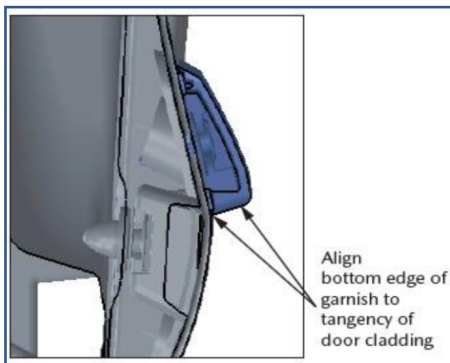
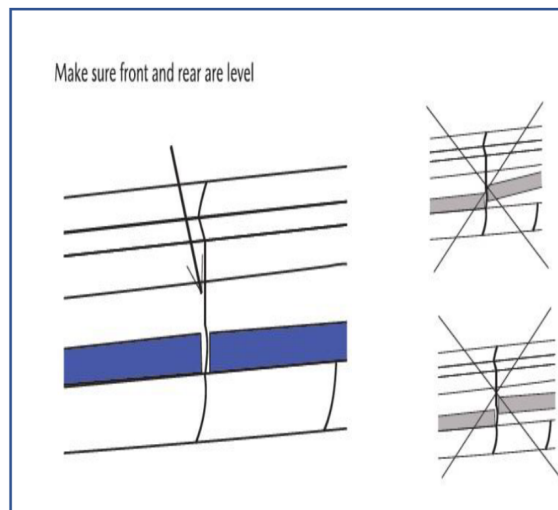
1. Check for proper alignment to the door cladding tangency point as shown in the images below.
2. If parts are misaligned, immediately remove them and re-position.
3. If holes have been drilled incorrectly and are the cause of the misalignment, *the door cladding must be replaced*.
