Subject: APPLE CARPLAY™ / ANDROID AUTO™ FREQUENTLY ASKED QUESTIONS (FAQ)	Service Alert No.: SA-026/22
	Last Issued : 04/27/2022

Frequently Asked Questions (FAQ)

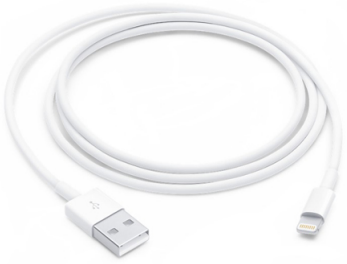
<p>Correct: Lightning to USB</p>

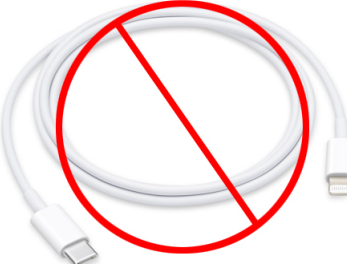
<p>Incorrect: Lightning to USB-C</p>

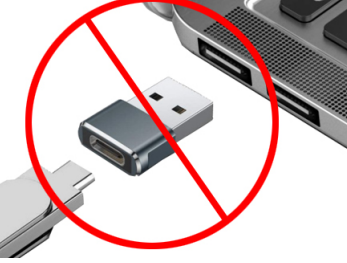
<p>Incorrect: USB-C Female to USB Male Adapter</p>

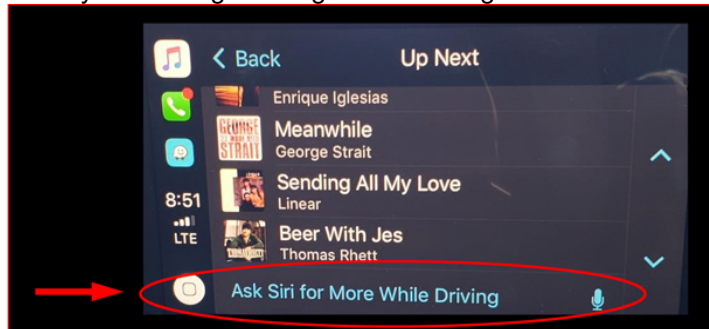
When driving, Apple CarPlay™/Android Auto™ limits some functions such as scrolling. Apple/Google expects drivers to keep their eyes on the road and use Siri/Google Assistant instead of scrolling.

Apple CarPlay™ scrolling message while driving

This is an Apple CarPlay™/Android Auto™ function. Vehicle infotainment system is functioning correctly.

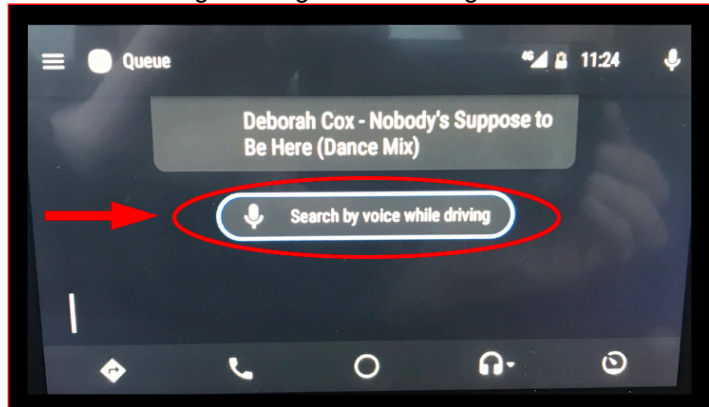
Android Auto™ scrolling message while driving

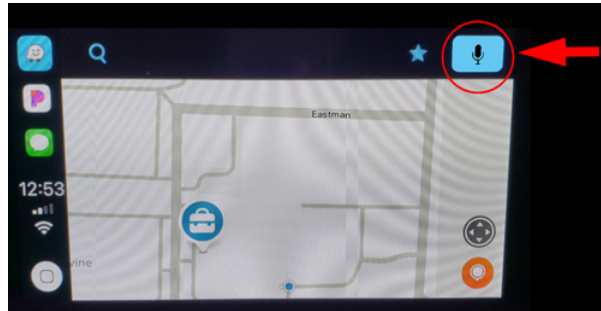
Waze app: Voice command is possible when selecting the Waze voice icon.

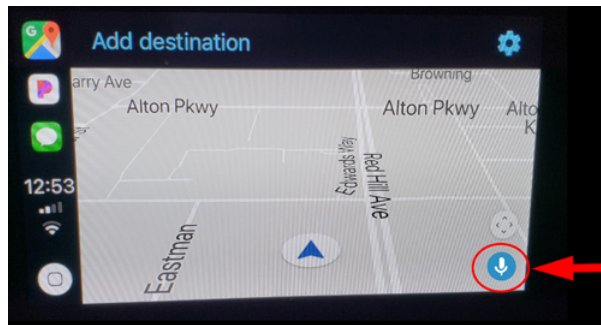
Google Maps app: Voice command is possible when selecting the Google Maps voice icon.

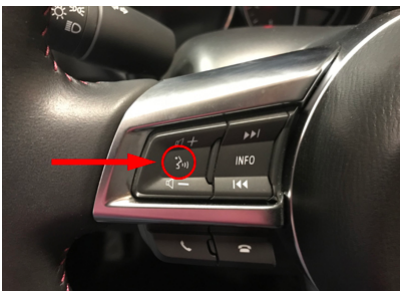
Android Auto™: The wrong navigation app opens when using the steering wheel Voice Command button.

When using the steering wheel Voice Command button to set a navigation destination, Android Auto™ defaults to the last navigation app that was used. Select the "Maps and Navigation" icon to set your default navigation app.

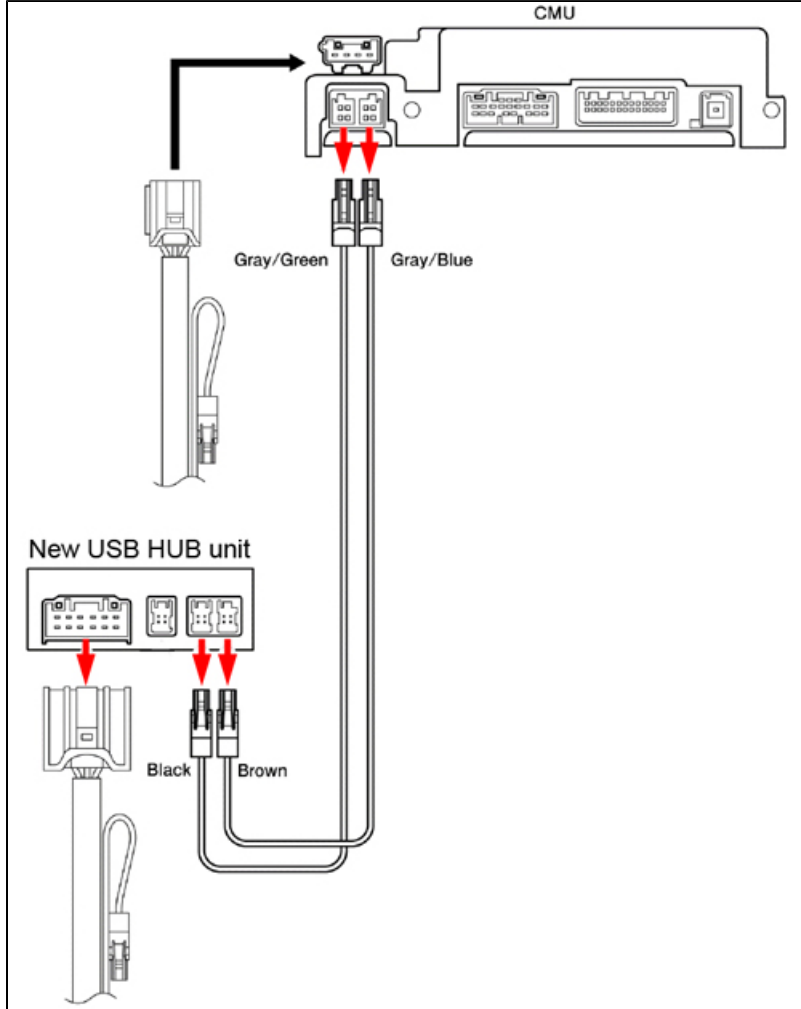
(Cannot install CMU software after smart phone Cable Set Kit (P/N C922-V6-605) installation)

1. Disconnect the new smart phone HUB unit and the new smart phone cables from the CMU.
