Service Update

N222365730 Power Tonneau Cover Calibration Loss

Release Date: May 2022

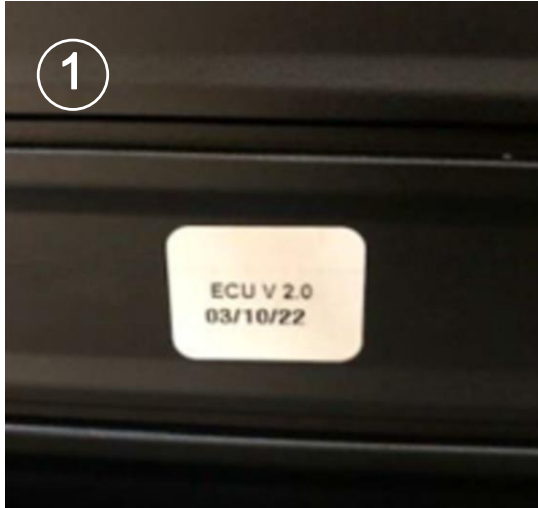
6051484

2.1 Inspect the underside of the roll top at the tailgate end (1) and the electronic control unit (ECU) (2) for the “ECU V 2.0” sticker:

2.2 If the electronic control unit (ECU) does not have the stickers as shown, continue to step 3.

2.3 If the electronic control unit (ECU) has the stickers shown, no further action is required.
