David J. Johnson
 Director
 Service Engineering Operations
 Ford Customer Service Division

SUBJECT: **Customer Satisfaction Program 21B04 – Supplement #3**
 Certain 2017 through 2020 Model Year F550 Equipped with Payload Plus Upgrade Package
 Frame Rail Crack

CERTAIN 2017-2020 MODEL YEAR F550 SUPERDUTY VEHICLES EQUIPPED WITH PAYLOAD PLUS UPGRADE PACKAGE — FRAME RAIL CRACKS

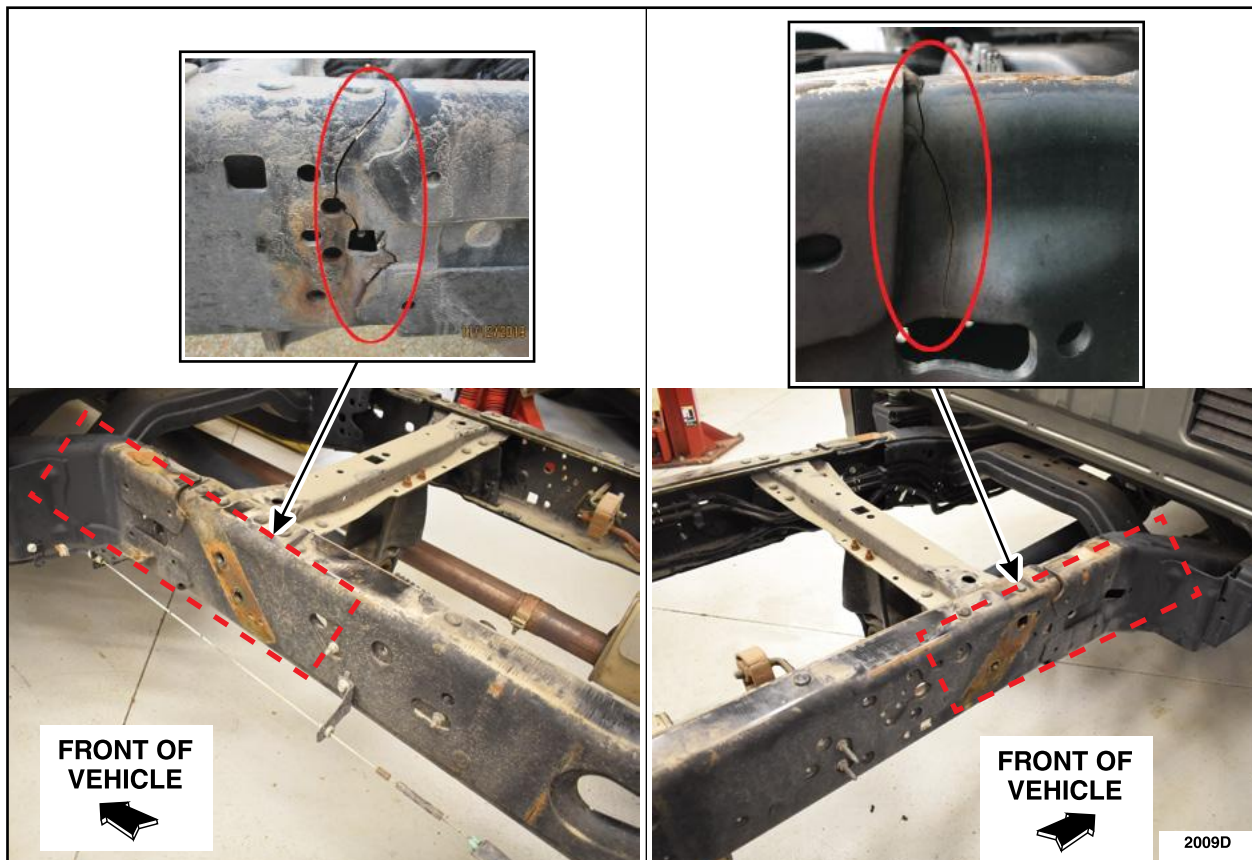
FIGURE 1

1. Identify and inspect the areas where the frame rail may exhibit signs of stress or a crack. Using compressed air, clear any debris that may be on the frame rails in the area of red dashed box. See Figure 1.

NOTE: 2nd unit body does not need to be removed to perform inspection, if any brackets are in the way inspect inside of frame for cracks.

- Are there any signs of stress or cracks found on the frame rail?

Yes - Contact Special Service Support Center (SSSC). Send photos of damage along with overall view of vehicle when contacting SSSC.

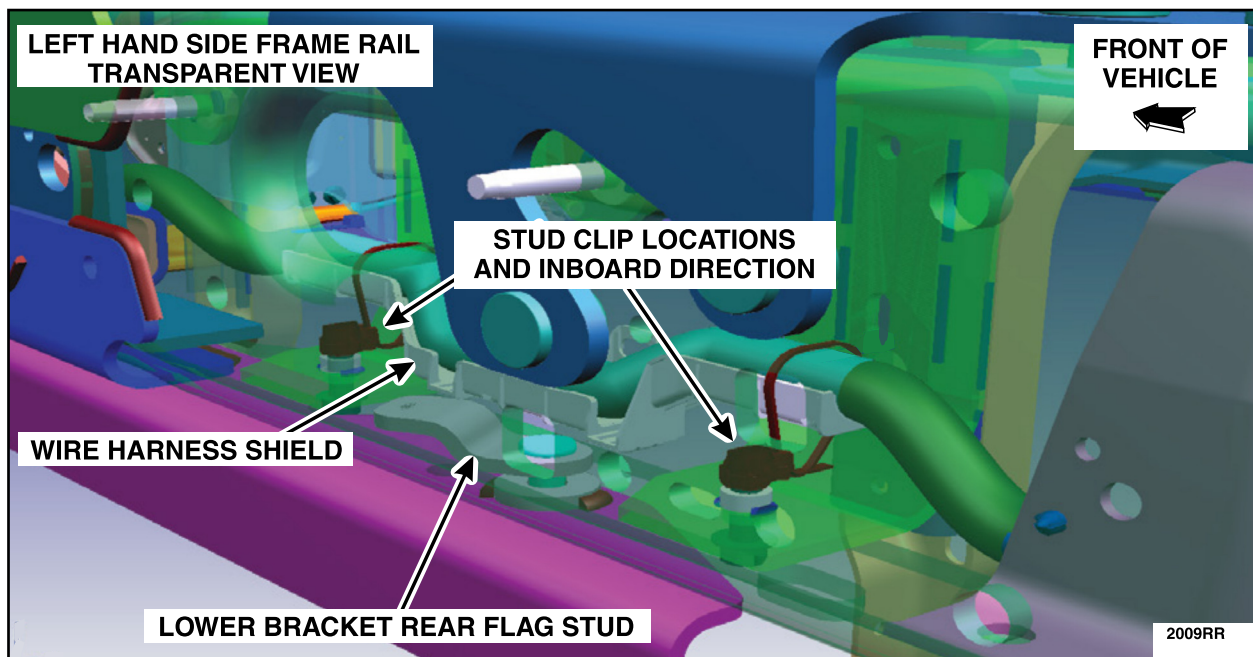
FIGURE 37

1. For the left hand side lower frame rail bracket, the rear flag stud will contact the harness shield if not raised. Raise the harness by completing the follow steps;
 - Position the supplied stud clips onto the studs with the zip ties side facing inboard as shown in Figure 37.
 - Secure the harness to the stud clips with the zip ties.
 - Ensure that the harness shield is positioned above the flag stud and the stud clips are fully seated on the studs.

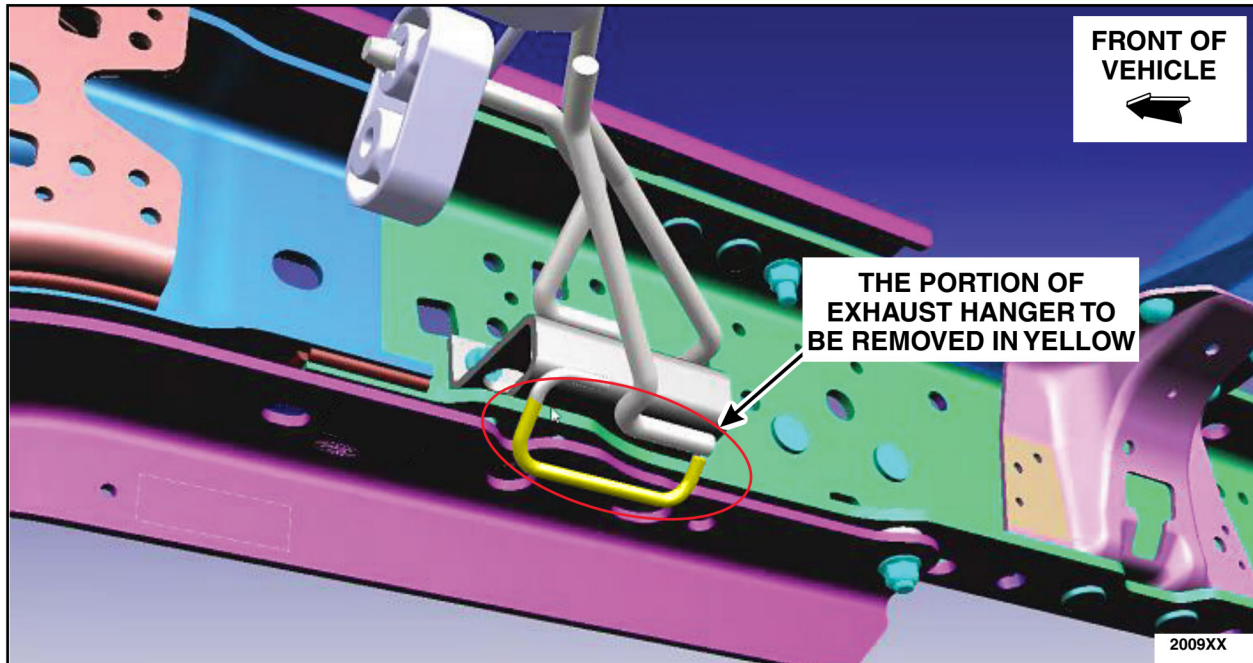
FIGURE 43

1. The right hand side exhaust hanger will interfere with right hand side lower reinforcement bracket.
Figure 43 shows the portion of the exhaust hanger that will be removed in order to obtain the clearance needed.

2. Using a suitable cutting tool, cut the exhaust hanger in the location shown in Figure 44. Remove and discard the cut off portion of exhaust hanger. See Figure 44.
