INSTRUCTION TO SERVICE

ITS60378	March 23, 2022		
SECTION:	292-Electrical Harness		
WRITTEN BY:	Aditya Gadepalli		
SUBJECT:	Alternator Ring Terminal Rework		
ISSUE:	The ring terminal connected to the indicator light terminal on the back of the Delco alternator could be corroded and cause intermittent issues.		
SUMMARY:	Changing the ring terminal to a more whether friendly part on the indicator light terminal will either resolve or prevent the intermittent issue. This ITS provides the steps to discard the existing terminal and crimp a new better version terminal.

ITS60378

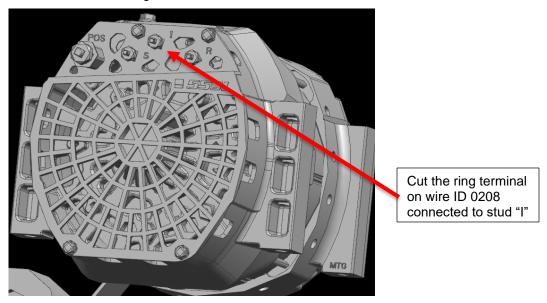
- 4. Locate wire ID 0208 behind the top alternator connected to the stud "I". Remove and save the nut securing the wire.
- 5. Cut and discard the ring terminal on wire 0208.

6. Crimp 4" of 18 AWG black wire, MCI P/N: 19-11-1251, to the 0208 wire using splice connector, MCI P/N: 19-11-3775, and heatshrink, MCI P/N: 19-11-1465.

- **NOTE:** Follow instruction in step 14 to crimp wire using splice connector.
- 7. Crimp #10 ring terminal, MCI P/N: 19-11-402, to the other end of the added wire using heatshrink, MCI P/N: 19-11-1465.

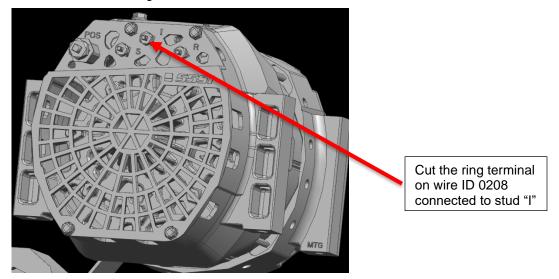
- 9. Locate wire ID 0207 behind the bottom alternator connected to the stud "I". Remove and save the nut securing the wire.
- 10. Cut and discard the ring terminal on wire 0207.

11. Crimp 4" of 18 AWG black wire, MCI P/N: 19-11-1251, to the 0207 wire using splice connector, MCI P/N: 19-11-3775, and heatshrink, MCI P/N: 19-11-1465.
