Technical Service Bulletin

| Subject: KNOCKING NOISE FROM STEERING COLUMN WHILE DRIVING | Bulletin No.: 06-001/22 |
| | Last Issued : 04/19/2022 |

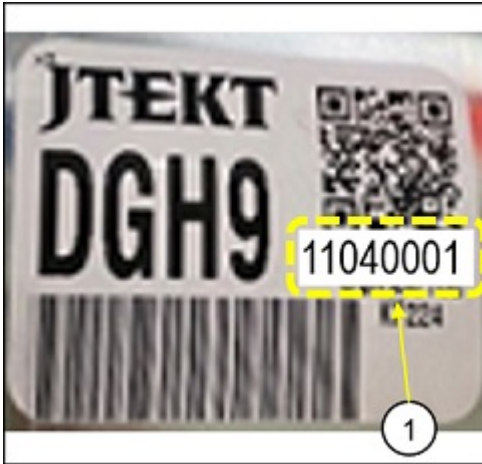
NOTE: The part number of the steering column has not been changed for the modification. Identify modified steering columns by the lot number on the steering column as follows.

Modified part (Service part of Steering Column):

- Lot Number (1) **11040001** or later.

The lot number is in YMDD**** format.

- Y: last digit of the production year (1: 2021, 2:2022)
- M: the production month (1: Jan., 2: Feb. ... X: Oct., Y: Nov., Z: Dec.)
- DD: the production date
- ****: serial number

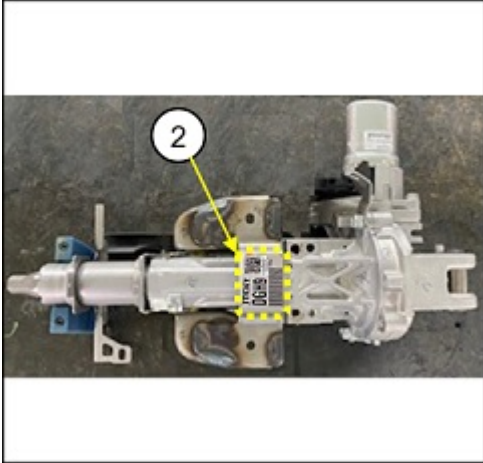
The location of the lot number label (2) is the upper side of the steering column.

NOTE: The steering columns installed in mass production DO NOT have the label in this location.

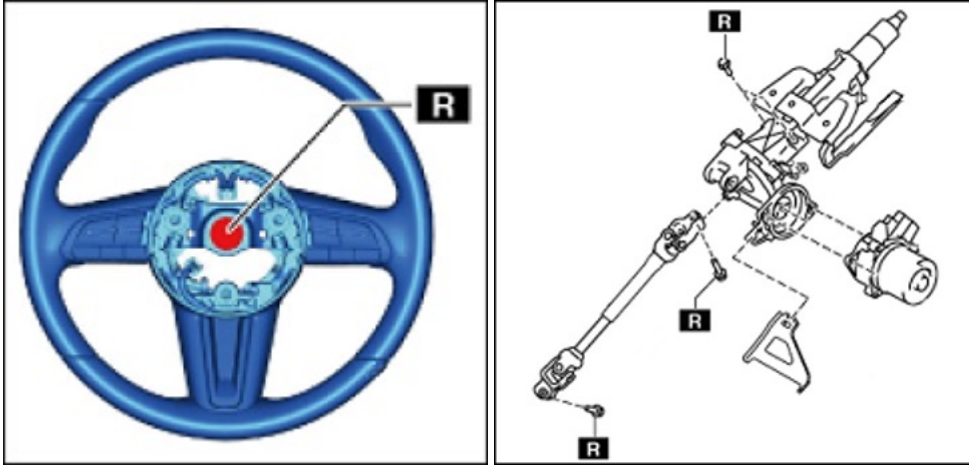
Replacement Parts Location:

- Lockbolt for Steering wheel
- Joint bolts for Intermediate shaft
- Bolts for Protector
