Technical Service Bulletin

Subject: FRONT DOOR INTERFERES REAR DOOR GARNISH	Bulletin No.: 09-014/22
	Last Issued : 04/12/2022

2019-2020 Mazda3 5-door HB (Japan built) with VINS lower than JM1BP*****158118 (produced before November 29, 2019)

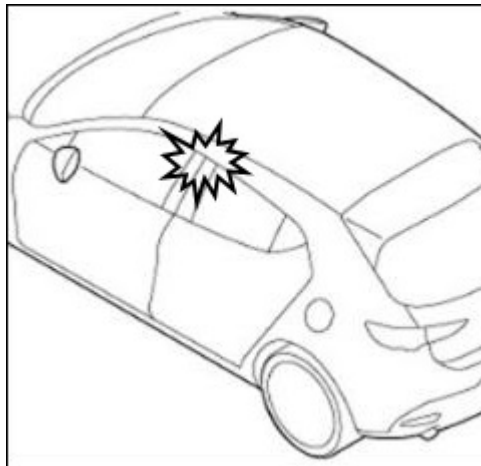
Some vehicles may exhibit that the glass run channel of the front door interferes with the rear door garnish.

Since the front door glass run channel is not fixed to the door strongly enough for the following situations, cycles of door operation may result in interference and lead to damage on the seal rubber at the rear door.

- When the front door glass is closed, the glass run channel may be forced to move to the B pillar side.
- In very hot climates, the glass run channel may expand to the B pillar side.

- Phase 1
 - Adhesive has been added between the front door glass run channel and the door panel.
- Phase 2
 - The shape of the front door glass run channel has been changed so as not to make contact with the rear garnish.
 - The shape of the clip at the rear side of the front door glass run channel has been changed for stronger fixing and the hole at the door panel has been changed accordingly.

1. Verify customer concern.
2. Replace the front door glass run channels with modified ones, regardless if the other side is damaged or not.

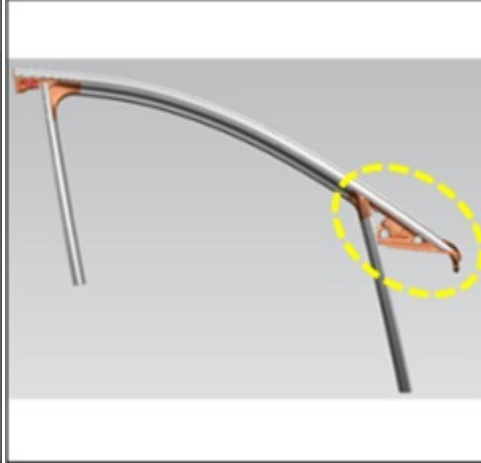
Front door glass run channel and sail garnish are integrally formed

- If the front door glass run channel obtained is BDMT-58/59-60ZJ or later level, remove and discard the sail garnish (1), which is originally installed on the vehicle according to the instructions on MGSS (SAIL GARNISH REMOVAL/INSTALLATION), before installing the front door glass run channel.

Discard
(1) Sail garnish
(BCJH-58-621)
