Instructions for navigating the document

Index of models

NEW TOPICS 3

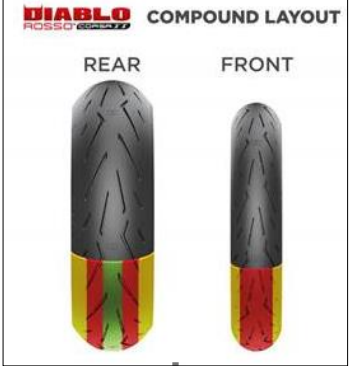
8	<p>Possible formation of a well-marked "band" in correspondence with the central area of the Pirelli Diablo Rosso Corsa II rear tire</p>	<p>Pirelli Diablo Rosso Corsa II rear tire</p>

<p>We have received some isolated reports of the appearance of a "band" in correspondence with the central area of the Pirelli Diablo Rosso Corsa II rear tire.</p> <p>We would like to inform you that, since these are extremely sporty tires with 5 different compound zones at the rear, it can happen that, depending on the type of use of the motorcycle, they wear out in a different way causing the above mentioned phenomenon to occur; sometimes this occurs on the shoulder area, sometimes in the central area but, in general, it is a purely aesthetic phenomenon that does not affect the performance of the tire itself.</p>

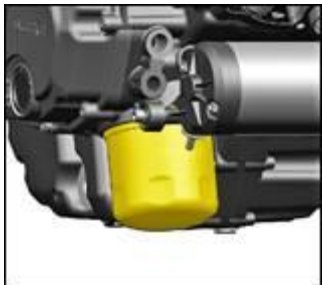
<p>We have received some reports about the improper tightening of front brake hose retaining clip fastening nut due to external machining operations requiring the involved clip to be removed.</p> <p>Check nut correct tightening during the first tightening at your workshop to avoid incorrect positioning of front brake hoses.</p> <p>Should you detect nut loosening, follow the instructions on the workshop manual for front brake hose correct positioning, and tighten nut to a torque of <u>4 Nm ± 10%</u>.</p>
20	Update of engine oil filter cartridge tightening torque	Engine oil filter cartridge

<p>Please, be informed that following changes concerning the engine oil filter cartridge, the tightening torque has been increased from 11 Nm to <u>13 Nm ± 1 Nm</u>.</p> <p>Please be reminded to lubricate the oil filter cartridge seal with engine oil and to use a commercial tool for tightening, as shown in the figure.</p>

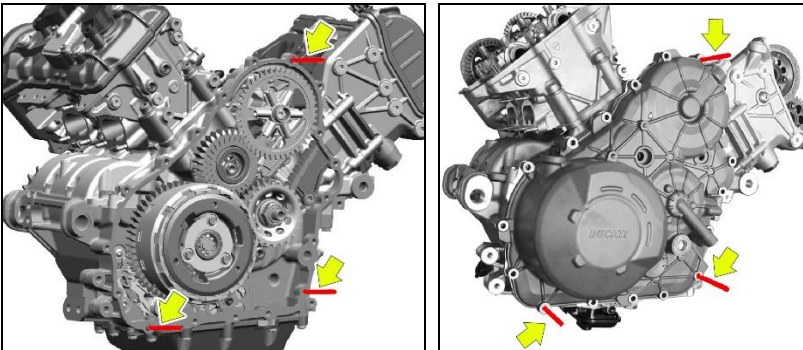
no.	Symptom	Subject	Photo	Notes and Indications - Corrective action
21	<p><u>ONLY</u> Desmosedici Stradale V4 ENGINES</p> <p>Possible damage to water pump gear oil seal</p>	Water Pump Gear Oil Seal

<p>We have received some reports of a pronounced blow-by effect that may cause small amounts of oil to leak from the clutch cover. This effect could be caused by excessive wear of the water pump gear oil seal on the clutch cover.</p> <p>If this problem is found, we suggest that you check the condition of the oil seal inside the clutch cover and replace it if necessary. When replacing it, remember to lubricate the oil seal with KLÜBERPLUS S 06/100 lubricant (or equivalent) and reposition it correctly using tool part no. 887138858.</p> <p><u>Warning:</u> During refitting, for correct positioning of the clutch cover, it is necessary to use 3 centering pins part no. 887132933, positioned as shown in the figure, to avoid possible damage to the water pump gear oil seal.</p>

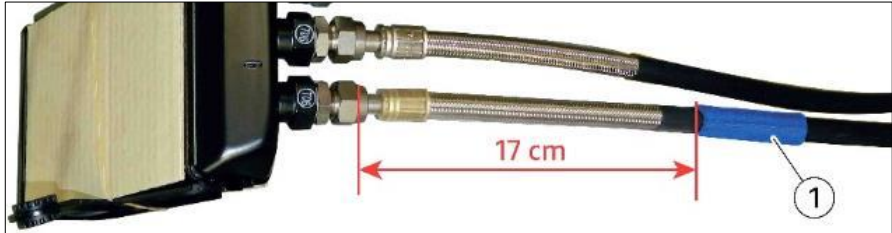
no.	Symptom	Subject	Photo	Notes and Indications - Corrective action
3	<p><u>ONLY</u> Multistrada 950 MY 17-20 Multistrada 1200 MY 15-17 Multistrada 1260 MY18-20 (all model versions)</p> <p>Possible superficial damage to the oil cooler return pipe</p>	Oil cooler pipes

<p>We have received some isolated reports of possible surface damage to the oil cooler return pipe due to rubbing with the top of the coolant radiator, over time. <u>This phenomenon is purely aesthetic and does not affect the correct operation of the system.</u> We inform you that for the models:</p> <p>a) Multistrada 1260: starting from the frame number ZDMAC03AAAKB011354 (on 27/05/2019) the anti-abrasion sheath (1) part no. 4601H701A has been introduced on the oil cooler return pipe, positioned at a distance of 17 cm measured from the upper end of the fitting. (This solution is also applicable to all Multistrada 1200 versions Model Year 2015-2017).</p>

<p>b) Multistrada 950:</p> <ul style="list-style-type: none"> - starting from the frame number ZDMAD00AAKB002259 (on 10/05/2019) the anti-abrasion sheath (1) part no. 4601H701A has been introduced on the oil cooler return pipe, positioned at a distance of 17 cm measured from the upper end of the fitting; - starting from the frame number ZDMAD00AALB005691 (on 12/03/2020) the longer fitting (2) part no. 81510391A has been introduced at the oil return pipe outlet from the cooler.

<p>We ask you to always check the condition of the oil cooler return pipe, and to replace it ONLY if the rubber sheath is damaged and the metallic braided hose can be seen. Follow the assembly notes indicated above according to the reference model. The spare part catalogue has been updated.</p>

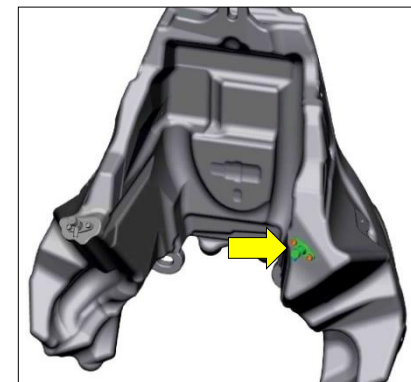
18	<p>ONLY <u>Multistrada V4</u> <u>(all model versions)</u></p> <p>Incorrect residual fuel in the tank</p>	Fuel tank	-	<p>In some cases, we have found that the tap on the right-hand side of the fuel tank is completely closed instead of open; this leads to an incorrect remaining range when there are only a few liters of fuel in the tank (fuel reserve conditions).</p> <p>If the above-mentioned event occurs, we ask you to ensure that the tap on the right-hand side of the fuel tank is fully open</p>

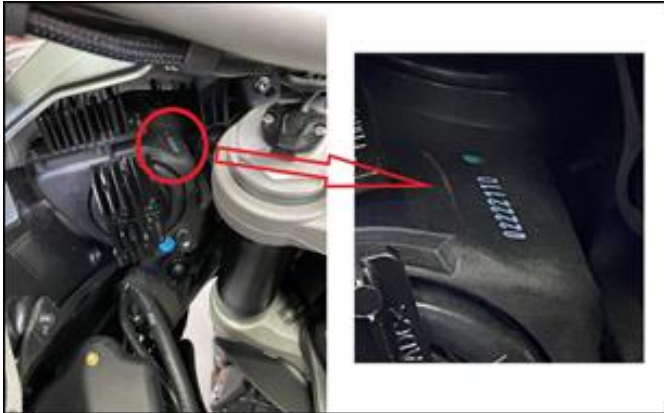
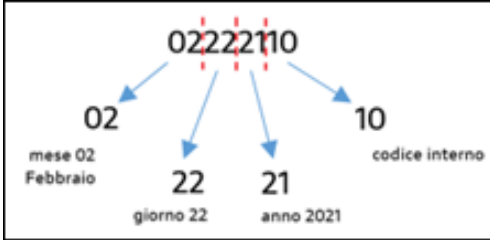
no.	Symptom	Subject	Photo	Notes and Indications - Corrective action
22	<p>ONLY <u>Multistrada V4S</u> <u>Multistrada V4S Sport</u></p> <p>Error C1134 – High DRL temperature</p>	Headlight	-	<p>We have received some reports concerning the display of error “C1134 - High DRL temperature” for which the generic Error warning light, linked to the specific malfunction of the DRL inside the headlight, would normally light up on the instrument panel.</p> <p>The error refers to an actual circuit overheating problem which, in the event of prolonged use, could lead to damage to the DRL function only (the headlight low beam and high beam would still work normally).</p> <p>If error “C1134 - High DRL temperature” is displayed, we kindly ask you to:</p> <ul style="list-style-type: none"> - Check the production date printed on the upper left side of the headlight

<p>the first two digits correspond to the month, the next two digits correspond to the day and the following two digits correspond to the year. The last two digits correspond to an internal code that never changes. E.g. code in figure 02222110</p>

<ul style="list-style-type: none"> - If the date is prior to 23 March 2021, replace the headlight and returning the item to Ducati - If the date is the same or after 23 March, inform your Area Manager with a specific Youtech, explicitly indicating the date on the headlight, and attaching, if possible, any photographic documentation.

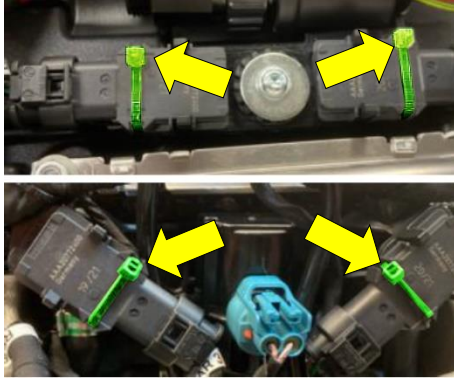
<p>We have received a few isolated reports of erratic engine operation at idle, hard starting, the possibility of the MIL warning light on the instrument panel coming on and/or memorized MAP sensor errors or P061B Torque Monitoring error. Our analysis has shown that this phenomenon could be due to the MAP sensors not fitting perfectly in their seats; we therefore ask you to check the correct installation of the MAP sensors if the symptoms described above should occur, and to fix them properly using self-locking ties positioned as shown in the figure.</p> <p>Create a Youtech for any cases found in your dealership. Attach PDF copy of the DDS Fault Report (with freeze frame parameters) and photos of the MAP sensor(s) as discovered during inspection and after with self-locking ties.</p>

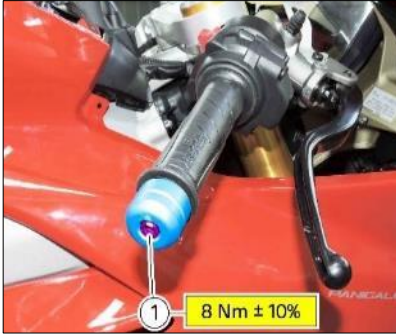
<p>We received some isolated claims about the possible triggering of a longitudinal crack on the handlebar, on balancing weight side. Our laboratory analyses found that said crack is due to an excessive tightening torque applied when installing the balancing weights.</p> <p>When installing balancing weights on the handlebar, please comply with the tightening torque specified for the M6x55 screw to 8 Nm ± 10%, as indicated on the bulletin introducing the model and on the Workshop Manual.</p>

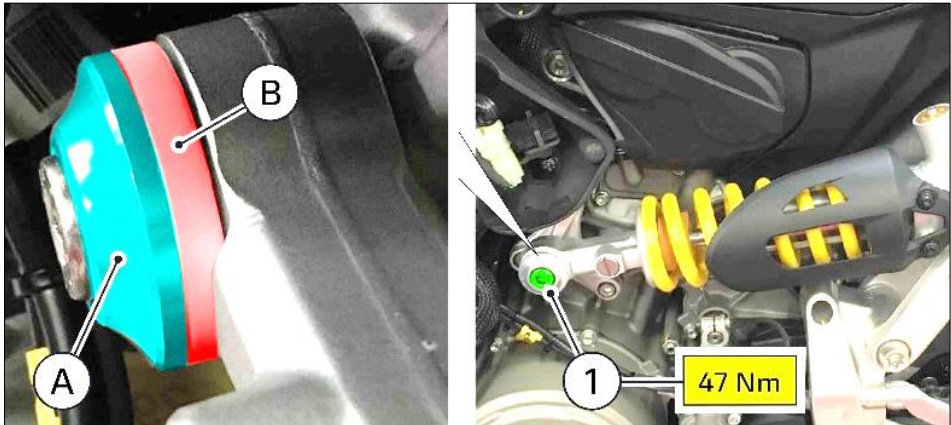
<p>We would like to inform you that starting from the frame number ZDMHAATW2MB003762, a spacer and a Teflon anti-rotation washer have been introduced at the front fixing screw of the shock absorber to prevent possible contact between the rear shock absorber reservoir and the vertical head manifold head guard. The contact results in a cosmetic defect only.</p> <p>In case of complaints from the Customer, it is possible to proceed with the installation of spacer part no. 7111D981AA (A) and washer part no. 7131E352A (B), as shown in the figure.</p> <p>We remind you to always apply the screw M10x45 (1) with Shell GADUS S2 V220 AD 2 grease and to tighten the screw to the new torque of 47 Nm (the previous tightening torque was 45 Nm).</p>

<p>The components are available as spare parts and can be ordered.</p>

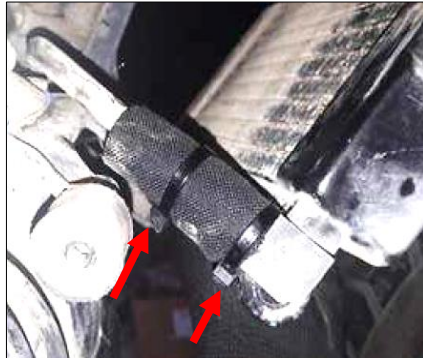
5	<p><u>ONLY</u> Scrambler 1100 PRO (all versions)</p> <p>Irregular operation at idle speed and engine power loss</p>	Vertical cylinder LH spark plug cable	-	<p>As a result of continuous quality tests on the product, we have found a possible irregular operation at idle speed and engine power loss. This phenomenon is due to a settling of the vertical cylinder LH spark plug cable on the coil caused by the contact with the fitting of the oil return pipe from cooler (visible on motorcycle RH side). The MIL light does not come on.</p> <p>We ask you to always check the conditions of vertical cylinder LH spark plug cable and to apply the protective sheath Part no. 4601C581A (cut in half and secured in place with two small self-locking ties) on the fitting of the oil return pipe from cooler to avoid the above-described phenomenon.</p>
