# Instructions for navigating the document

**NEW TOPICS** 3

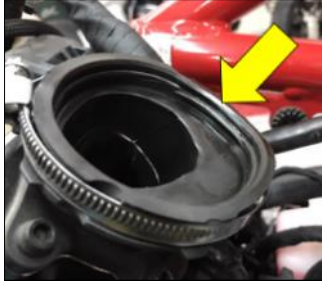
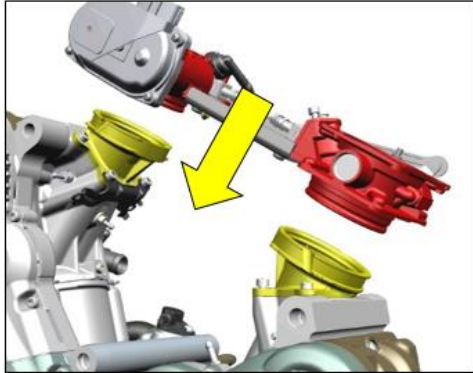
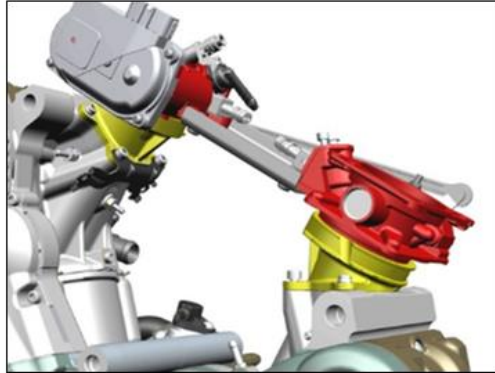
no.	Symptom	Subject	Photo	Notes and Indications - Corrective action
1	<p><u>ONLY</u> <u>Monster 821</u> <u>Monster 1200</u> <u>SuperSport</u></p> <p>Possible engine popping sound during deceleration and/or irregular idling</p>	Airbox

<p>We have received some complaints about a possible engine popping sound during deceleration. The performed analyses have shown that this symptom could be caused by an incorrect installation of the throttle bodies in the relevant intake manifolds (possible deformation of the rubber profile).</p> <p>Therefore, if you find any similar symptoms, we kindly ask you to check the correct installation of the Airbox on the motorcycle and in particular that:</p> <ul style="list-style-type: none"> <li>- throttle bodies are correctly inserted inside rubber intake manifolds, along the whole perimeter;</li> <li>- the rubber profile of the intake manifolds is not deformed.</li> <li>- the 2 fastening ties are correctly positioned in the seat on the intake manifolds</li> </ul> <p><b>Please be reminded that, in order to make throttle body insertion easier on rubber intake manifolds, the use of silicone lubricant or similar product is absolutely necessary.</b></p> <div data-bbox="1137 676 1608 1050">

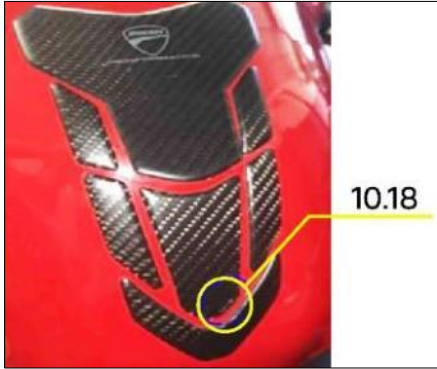
<p>We have received some reports about the detachment of the carbon adhesive protection from the fuel tank. We inform you that the supplier of the component has introduced improvements to avoid the detachment of the protection, since year of manufacture 2019. The lot and the year of manufacture <b>XX-19 (week-year of manufacture)</b> can be identified on the component, like in the example shown in the figure.</p>

<p>In case you still have in stock some carbon tank protectors produced in 2018 you can still sell them to Customers and install them. Should any anomaly occur on the latter, you can manage the replacement of the protection through an accessory warranty. The spare parts in stock have been reclaimed.</p> <p>In any case, it is essential to follow the accessory instructions ISTR-892 ed.01 published in DCS for the application of the tank protection. The cleaning of the tank surface and the use of the template supplied with the protection are essential for a successful application.</p>

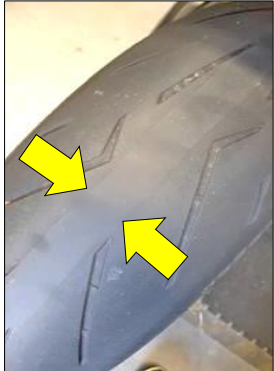
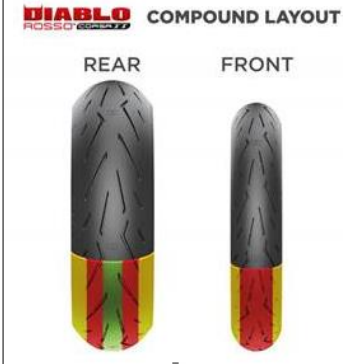
8	<p>Possible formation of a well-marked "band" in correspondence with the central area of the Pirelli Diablo Rosso Corsa II rear tire</p>	<p>Pirelli Diablo Rosso Corsa II rear tire</p>

<p>We have received some isolated reports of the appearance of a "band" in correspondence with the central area of the Pirelli Diablo Rosso Corsa II rear tire.</p> <p>We would like to inform you that, since these are extremely sporty tires with 5 different compound zones at the rear, it can happen that, depending on the type of use of the motorcycle, they wear out in a different way causing the above mentioned phenomenon to occur; sometimes this occurs on the shoulder area, sometimes in the central area but, in general, it is a purely aesthetic phenomenon that does not affect the performance of the tire itself.</p>

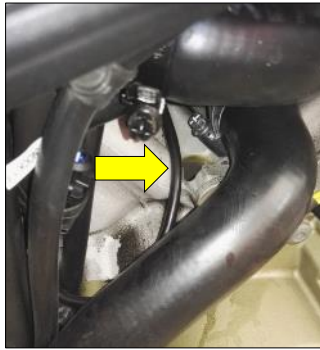
no.	Symptom	Subject	Photo	Notes and Indications - Corrective action
9	<p><u>ONLY</u> <u>Panigale V4</u> <u>Streetfighter V4</u> <u>(all model versions)</u></p> <p>Possible engine oil leakage from the water pump drain hole</p>	Water pump

<p>We have received some isolated reports of possible traces of engine oil leaking out of the drain hole of the water pump; the analysis has shown that this phenomenon is due to a possible incorrect installation of the oil seal by the supplier.</p> <p>We inform you that a new re-designed water pump <b>Part no. 24920510H</b> that avoids the phenomenon described above is now available as a spare part . Should you find traces of engine oil in the drain hole of the water pump on engines with serial number prior to the one indicated above, replace the component.</p>
10	<p><u>ONLY</u> <u>Panigale V4</u> <u>Streetfighter V4</u> <u>(all model versions)</u></p> <p>Possible engine power delivery discontinuity</p>	Engine power delivery	-	<p>We have received some isolated reports about a possible engine power delivery discontinuity.</p> <p>Before making further analyses, we would like to ask you to check coil fastening and, in particular, to <u>apply LOCTITE 243</u> along the threading of fastening screws and tighten them to <b>10 Nm ± 10%</b>.</p>

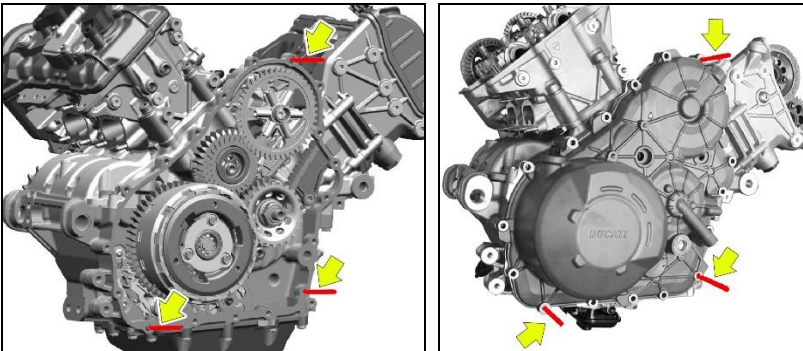
no.	Symptom	Subject	Photo	Notes and Indications - Corrective action
21	<p><u>ONLY</u> <b>Desmosedici Stradale V4</b> <b>ENGINES</b></p> <p>Possible damage to water pump gear oil seal</p>	Water Pump Gear Oil Seal

<p>We have received some reports of a pronounced blow-by effect that may cause small amounts of oil to leak from the clutch cover. This effect could be caused by excessive wear of the water pump gear oil seal on the clutch cover.</p> <p>If this problem is found, we suggest that you check the condition of the oil seal inside the clutch cover and replace it if necessary. When replacing it, remember to lubricate the oil seal with KLÜBERPLUS S 06/100 lubricant (or equivalent) and reposition it correctly using tool part no. <b>887138858</b>.</p> <p><u>Warning:</u> During refitting, for correct positioning of the clutch cover, it is necessary to use 3 centering pins <b>part no. 887132933</b>, positioned as shown in the figure, to avoid possible damage to the water pump gear oil seal.</p>

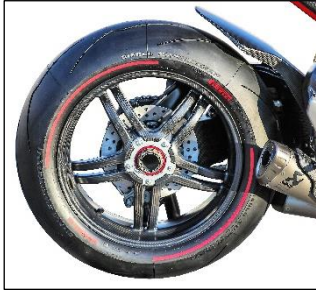
no.	Symptom	Subject	Photo	Notes and Indications - Corrective action
23	<p><u>ONLY</u> <u>Models equipped with carbon rims</u></p> <p>Possible slow loss of front or rear tyre pressure</p>	Carbon rims

<p>We would like to remind you how to detect a possible slow loss of pressure on carbon rims for all versions.</p> <p>Should you find that the problem is caused by the valve/rim coupling (which can be identified with a simple "bubble check"), it is possible to replace the valve only, <b>part no. 49720081A</b>, following the instructions in the workshop manual (e.g. Panigale 1299 Superleggera).</p> <p>If it is not possible to identify the leakage area in the sealing valve, try removing the tyre and refitting it in a different position (e.g. rotated by 180°). The anti-skid treatment of the carbon rim inside the channel is very rough, so special care must be taken when fitting the tyre.</p> <p>Finally, if the problem is not solved, please fill out a <b>YouTech</b> report.</p>

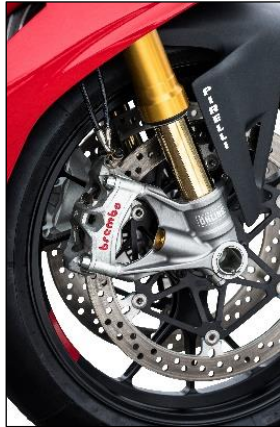
24	<p>Possible traces of brake fluid on the left or right front brake calliper</p>	Front brake calliper hose

<p>We would like to inform you that as a result of the production process of the front brake callipers, on new motorcycles that are being pre-delivered, there may be traces of brake fluid that could lead to think there is a defect that is not actually present.</p> <p>Should you detect this issue, please:</p> <ul style="list-style-type: none"><li>• wash the area of the brake calliper affected by the fluid trace with water and dry it thoroughly;</li><li>• fit a self-locking tie (NO elastic band) to the throttle twistgrip so as to keep the brake lever (<i>Figure A</i>) pulled;</li><li>• leave the front brake system under pressure for a whole day;</li><li>• ensure there are no oil traces on the calliper.</li></ul> <p>If the leak is confirmed, photograph it and fill out a <b>YouTech</b> service request and replace the affected brake calliper.</p>

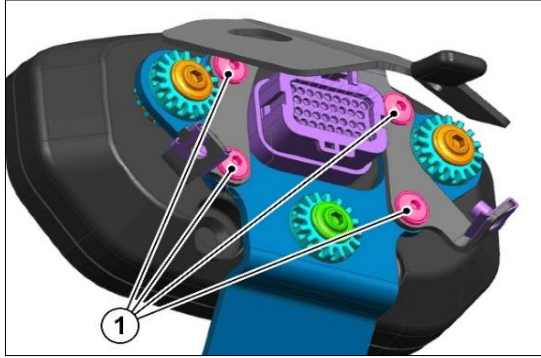
no.	Symptom	Subject	Photo	Notes and Indications - Corrective action
1	<p><u>ONLY</u> <b>Monster Plus MY21 (937cc)</b></p> <p>M5x8 screws are missing from the kit supplied with the vehicle</p>	<p>Kit supplied with the vehicle</p>

<p>We have received a few reports stating that <b>4 M5x8 screws (1)</b> part no. 77240243C required to fix the headlight fairing support bracket to the instrument panel support bracket are missing from the kit supplied with the motorcycle.</p> <p>We would like to inform you that the kits available in stock have all been sorted out.</p> <p>For the headlight fairing assembly procedure and all Pre-delivery operations, please refer to the model introduction bulletin SRV-SRB-21-022.</p>

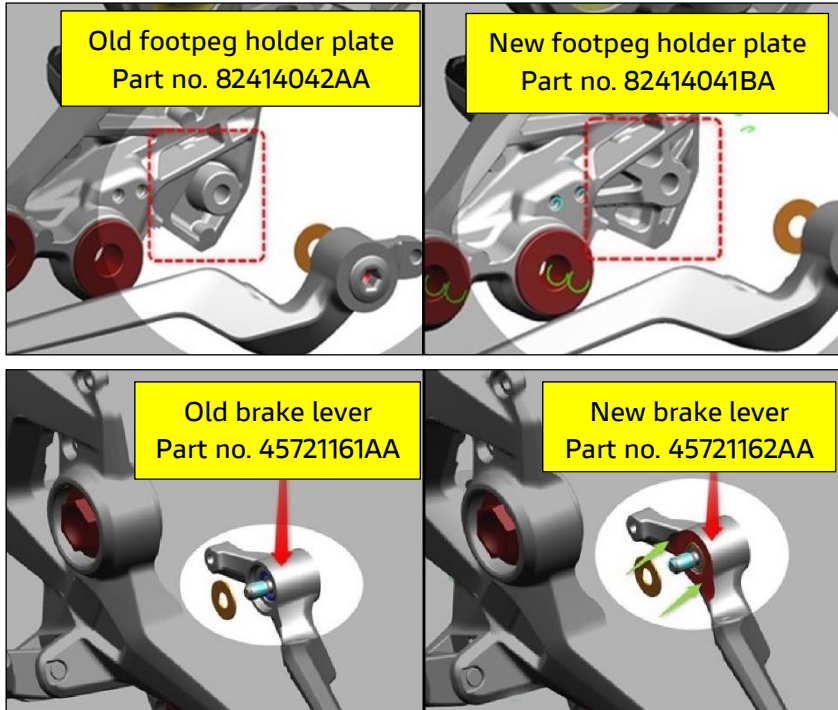
<p>We have received some reports on the possible breakage of the right-hand footpeg holder plate in the area close to rear brake pedal retaining screw. All the cases analysed were caused by a fall of the vehicle or an incorrect fixing of the vehicle during transport.</p> <p>We would like to inform you that the issue described above has been analysed and a new reinforced right-hand footpeg holder plate with Part no. 82414041BA has been introduced. At the same time, a new brake lever with Part no. 45721162AA has been made, as <u>the previous brake lever cannot be installed on the new plate.</u></p> <p>For this reason, the new rear brake lever should also be ordered when ordering a new right-hand footpeg holder plate.</p> <p>If only the rear brake lever needs to be replaced, you can order the single component available in the catalogue, as it is compatible with the old footpeg holder plate.</p> <div data-bbox="1205 754 2040 1466">

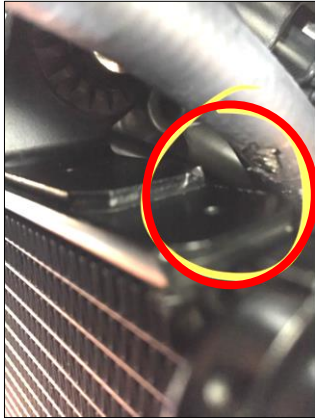
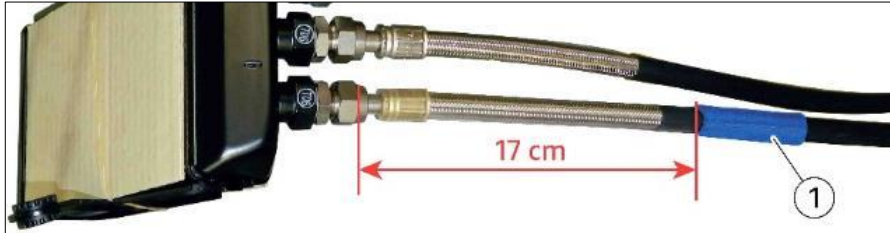
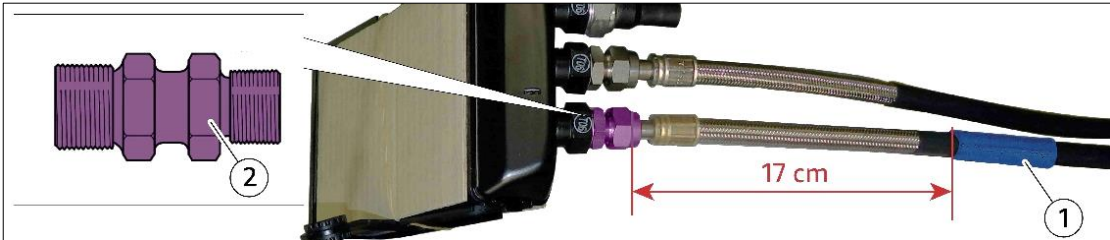
no.	Symptom	Subject	Photo	Notes and Indications - Corrective action
3	<p>ONLY  <b>Multistrada 950 MY 17-20</b>  <b>Multistrada 1200 MY 15-17</b>  <b>Multistrada 1260 MY18-20</b>  <b>(all model versions)</b></p> <p>Possible superficial damage to the oil cooler return pipe</p>	Oil cooler pipes

<p>We have received some isolated reports of possible surface damage to the oil cooler return pipe due to rubbing with the top of the coolant radiator, over time. <u>This phenomenon is purely aesthetic and does not affect the correct operation of the system.</u> We inform you that for the models:</p> <p>a) <b>Multistrada 1260:</b>  starting from the frame number ZDMAC03AAAKB011354 (on 27/05/2019) the <b>anti-abrasion sheath (1) part no. 4601H701A</b> has been introduced on the oil cooler return pipe, positioned at a distance of <b>17 cm</b> measured from the upper end of the fitting. (This solution is also applicable to all Multistrada 1200 versions Model Year 2015-2017).</p>

<p>b) <b>Multistrada 950:</b></p> <ul style="list-style-type: none"> <li>- starting from the frame number ZDMAD00AAKB002259 (on 10/05/2019) the <b>anti-abrasion sheath (1) part no. 4601H701A</b> has been introduced on the oil cooler return pipe, positioned at a distance of <b>17 cm</b> measured from the upper end of the fitting;</li> <li>- starting from the frame number ZDMAD00AALB005691 (on 12/03/2020) the longer fitting (2) part no. 81510391A has been introduced at the oil return pipe outlet from the cooler.</li> </ul>

<p>We ask you to always check the condition of the oil cooler return pipe, and to replace it ONLY if the rubber sheath is damaged and the metallic braided hose can be seen. Follow the assembly notes indicated above according to the reference model. The spare part catalogue has been updated.</p>

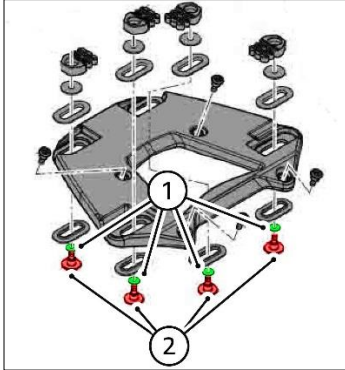
8	<p><b>ONLY</b> <b><u>Multistrada V4</u></b> <b><u>(all model versions)</u></b></p> <p>Possible incorrect operation of the swinging system - Top Case accessory kit part no. 96781531AA</p>	Top Case Part no. 96781531AA

<p>We inform you that the first Top Case accessory kits part no. 96781531AA delivered may not operate correctly with the swinging system, which may seem "too braked". To improve this condition, it is possible to insert <b>4 copper washers (1)</b> part no. <b>85250231A</b> on the <b>4 screws (2)</b> retaining the bottom plate to the top one.</p> <p>For a better understanding of the assembly procedure of the Top Case accessory kit, a video has been made which can be viewed at the following link: <a href="https://youtu.be/DVEHKVvdKQI">https://youtu.be/DVEHKVvdKQI</a>.</p> <p>All Top Case kits in stock will be restored by February 2021.</p>

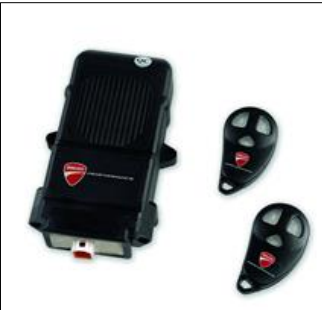
<p>We have received some reports concerning the difficulty in securing the Top Case (Kit Part no. 96781531AA) to the top plate Part no. 8291M033A due to a machining error of the supplier. In particular, the locking tooth on the upper plate Part no. 8291M033A shows a hole 2mm narrower than specified. To eliminate this defect, the locking tooth of the plate must be milled by <u>2mm in the upper area</u> using a flat file, as shown in the figure.</p> <p>We inform you that the upper plates present inside the kits in stock have been restored.</p>
27	Anti-theft system kit Part no. 96681081AA malfunction	Anti-theft system kit Part no. 96681081AA

<p>After having installed the anti-theft system Kit Part no. 96681081AA and enabled it on the BBS control unit, some malfunctions may occur during activation due to a possible incorrect pin arrangement in the connector of the wiring branch supplied with the kit.</p>

<p>The kits currently in stock have been restored.</p>

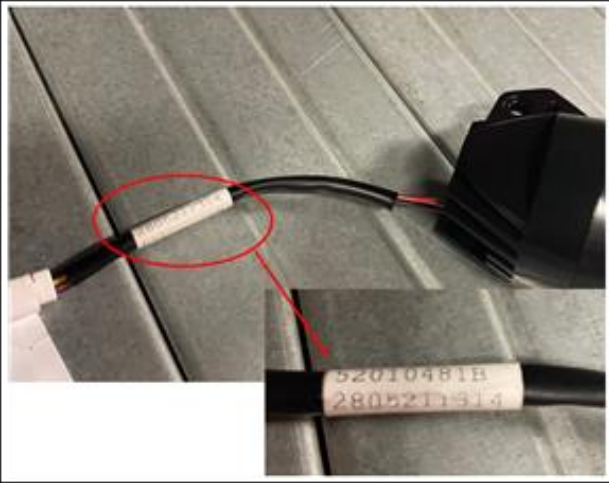
no.	Symptom	Subject	Photo	Notes and Indications - Corrective action
39	<p><u>Multistrada V4, ONLY</u> <u>(all versions)</u></p> <p>Possible water infiltration into the fog lights</p>	Fog lights

<p>We have received some reports of unusual infiltration of water into the LED supplementary lights, which are available as spare parts – accessory part no.: <b>96681031AA</b>. For this reason, the supplier has introduced some considerable improvements in the assembly, which should avoid the problem. In case of an unusual presence of water, please check the manufacturing date indicated on the label on the wiring:</p>

<p>The first line corresponds to the part number (52010481B). The second line contains the date: the first two digits correspond to the day, the next two digits correspond to the month and the following two digits correspond to the year. The last four digits correspond to an internal serial code.</p> <p>E.g. code in figure <b>2805211314</b> → 28 May 2021</p>

<ul style="list-style-type: none"> <li>- If the date is prior to 01 August 2021 and you notice water infiltrations, replace the lights.</li> <li>- If the date is the same or after 01 August 2021, inform your Area Manager with a specific <b>Yotech</b>, explicitly indicating the date on the headlight, and attaching any photographic documentation.</li> </ul>

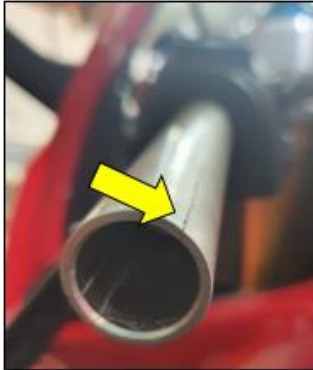
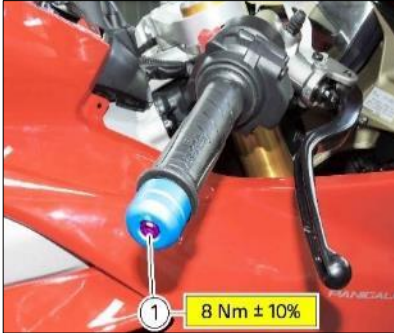
2	<p><u>ONLY</u> <u>Panigale V4</u></p> <p>Precautions during PDI: installation of the balancing weights on the handlebar</p>	Balancing weights on handlebar

<p>We received some isolated claims about the possible triggering of a longitudinal crack on the handlebar, on balancing weight side. Our laboratory analyses found that said crack is due to an excessive tightening torque applied when installing the balancing weights.</p> <p>When installing balancing weights on the handlebar, please comply with the tightening torque specified for the M6x55 screw to <b>8 Nm ± 10%</b>, as indicated on the bulletin introducing the model and on the Workshop Manual.</p>

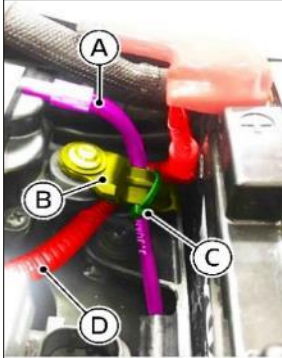
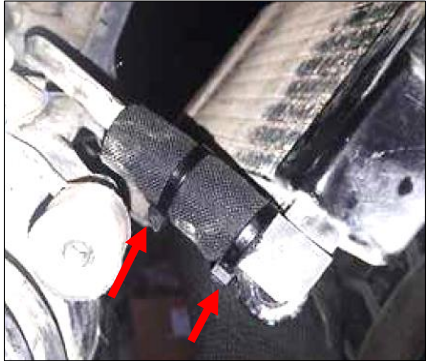
5	<p><u>ONLY</u>  <b>Scrambler 1100 PRO</b>  <b>(all versions)</b></p> <p>Irregular operation at idle speed and engine power loss</p>	Vertical cylinder LH spark plug cable	-	<p>As a result of continuous quality tests on the product, we have found a possible irregular operation at idle speed and engine power loss. This phenomenon is due to a settling of the vertical cylinder LH spark plug cable on the coil caused by the contact with the fitting of the oil return pipe from cooler (visible on motorcycle RH side). The MIL light does not come on.</p> <p>We ask you to always check the conditions of vertical cylinder LH spark plug cable and to apply the protective sheath Part no. 4601C581A (cut in half and secured in place with two small self-locking ties) on the fitting of the oil return pipe from cooler to avoid the above-described phenomenon.</p>
