RCA-78-22-006-1: Increase Clearance between Frame Harness and Steering Column

Document Type	Customer Satisfaction Campaign Bulletin
Date	April 12, 2022
Affected Region(s)	USA
Affected Model(s)	R1T
Model Year(s)	2022
Approximate Build Dates Refer to the FSA Dashboard to determine if this document applies to a specific vehicle.	August 2021 - October 2021
Vehicle System	78 - Low Voltage Electrical
Minimum Service Location	Mobile

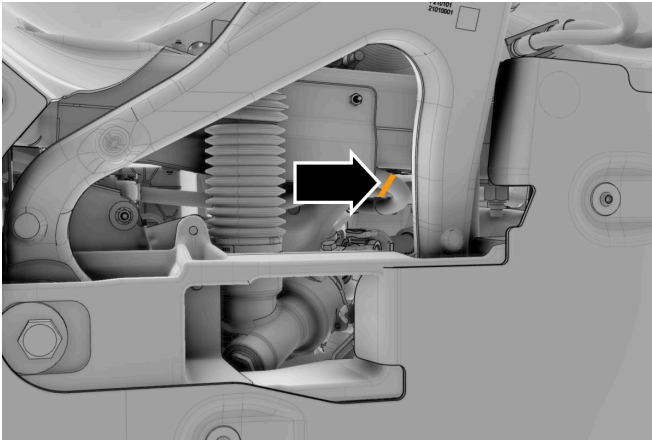
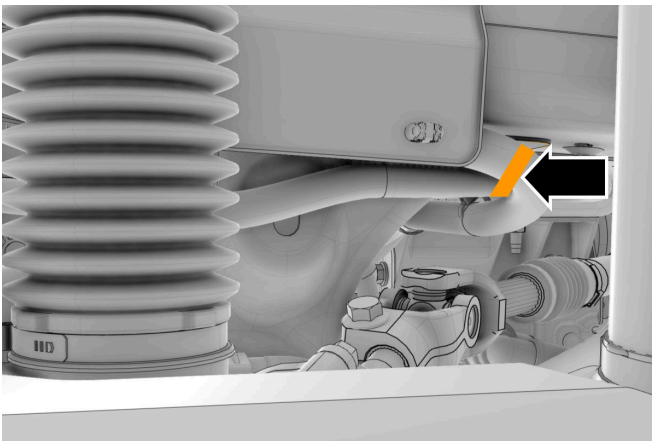
Rivian is initiating a customer satisfaction campaign for some model year 2022 R1T vehicles that may have been built with a low clearance condition between the left front frame harness and the steering column intermediate shaft. If the frame harness touches the steering column intermediate shaft and this condition persists over time, the vehicle may experience a wear-through condition of the wires in the frame harness. The wear-through condition, which has not been observed to date in any customer vehicle, would only result if the frame harness length is near the limits of the specification and the nearby harness that normally constrains the frame harness is misrouted. The potential wear-through condition may result in a loss of electronic stability control. If loss of electronic stability control occurs, the vehicle will enter a reduced performance safe-state mode and an "Electronic Stability Control (ESC) system malfunction" indicator light will illuminate on the driver display alerting the driver to have service performed on their vehicle. Rivian will install a cable tie to ensure clearance between the frame harness and the steering column intermediate shaft. Rivian is launching this campaign for customer satisfaction and to ensure the quality of Rivian vehicles.

2. Install the cable tie to secure the frame harness to the power steering harness. Tighten the cable tie enough so that the frame harness can not contact the steering column intermediate shaft.
