Engine Control Module (EMS) Software Information - Improvement List, August 2021 - US17+OBD2019 Emissions ONLY

Software Release Table (Latest information at top)

EMS software improvements with MSW Part Number 23969369/23985827.

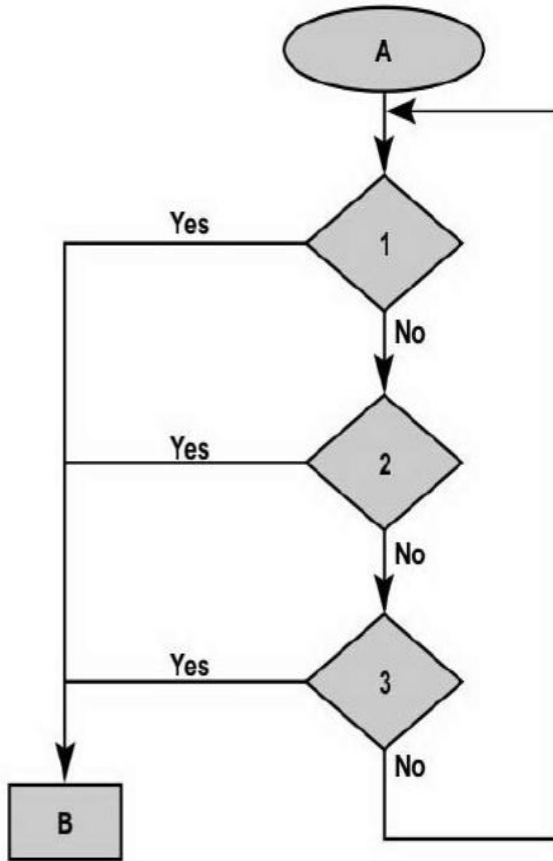
Smart Revert High Level Summary

Smart Revert was added to prevent urea doser clogging. Reduces occurrences of clogged urea dosage valve. Smart Revert requires EMS and ACM software for functionality.

DEF Delayed Draining Function	
A	Engine Shutdown/Key Off
1	DEF is at risk of freezing
2	Battery voltage is below 12.2v
3	DEF system waiting state exceeds 17 hours (the maximum time delay)
B	Initiate DEF draining process
