## Volvo SNV15-002 Meritor - WABCO ECAD - Electronically Controlled Air Dryer, Connector Issue

**Bulletin:** SNV15-002  
**Date:** Jan. 7, 2015  
**Valid to:** Until Further Notice  
**Replaces:** N/A  
**Action Required?** **Yes**

**Subject:** Meritor-WABCO ECAD – Electronically Controlled Air Dryer.

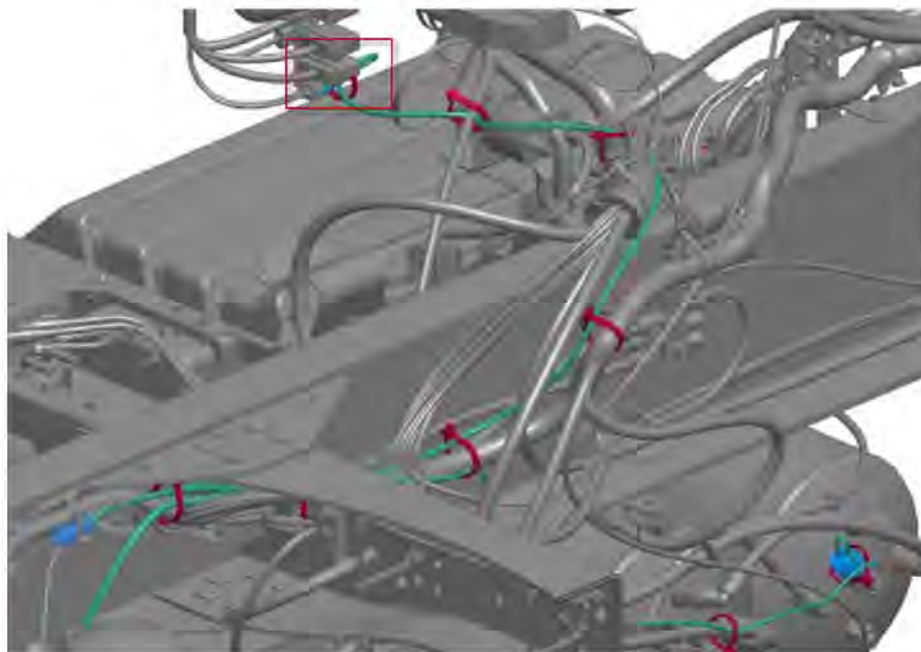
Volvo Trucks has received complaints of paint in the air dryer harness connector on units equipped with Meritor-WABCO Electronically Controlled Air Dryers. Paint build up in this connector can cause erratic air dryer behavior including, but not limited to, over-pressurizing of the system (including opening of wet tank relief valve) and excessive moisture build up. This connector should be the first point of inspection when trouble-shooting Meritor-WABCO ECAD issues until further notice.

The concerned connector is a six pin connector that goes from the air dryer harness to the main cab harness. It is located on the LHS over the battery box in most cases, see illustration below.

If paint is found in the connector, clean thoroughly and reassemble. Continue normal trouble-shooting if this does not resolve the problems.

In some cases when paint in the connector has caused over pressurization of the system for an extended period of time the spring in the pressure relief valve could be weakened causing it to relieve pressure below the cutout pressure of the compressor. Using an external gauge in the wet tank to differentiate between over pressurization and a weakened relief valve might be necessary in some cases. Replace Pressure Relief Valve 21608472 as needed.

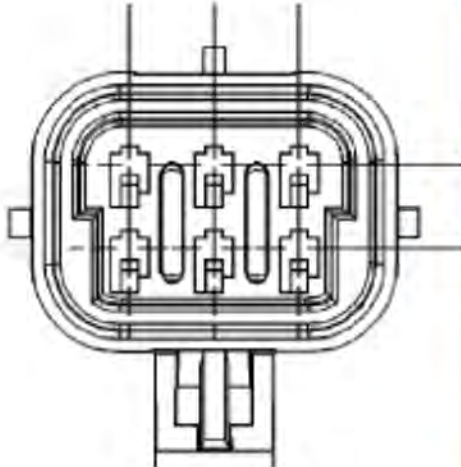
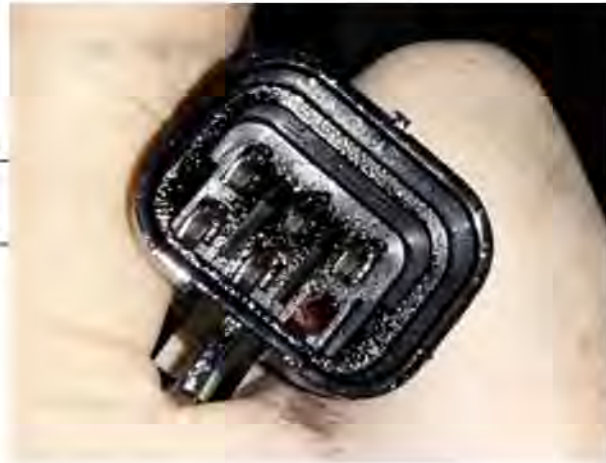
Below are pictures showing the connector.
