## Volvo Chassis - Windshield Wiper Function Inoperative In Intermittent Mode ONLY

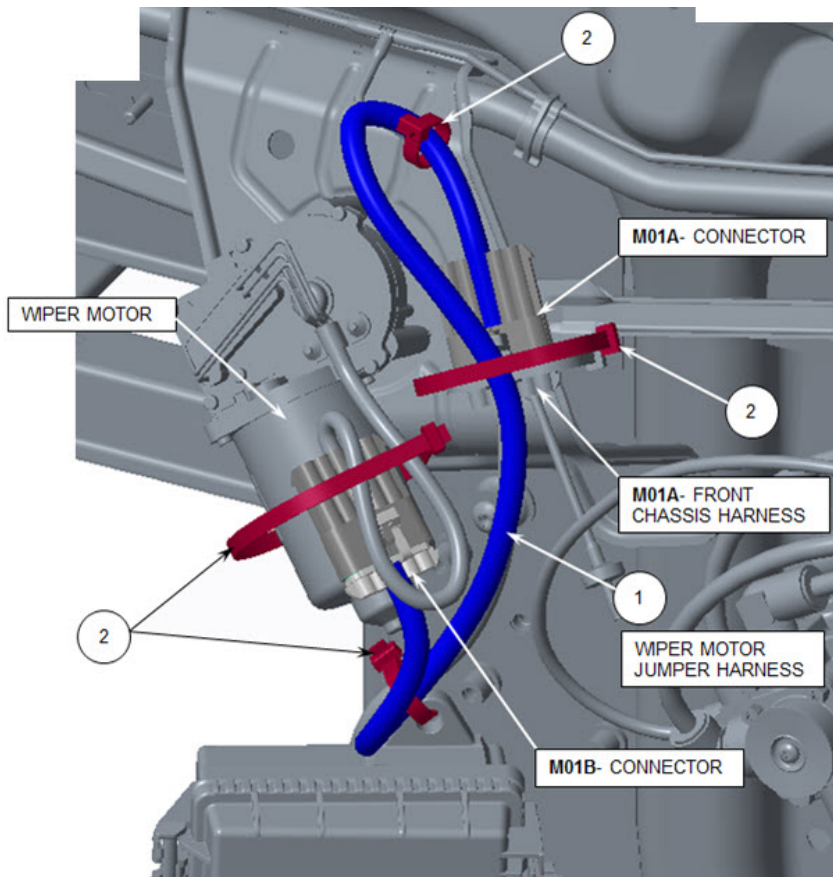
A partial containment will be for the installation of a jumper harness that contains a resistor to increase the current flow to the motor slip ring. Future containment will be a new cab harness that will have the resistor integrated.

1. Order Harness Jumper 23522546.
2. Install the jumper harness as shown in the picture below.

Live UI motor functionality after harness installation, typically the wiper motor does not need to be replaced.
