Technical product information

Topic	W12 TSI - Engine MIL light illuminated with numerous DTC's within 0001 including - P032700 and/or P033200
Market area	Russische Föderation (5RU),Australia E04 Bentley rest Asia and Australia (6E04),China 796 VW Import Comp. Ltd (Vico), Beijing (6796),Germany E02 Bentley rest Europe (6E02),Japan E03 Bentley Japan (6E03),Korea, (South) E08 Bentley South Korea (6E08),United Arab Emirates E06 Bentley Middle East and Africa (6E06),United Kingdom E01 Bentley UK (6E01),United States E05 Bentley USA and rest America (6E05)
Brand	Bentley
Transaction No.	2065398/2
Level	EH
Status	Approval
Release date

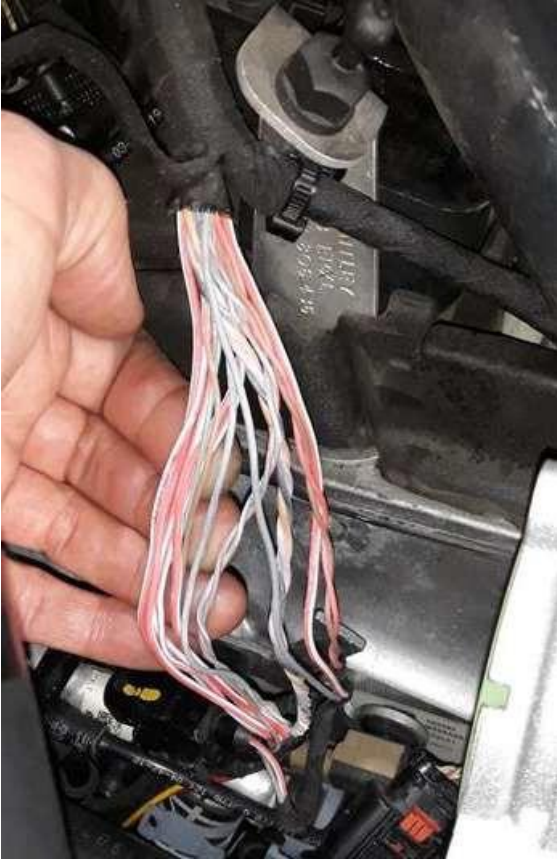
2) Referring to Figure 2 - Remove the harness tape in the location shown, check for any damaged/broken wiring
