Rattling from the Front of the Vehicle

Supersedes 20-036, dated June 3, 2021, to revise the information highlighted in yellow

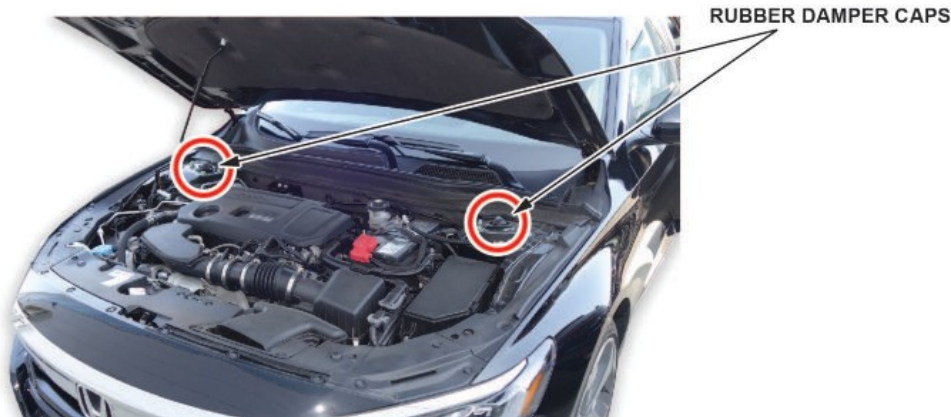
The rubber damper cap(s) are faulty.

Remove the rubber damper caps, then test-drive the vehicle.

- If you no longer hear a rattling from the front of the vehicle with the caps removed, go to REPAIR PROCEDURE.
- If you still hear a rattling from the front of the vehicle with the caps removed, this bulletin does not apply. Continue with normal system troubleshooting.
