Service Bulletin

Bulletin No.: 22-NA-088

Subject: Roof Panel Joint Front Finish Molding Gap Near Front of Windshield

Brand:	Model:	Model Year:		VIN:		Engine:	Transmission:
		from	to	from	to		
BrightDrop	EV600	2022	2022			All	All

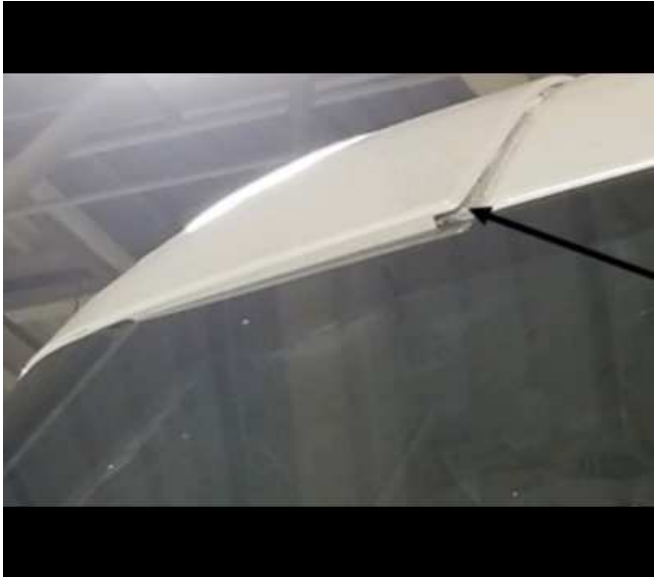
<p style="text-align: right; font-size: small;">6051386</p> <p>Some customers may comment that one, or both, of the roof panel joint front finish moldings sit higher than desired where the forward area of the upper roof cap meets the windshield.</p>
Cause	The cause of the condition may be that the roof finish molding forward edge can contact adhesives used in the build process, thus not allowing it to sit flush.
Correction	Upon verifying the condition, follow the repair steps in the Service Procedure below.
