# Technical product information

<b>Topic</b>	DTC P263500 with symptom code -10061 - Noise from within the fuel tank
<b>Market area</b>	Russische Föderation (5RU),Australia E04 Bentley rest Asia and Australia (6E04),China 796 VW Import Comp. Ltd (Vico), Beijing (6796),Germany E02 Bentley rest Europe (6E02),Japan E03 Bentley Japan (6E03),Korea, (South) E08 Bentley South Korea (6E08),United Arab Emirates E06 Bentley Middle East and Africa (6E06),United Kingdom E01 Bentley UK (6E01),United States E05 Bentley USA and rest America (6E05)
<b>Brand</b>	Bentley
<b>Transaction No.</b>	2066591/1
<b>Level</b>	EH
<b>Status</b>	Approval
<b>Release date</b>

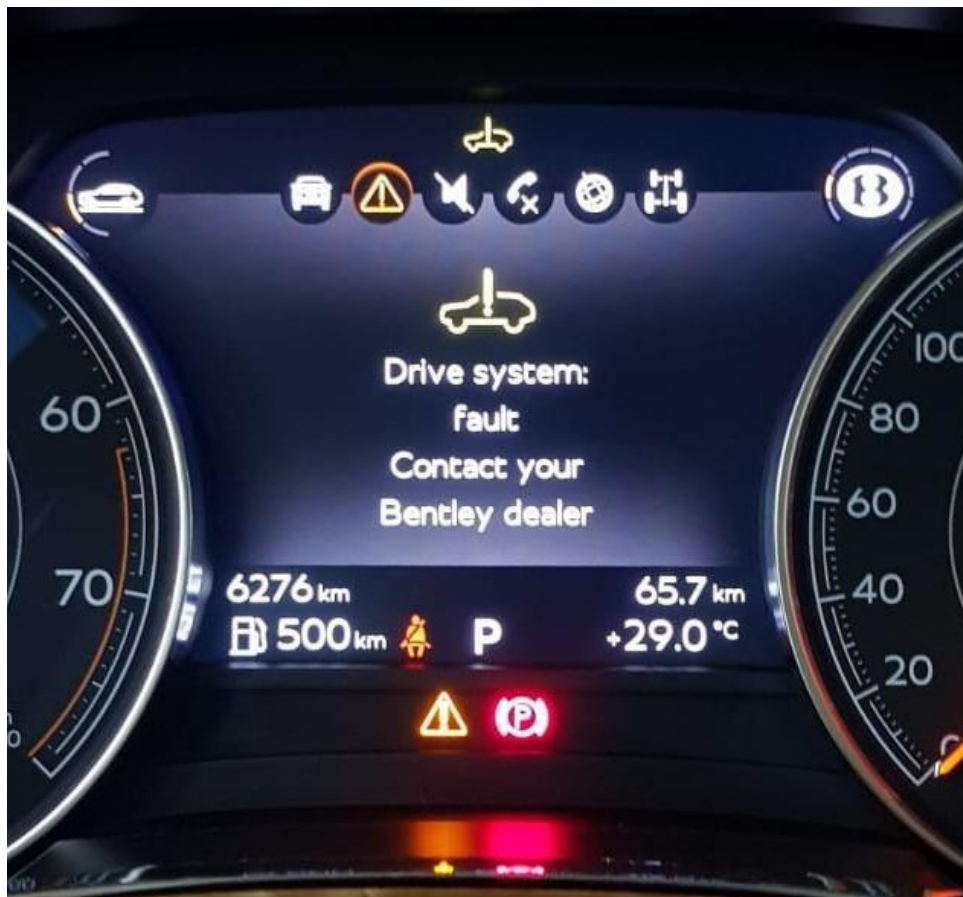
Figure 1

- Drive system fault warning within the DIP (Figure 1)

- DTC P263500 - Fuel Pump "A" Low Flow/Performance evident within diagnostic address 01 and/or 11 - With symptom code 10061
- Noise from within the fuel tank (fuel pump) - Refer to the video on the Bentley hub referencing TPI 2066591/-

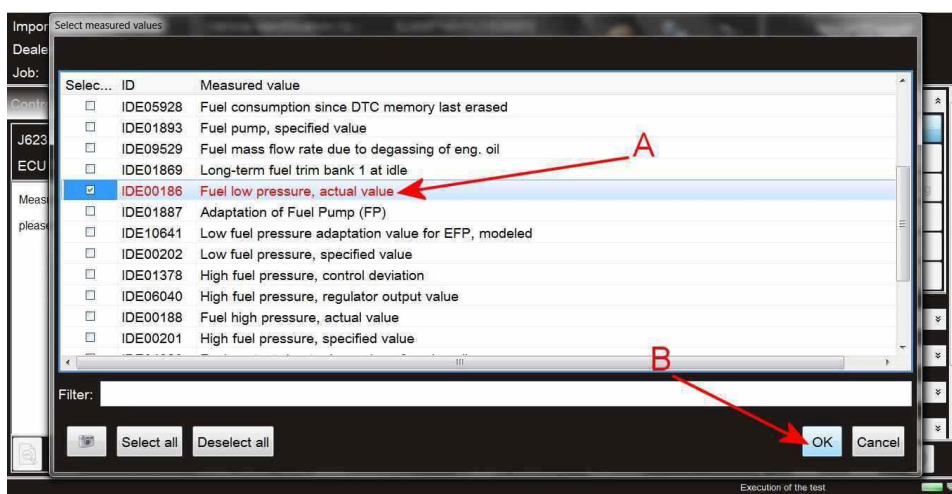
- The engine must be running and at operating temperature, Do Not switch off the engine until advised CAUTION: Ensure that suitable exhaust extraction is used whilst the engine is running within the workshop
- Using ODIS Carry out a full GFF of all control modules
- Clear all applicable DTC's
- Select Engine control module 1
- Select Guided functions - Read measured values
- Referring to Figure 2 (Point A) - Navigate to Measured value IDE00186 Fuel low pressure, actual value

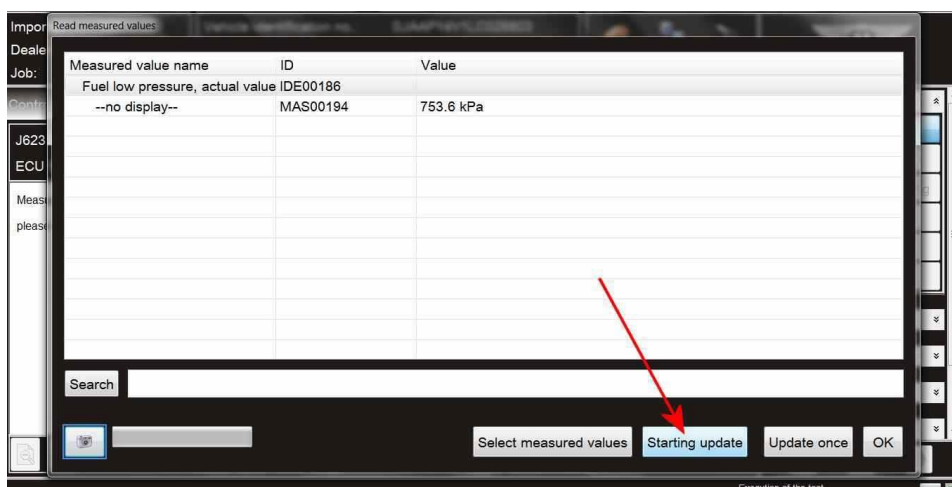
### 2) Referring to Figure 3 - Select Starting update

- Switch off the engine and leave the ignition on
- Monitor the pressure decay of the low pressure fuel system for 10 minutes

- Should the pressure drop below 300 kPa after 10 minutes and the fuel tank fuel pump is noisy (as per the video on the Bentleyhub) the operative should replace the fuel pump as instructed within Rep.Gr 20 - Fuel pump, fuel level sensors, and jet pump (RH) - To remove and fit
