Technical product information

Topic	Engine coolant - Overheat condition - Warning evident within the DIP - DTC's P2B6500 and P2B8600 are evident
Market area	Russische Föderation (5RU),Australia E04 Bentley rest Asia and Australia (6E04),China 796 VW Import Comp. Ltd (Vico), Beijing (6796),Germany E02 Bentley rest Europe (6E02),Japan E03 Bentley Japan (6E03),Korea, (South) E08 Bentley South Korea (6E08),United Arab Emirates E06 Bentley Middle East and Africa (6E06),United Kingdom E01 Bentley UK (6E01),United States E05 Bentley USA and rest America (6E05)
Brand	Bentley
Transaction No.	2066669/1
Level	EH
Status	Approval
Release date

W12-New Continental GT/GTC (All variants) & New Flying Spur

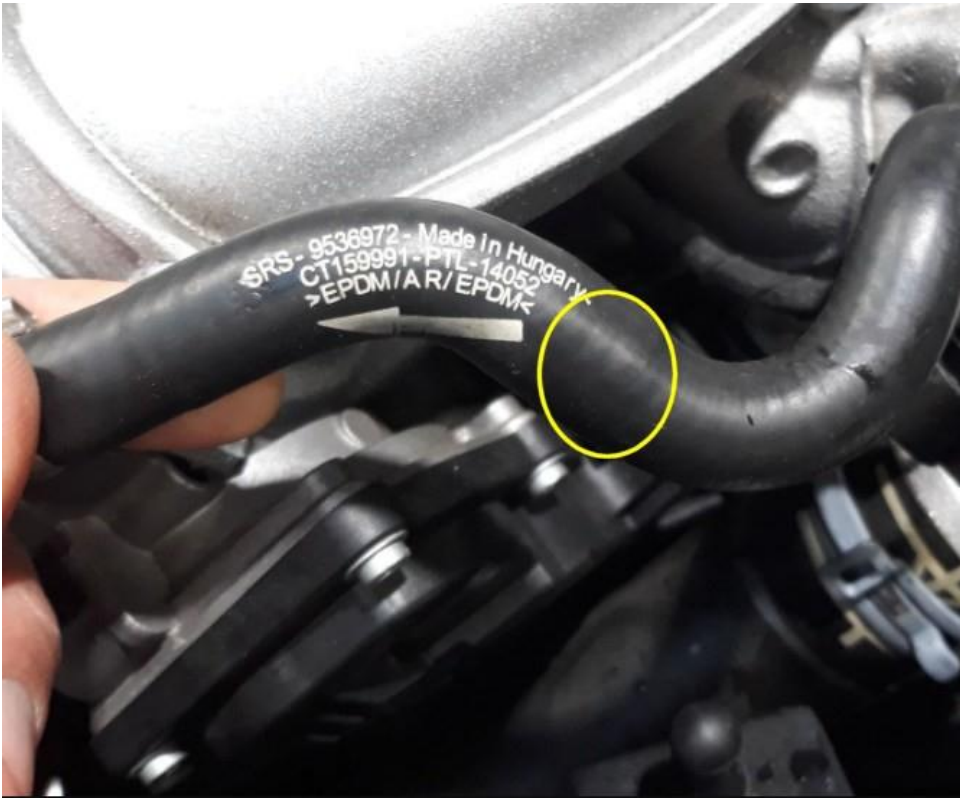
- The vent hose has an internal check valve, the valve is positioned within the vent hose at the location shown in Figure 3 (Circled)

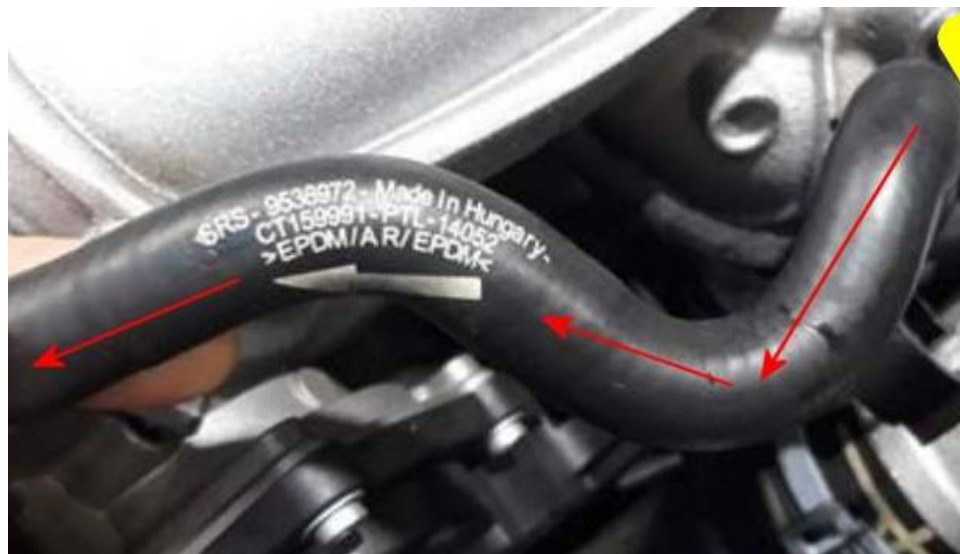
- Referring to Figure 4 - The coolant flows in the direction shown (Arrows) in the event the internal check valve is faulty the flow of the coolant will be restricted (Causing the symptoms described within the customer findings/workshop findings section)

4) Replace the vent line

- Once the vent line has been replaced - Referring to Rep.Gr 19 - Bleed the coolant system
- Erase all applicable DTC's
- Conduct a road test - On return check to confirm that no coolant related DTC's are evident

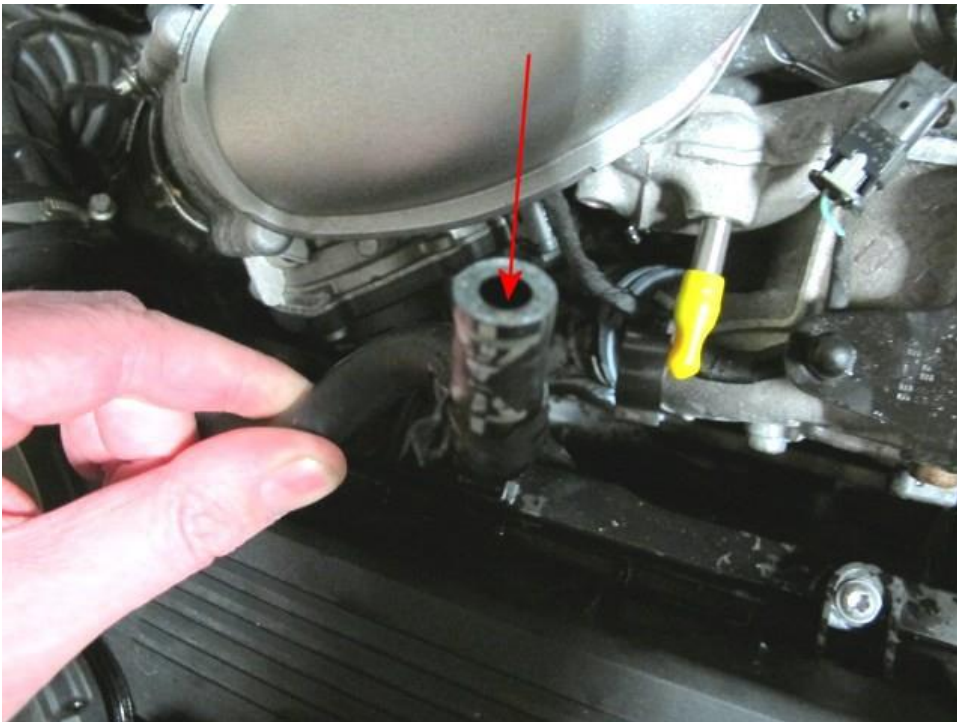
Does the air flow through the vent line without any restrictions?

5) Referring to Figure 8 - Apply light air pressure into hose (Arrow)

No - Go to step 4

Yes - Raise a DISS query and await feedback before conducting any further work
