Field campaign

Topic	FPIN tag - Not attached to the vehicle keys (SC22/13)
Market area	China 796 VW Import Comp. Ltd (Vico), Beijing (6796),Germany E02 Bentley rest Europe (6E02),United Kingdom E01 Bentley UK (6E01),United States E05 Bentley USA and rest America (6E05)
Brand	Bentley
Transaction No.	2066724/1
Campaign number	EC39
Note	
Type	
US code

Bentayga - New Continental GT/C and New Flying Spur

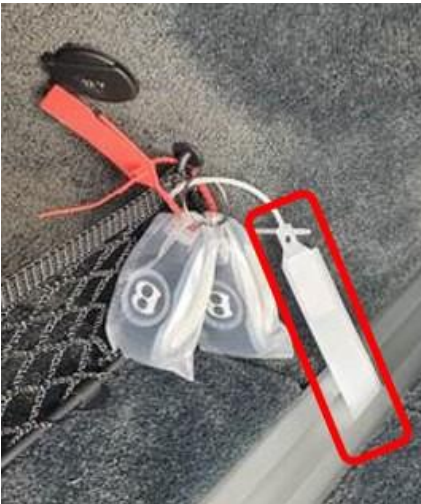
▪
Please Note: This is an ongoing exercise and therefore the latest VIN list can be found within the Bentley Hub The white FPIN tag is not attached to the vehicle keys

- Figure 2 shows how the vehicle key sets should have been supplied (with the white FPIN tag attached)

▪
VERY IMPORTANT: In the event the white FPIN tag is evident as shown in 2 and 3, the 10 digit FPIN vehicle code can be entered into MMI, in this scenario there is no need to raise a DISS query for a new FPIN, the operative should refer to the Identification section of this TPI to ensure the specific VIN is removed from the applicability list

If there is no white FPIN tag carry out the instructions within the work section

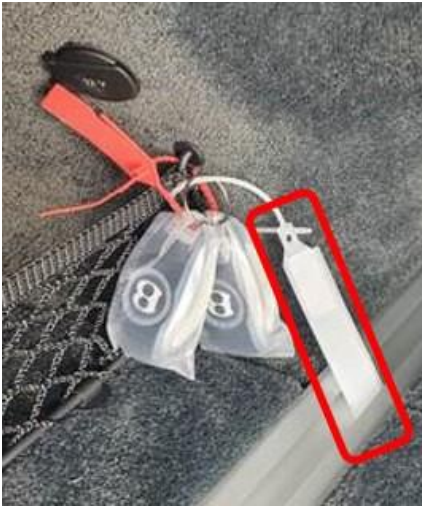
Please Note: This is an ongoing exercise and therefore the latest VIN list can be found within the Bentley Hub The white FPIN tag is not attached to the vehicle keys

- Figure 2 shows how the vehicle key sets should have been supplied (with the white FPIN tag attached)

VERY IMPORTANT: In the event the white FPIN tag is evident as shown in 2 and 3, the 10 digit FPIN vehicle code can be entered into MMI, in this scenario there is no need to raise a DISS query for a new FPIN, the operative should refer to the Identification section of this TPI to ensure the specific VIN is removed from the applicability list

If there is no white FPIN tag carry out the instructions within the work section
