Service Update

N222360520 Outdated Map Data (Inventory Vehicles Only)

Release Date: May 2022

Models: 2022 Chevrolet Bolt EUV
Equipped with Super Cruise (RPO UKL)

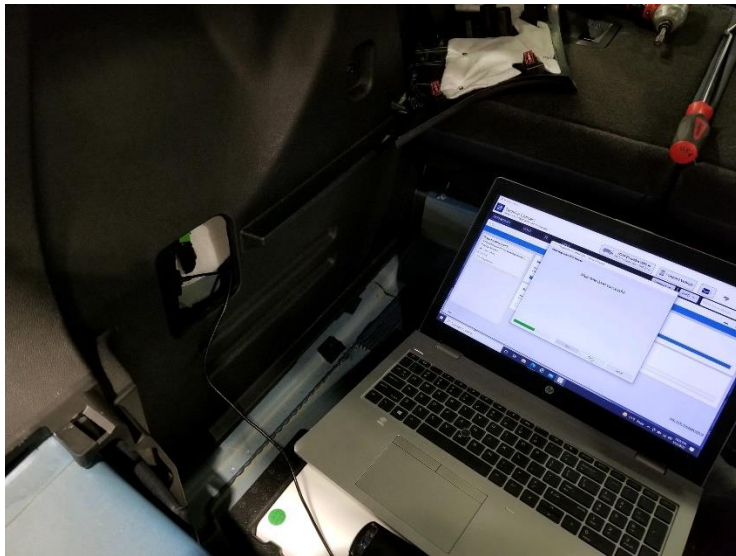
6051151

1. Key on vehicle select "Disable WiFi" through the radio settings.
2. Key off the vehicle and let it go to sleep.
3. Key the ignition ON.
4. Connect battery support tool 12V and connect SPS Bypass hood latch switch.
5. Remove left inner rear panel access door.
6. Remove USB cap from bottom of the K179 Digital Map Control Module located at the left inner rear panel access door.

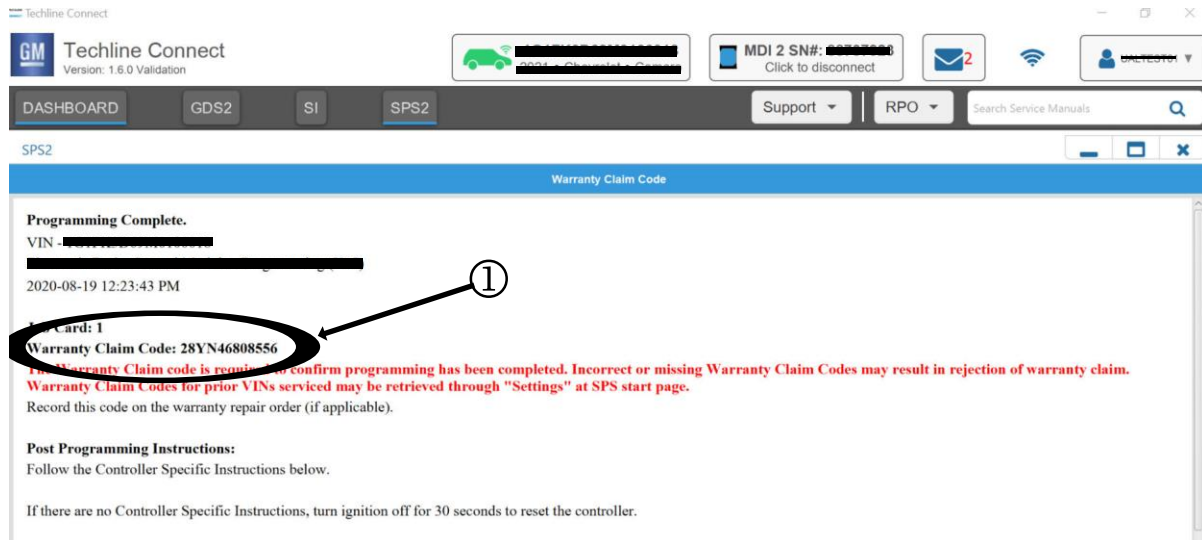
5644478

Note: The screenshot above is an example of module programming and may not be indicative of the specific module that is being programmed. Module selection and VIN information have been blacked out.

Important: To avoid warranty transaction rejections, you **MUST** record the warranty claim code provided on the Warranty Claim Code (WCC) screen shown above on the job card. Refer to callout 1 above for the location of the WCC on the screen.

17. Record SPS Warranty Claim Code on job card for warranty transaction submission.
