# HYUNDAI

## Technical Service Bulletin

GROUP	NUMBER
CAMPAIGN	22-01-031H
DATE	MODEL(S)
APRIL 2022	Sonata Hybrid/Plug-In (LF HEV/PHEV)

**SUBJECT:** ENGINE MONITORING LOGIC (SERVICE CAMPAIGN 982)

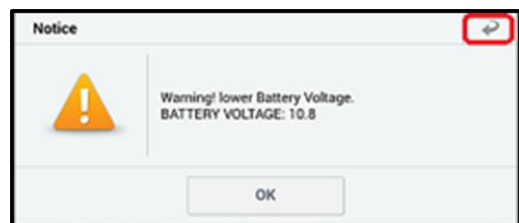
**GDS Vehicle Battery Voltage Warning:**

If voltage is below 12 volts as per the GDS warning, then select **Back** and run the engine at least 15 minutes to reach an adequate battery state of charge to prevent ECU Update failure. Cycle the ignition **OFF/ON** before retrying ECU update again.
