Service Bulletin

Bulletin No.: 18-NA-115

Subject: Cold Start Misfire and/or Rough Idle – DTC P0300 May Be Set

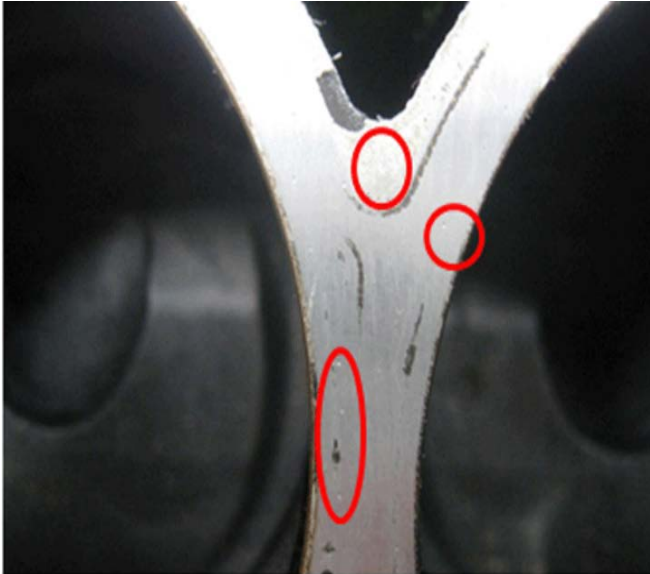
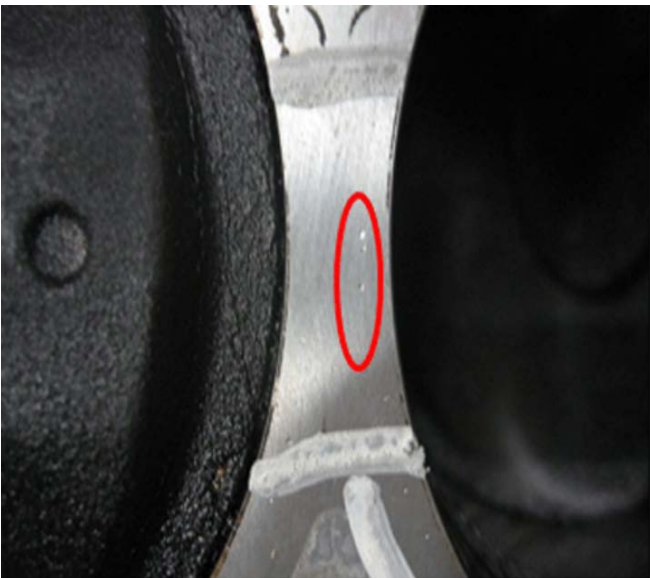
Notice: Small surface pock marks or pitting appearance on the deck surface is normal and an engine should not be replaced for any such appearance marks as they do not connect to the engine coolant passages and cause a leak path that will generate engine misfires.

6. With the cylinder head removed, perform a visual inspection. Reference the following pictures provided. The first two pictures represent normal examples of deck pitting and **are not** the cause of the misfire and/or rough idle condition.

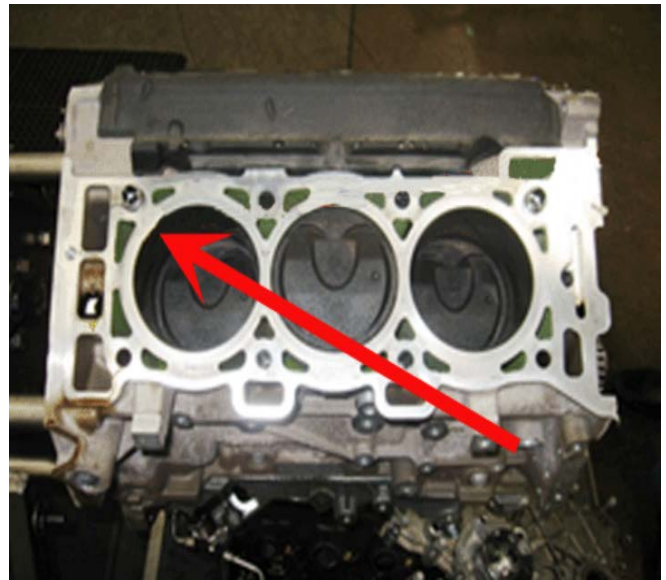
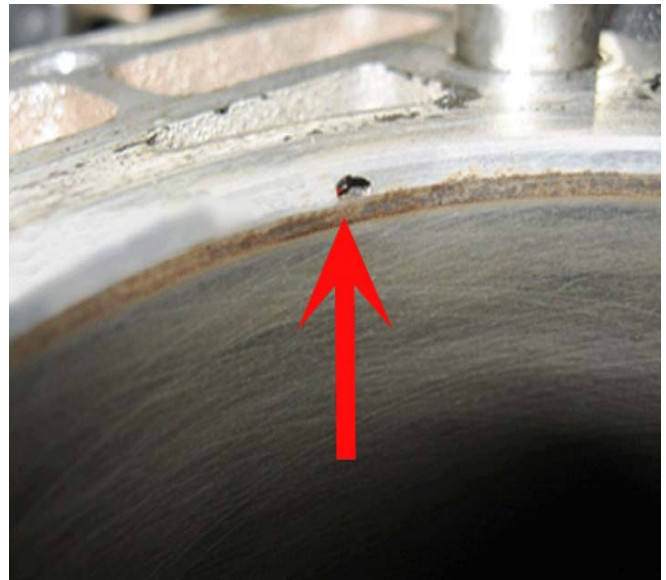
7. The two following pictures represent an example and the location of how actual engine cylinder block porosity appears. This would be a cause of the condition.

Notice: This porosity condition is rare, therefore the technician should inspect the suspect cylinder(s) and look for a break/pinhole in the carbon ring area.

Shown at the deck face to cylinder liner interface location is an area of engine cylinder block porosity that has caused an engine coolant leak path into the cylinder, causing medium to high misfire counts when the engine is cold.

⇒ If this condition is verified, the engine **must** be replaced.
