Service Update

N222362410 Main Body Wire Harness Contact Damage

Release Date: May 2022

Condition	Certain 2022 model year BrightDrop 600 eLCV vehicles have a main body wire harness (MBWH) that may come in contact with the lower intermediate steering shaft joint (bellows).
Correction	Dealers will install butyl patches, abrasion sleeves, and zip ties.

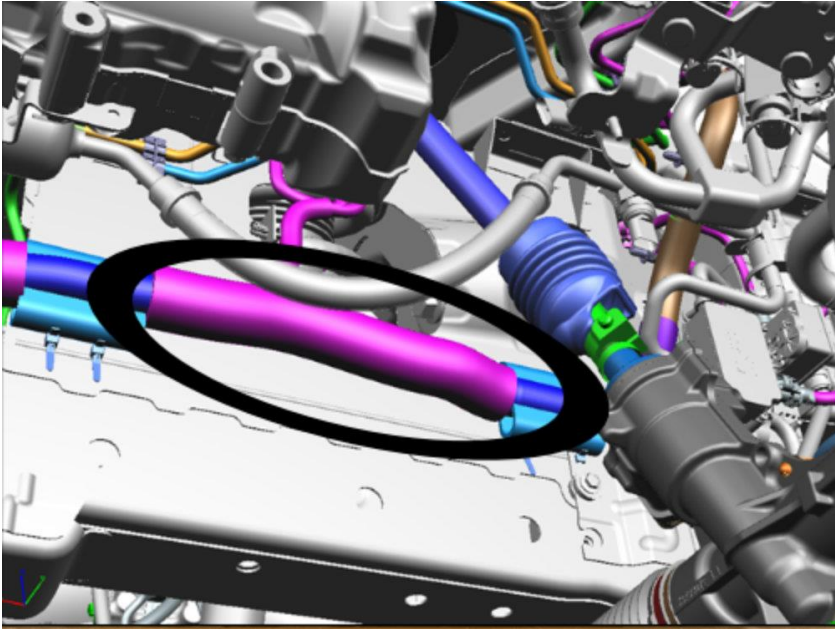
6043726

4. Locate the wire harness running along the driver's side frame rail beneath and behind the steering gear intermediate shaft as shown.
5. Inspect the wire harness for any damage.
 - If no damage is found, proceed to the next step.
 - If any damage is found, repair the wire harness. Refer to *Wire to Wire Repair* in SI.
