Service Update

N222362410 Main Body Wire Harness Contact Damage

Release Date: May 2022 **Revision:** 01
Revision Description: The Service Procedure and Labor Table have been updated. Please discard all previous copies of bulletin N222362410.

Make	Model	Model Year		RPO	Description
		From	To		
BrightDrop	EV600	2022	2022

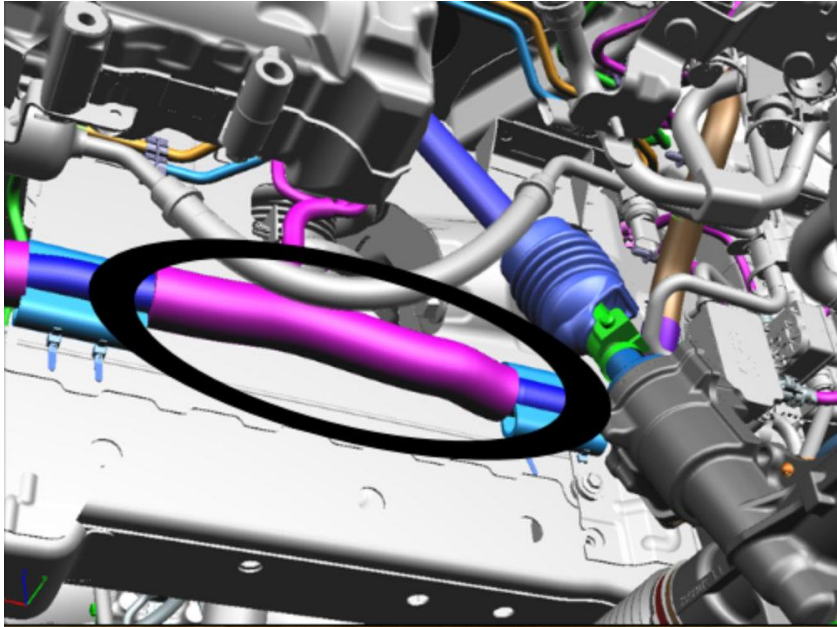
6043726

4. Locate the wire harness running along the driver's side frame rail beneath and behind the I-shaft as shown.
5. Inspect the wire harness for any damage.
 - If no damage is found, proceed to the next step.
 - If any damage is found, repair the wire harness. Refer to *Wire to Wire Repair* in SI.

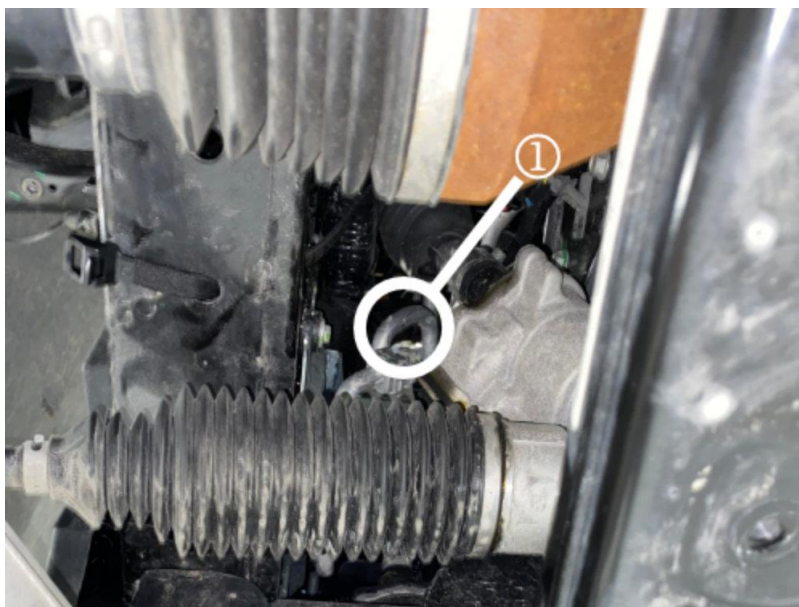
6055825

13. Locate the AC line (1) between the main body wire harness and the steering gear.
