RECREATIONAL VEHICLE CUSTOMER SATISFACTION

Customer Satisfaction Campaign: 22-425

CUSTOMER SATISFACTION CAMPAIGN

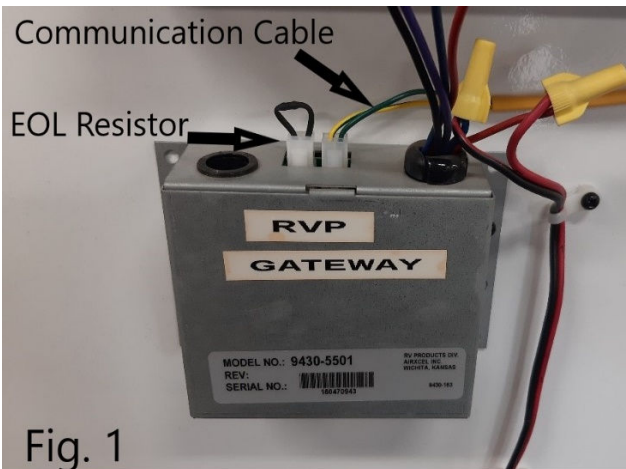
Fig. 1

Figure 1-Shows a Gateway, the communication cable from In-Command system and the EOL resistor as it should be for proper operation.

4. Note: When a 2nd A/C is installed later, unplug the EOL resistor from the 1st Roof A/C Gateway, reinstall the 2nd A/C communication cable. Install the Pre-wired Communication cable and the EOL resistor into the 2nd A/C Gateway as seen in Figure 1.

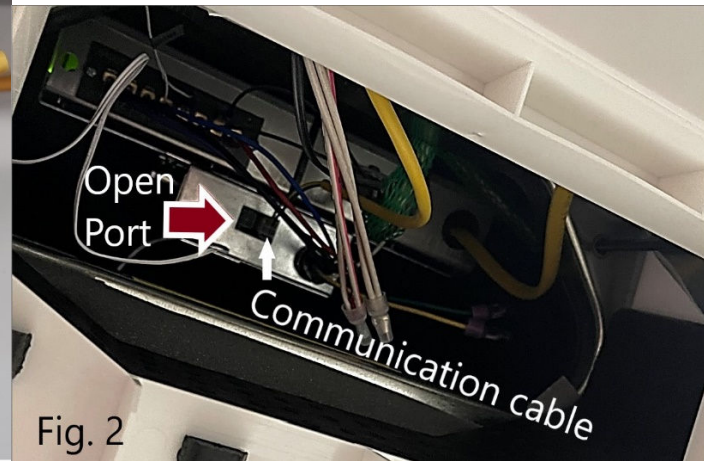
Fig. 2

1. System with one Roof A/C. Turn off the A/C, remove the return air grill, and locate the Gateway (See Figure 2). If there is an open port as seen in Figure 2 & 3, corrective action is needed. Upon completion, the wiring should be as seen in Figure 1.

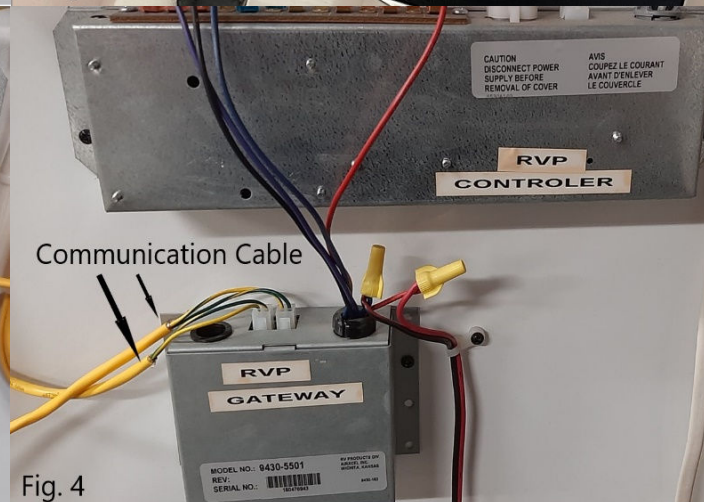
Fig. 4

2. System with two Roof A/C's. Turn off the A/C's, remove the return air grill, and locate the Gateway's. The EOL will need to be installed on the 2nd A/C's Gateway. The first A/C Gateway (typically the middle of the unit) will have two communication cables plugged in (See Figure 4). One cable from In-Command to the 1st A/C, one cable from the 1st A/C to the 2nd A/C. The second A/C Gateway should look like Figure 1, if not, take corrective action.

3. System with one Roof A/C and Pre-Wired for 2nd A/C. If Pre-Wired for 2nd A/C, the 1st A/C Gateway may have two communication cables plugged in, See figure 4. One cable from In-Command to the 1st A/C, one cable from the 1st A/C to the 2nd A/C. The 2nd A/C communication cable will need to be unplugged and the EOL Resistor will need to be plugged in to that port. See Figure 1. The 2nd communication cable can be left protected and unplugged. To determine which communication cable is "live" unplug one cable at a time and operate the A/C functions at the In-Command panel.
