### PIT5885A Service Restraint System Message / Air Bag Warning MIL / DTC B14DC Set

Product Investigation Review Required

Brand:	Model:	Model Years:	VIN:		Engine:	Transmissions:
			from	to		
Cadillac	Escalade Models	2021 - 2022	All	All	All	All
Chevrolet	Suburban	2021 - 2022	All	All	All	All
Chevrolet	Tahoe	2021 - 2022	All	All	All	All
GMC	Yukon Models	2021 - 2022	All	All	All	All

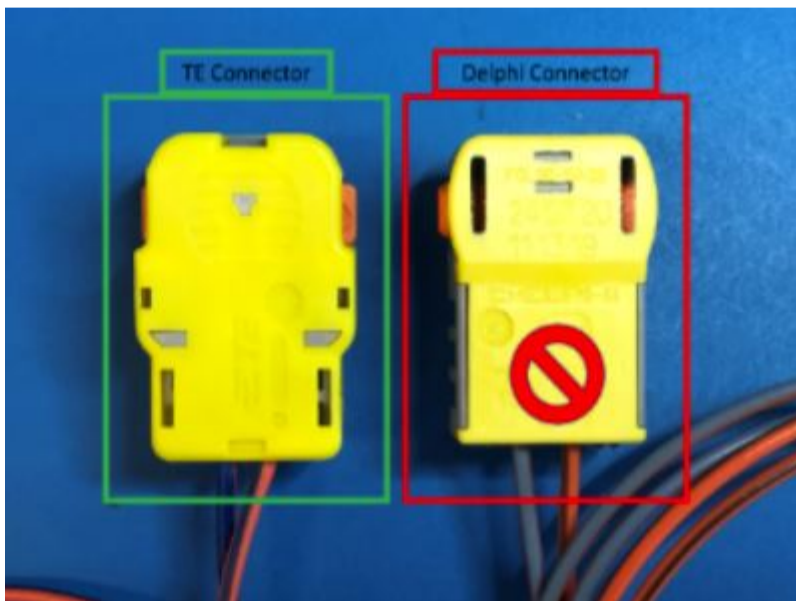
5. On the lower right side of the seat, pull back the seat cover to expose foam and locate the seat airbag connector.
