Bulletin No.: PIT5287G

PIT5287G Diagnostic Tip - Front Shock Terminal Removal

With Magnetic Ride Suspension Package (RPO Z95)

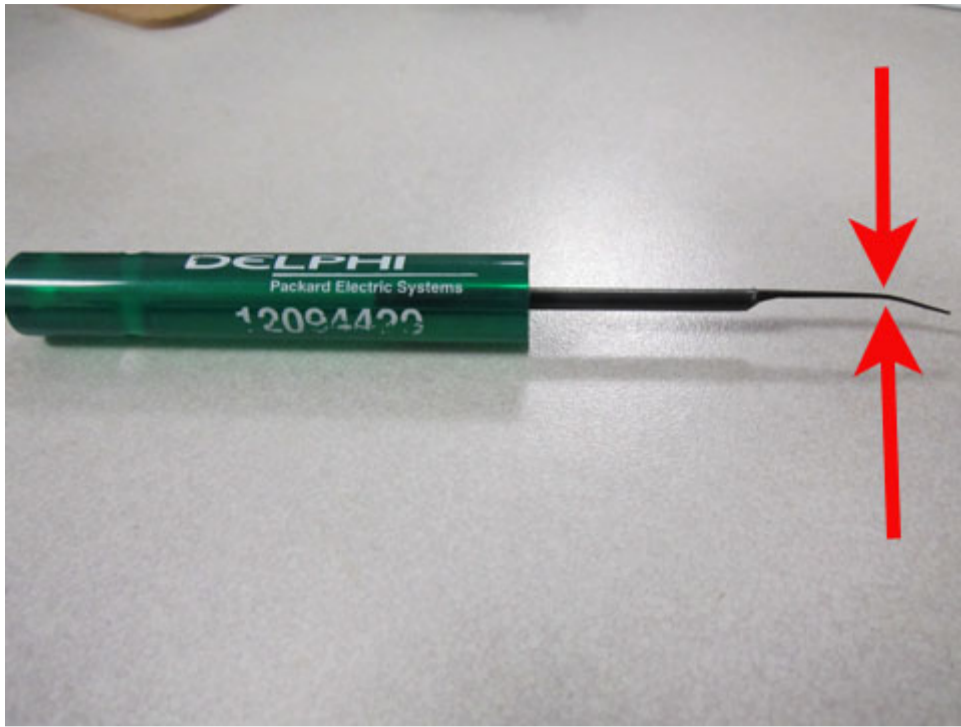
Certain repairs to the front suspension require the removal of the front shock electrical connector terminals. Because the terminals are positioned deep into the connector body, it may be difficult to remove the terminals.

The use of terminal release tool J-38125-12A (Delphi # 12094429), with a small modification, has been found to make removal of the terminal(s) much easier.

Slightly bend the end of the J-38125-12A release tool, as shown in the photo below.
