PIT5287H Diagnostic Tip - Front Shock Terminal Removal

With Magnetic Ride Suspension Package (RPO Z95)

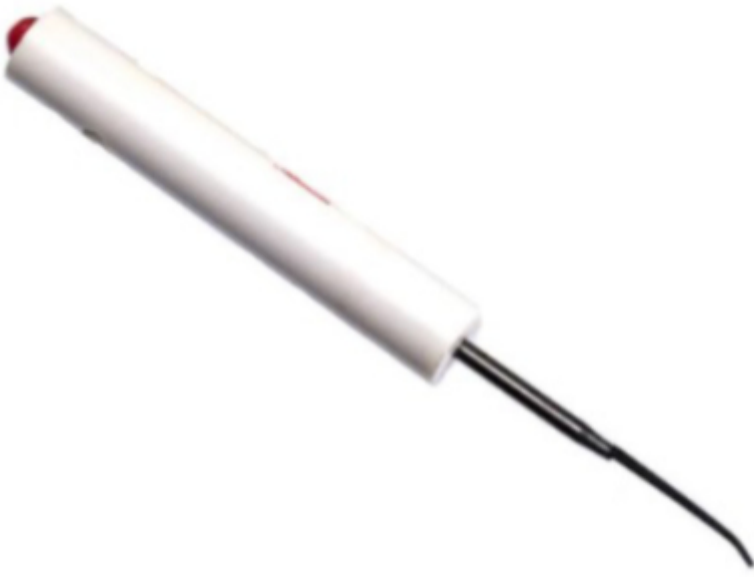
Use terminal release tool J-38125-554 (Delphi # 12152110), shown below.

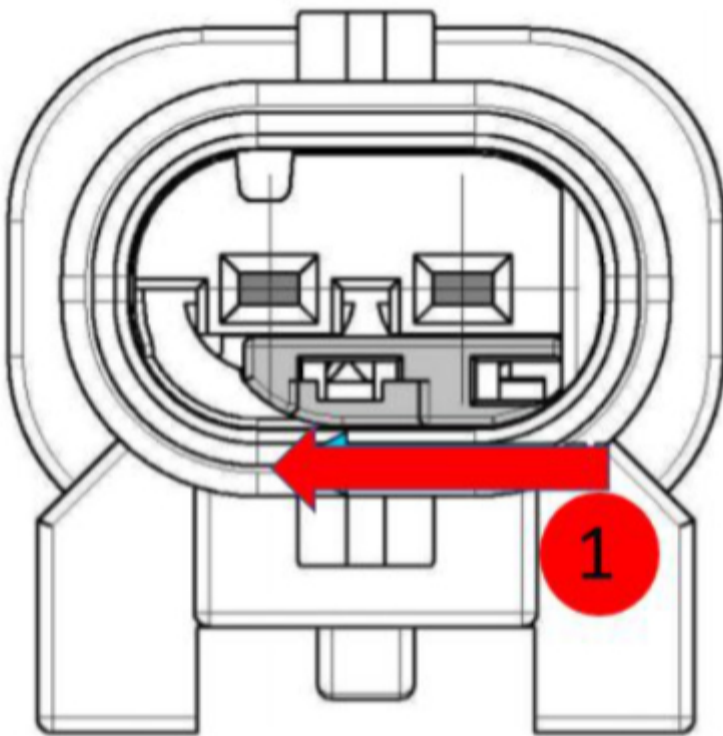
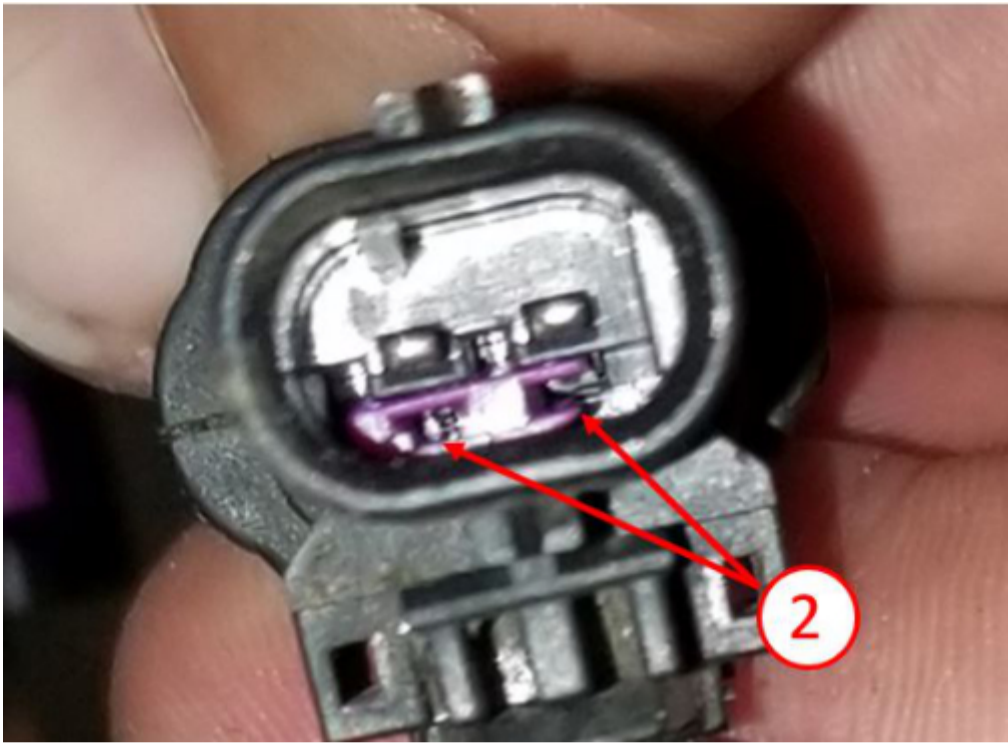
1. While looking down into the connector body at the terminals, there is a purple TPA. Slide the TPA over to expose the terminal release hole openings, as shown below in callouts 1 and 2.

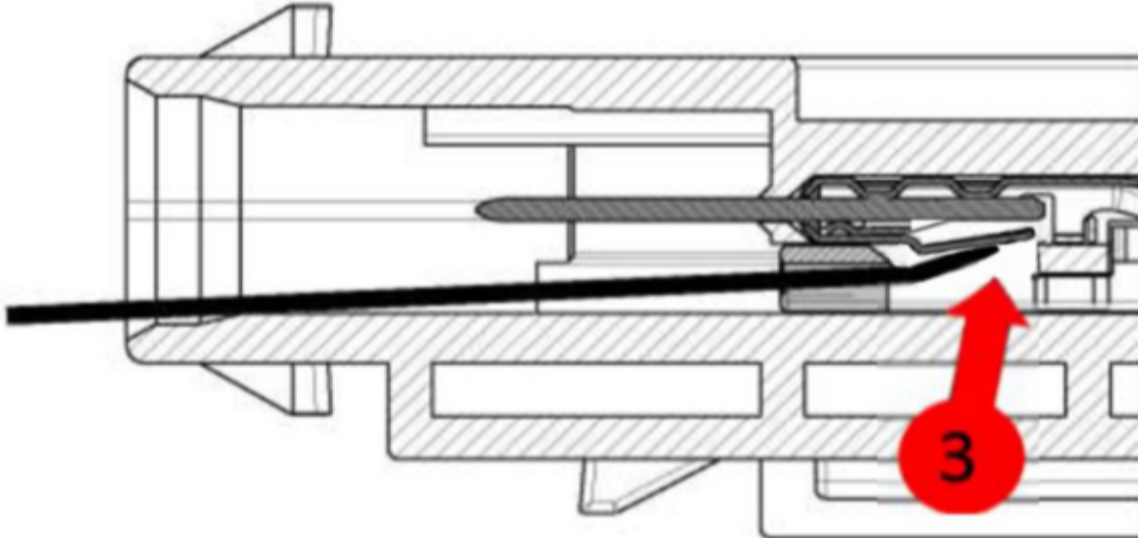
2. Next, insert the terminal release tool J-38125-554 (Delphi # 12152110) into one of the terminal release holes. Then, tilt the release tool so that it will push in on the terminal's release tab, as shown below in callout 3. The heavy black line in the photo below represents the release tool.

3. Once the terminal's release tab is pushed in, then pull the wire and terminal out the rear of the connector body.
