Preliminary Information

PIP5794B Diagnostic Tips For Engine Related Shudder / Surge Concerns

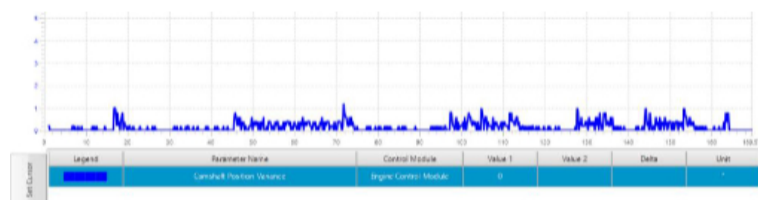
Although target variance is 0 degrees, it is not uncommon to observe variance of up to 3-4 degrees on a properly functioning system.

Normal operation (variance under 4 degrees):

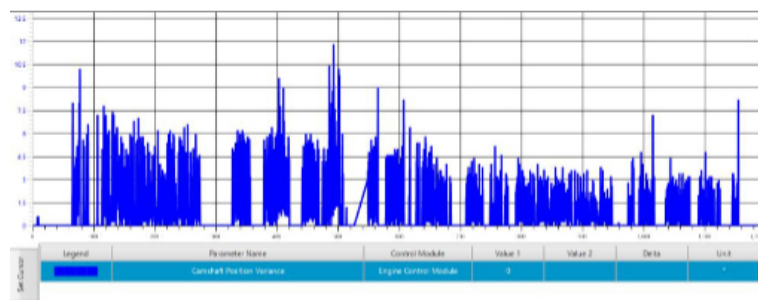
Any variance exceeding 3-4 degrees could potentially cause a noticeable shudder / surge concern.

Fault in camshaft actuator system (variance over 4 degrees):

If the concern has been isolated to the camshaft actuator system, it is recommended to replace the camshaft actuator magnet and re-evaluate.

If the shudder / surge is still present after camshaft actuator magnet replacement and camshaft actuator variance is over 4 degrees, refer to GM Service Information or GM TAC for further assistance with diagnosis.
