**DTC U010087 & No Start/ Replaced Engine ECU After Jump Starting**

2019-2022	Avalon HV	2021-2022	Venza HV
2020-2022	Highlander HV	2021-2022	RAV4 Prime
2019-2022	RAV4 HV	2020-2022	Camry HV
2021-2022	Sienna HV

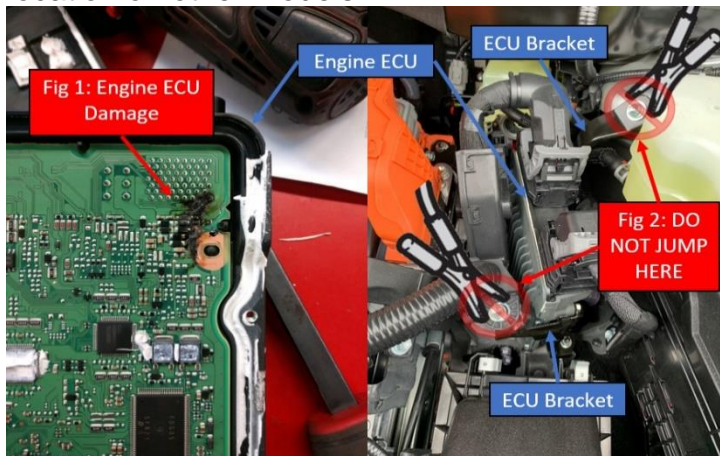
After jump-starting, the vehicle may experience a no-start condition and multiple DTCs including U010087. Upon investigation, it is found that the engine ECU has been damaged and needs to be replaced (Fig 1). In several cases, it was found that the cause of the ECU damage was improper jump starting. Further investigation found that ECU damage may occur if the jumper cables are hooked up on or around the engine ECU or ECU mounting bracket (Fig 2).
