Technical Service Bulletin

91 SOS Emergency call function deactivated message in the cluster, DTC U153E00 is stored in the telematics module

91 22 99 2055945/9 May 5, 2022. Supersedes Technical Service Bulletin Group 91 number 21-49 dated November 17, 2021 for reasons listed below.

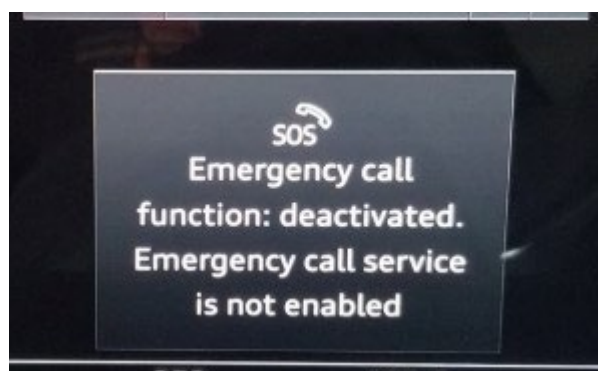
- The warning message “SOS Emergency call function deactivated” is seen in the instrument cluster (Figure 1 or 2).

Figure 1. SOS warning in the instrument cluster.

The warning message is generated by the telematics control module (ConBox Low for MY19), J949 (address word 0075) and is primarily seen in two different scenarios:

- When there is a hardware or software malfunction of the control module.
- When there is a problem connecting to the Mobile Network Operator (AT&T).
