Service Update

N212353390 Serial Data Gateway Module Replaced in Service Not Capable of OTA Updates

Release Date: May 2022

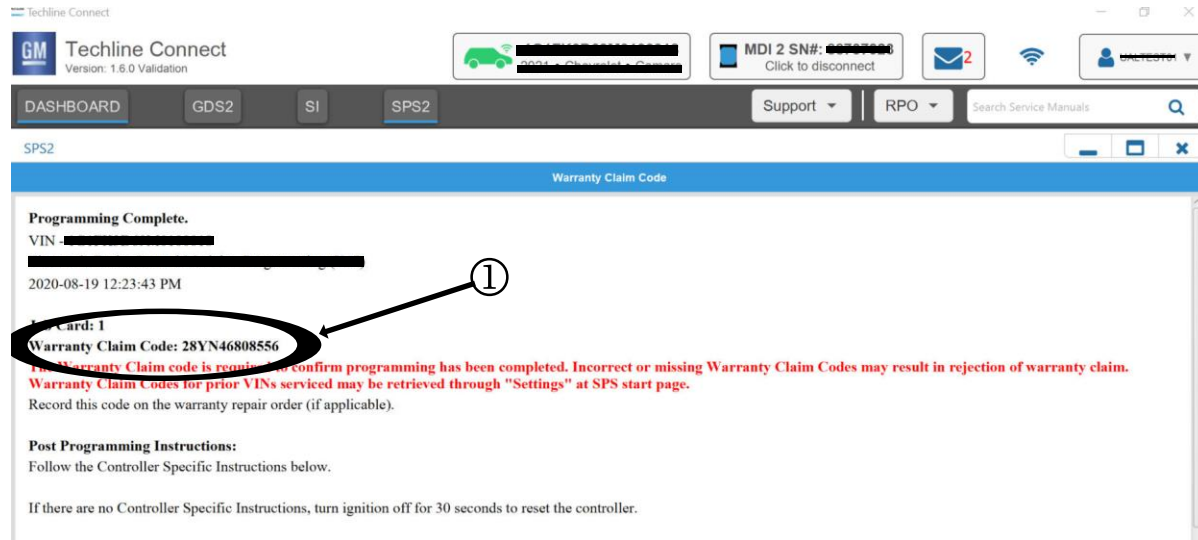
5644478

Note: The screenshot above is an example of module programming and may not be indicative of the specific module that is being programmed. Module selection and VIN information have been blacked out.

Important: To avoid warranty transaction rejections, you **MUST** record the warranty claim code provided on the Warranty Claim Code (WCC) screen shown above on the job card. Refer to callout 1 above for the location of the WCC on the screen.

2. Record SPS Warranty Claim Code on job card for warranty transaction submission.
