Classification:  
EC17-031A

Reference:  
ITB17-050A

## MIL ON WITH DTC(S) STORED IN THE ECM

**APPLIED VEHICLES:** 2016-2017 Q50 (V37)  
2017 Q60 (CV37)  
**APPLIED ENGINES:** VR30DDTT

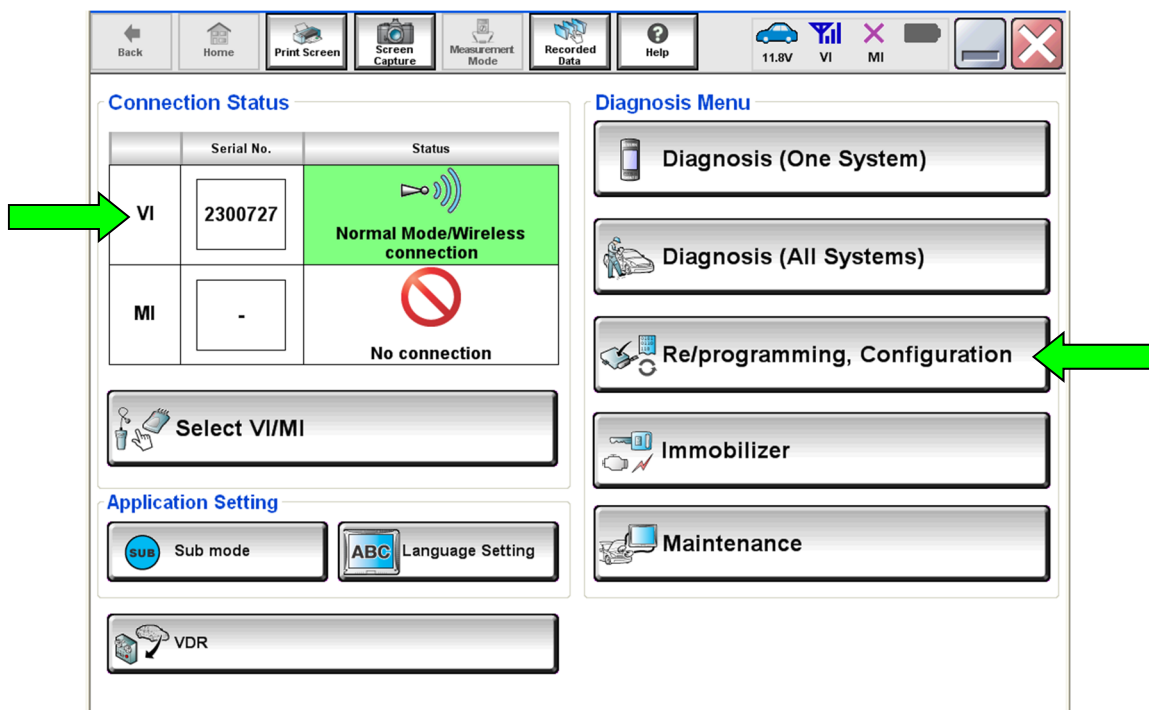
Figure 1

1. Connect the VI to the vehicle.
2. Start CONSULT.
3. Wait for the VI to be recognized.
  - The serial number will display when the VI is recognized (Figure 1).
4. Select **Re/programming, Configuration**.

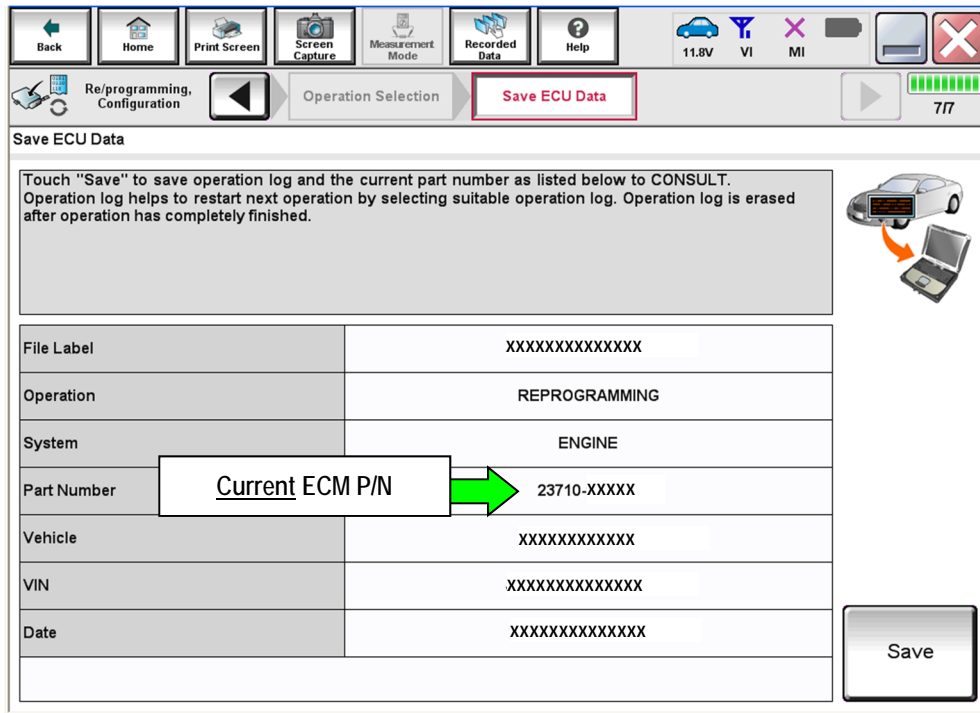
Figure 2

6. When you get to the screen shown in Figure 2, confirm that a reprogram is available as follows.
- a. Find the ECM **Part Number** and write it on the repair order.

**NOTE:** This is the current ECM Part Number (P/N).

- b. Compare the P/N you wrote down to the numbers in the **Current ECM Part Number** column in **Table A**, beginning on the next page.
- If there is a match, this bulletin applies. Continue with the reprogramming procedure.
  - If there is not a match, this bulletin does not apply. Refer to ASIST for further diagnostic and repair information.

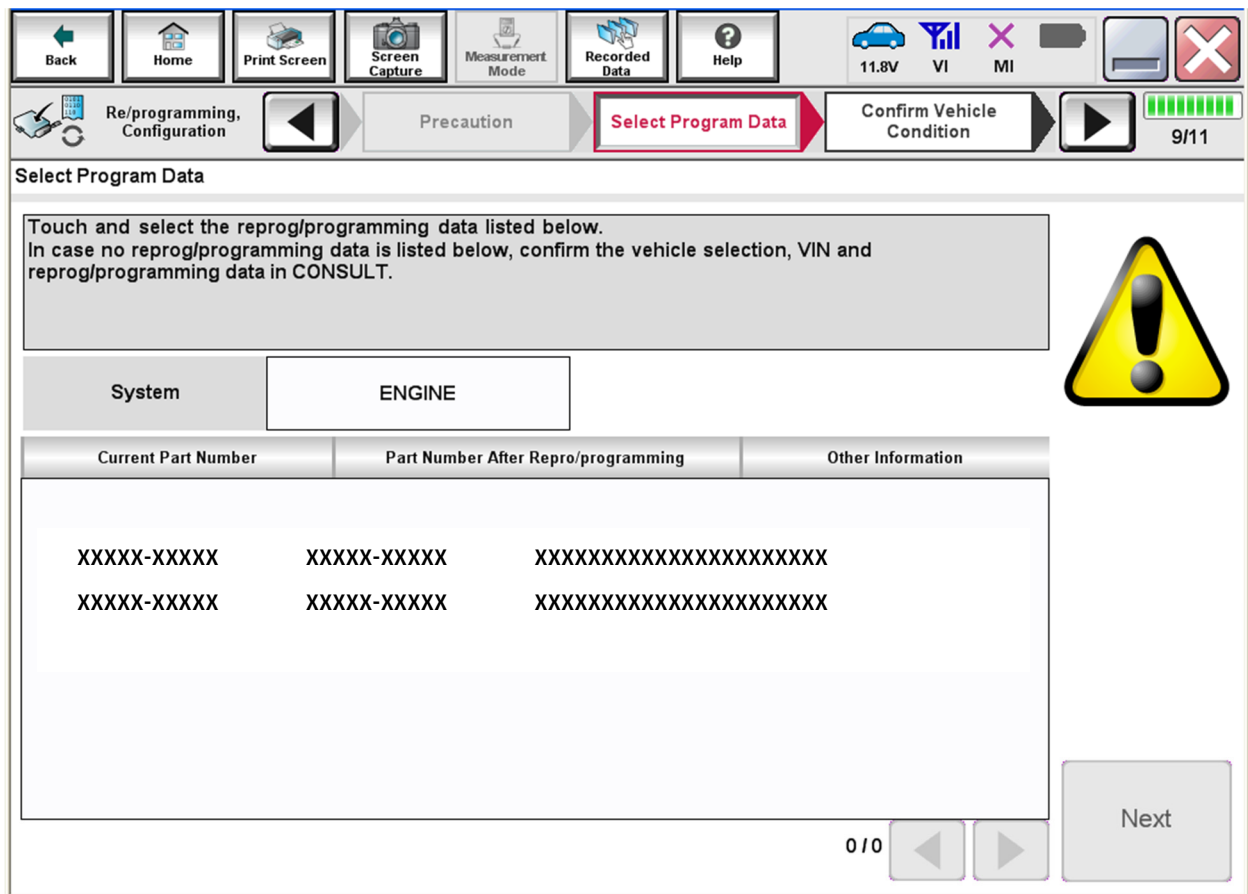
- In some cases, more than one new P/N for reprogramming is available.
  - In this case, the screen in Figure 3 displays.
  - Select and use the reprogramming option that **does not** have the message “Caution! Use ONLY with ITBXX-XXX”.
  - If you get this screen and it is blank (no reprogramming listed), it means there is no reprogramming available for this vehicle. Close CONSULT and disconnect from the vehicle.

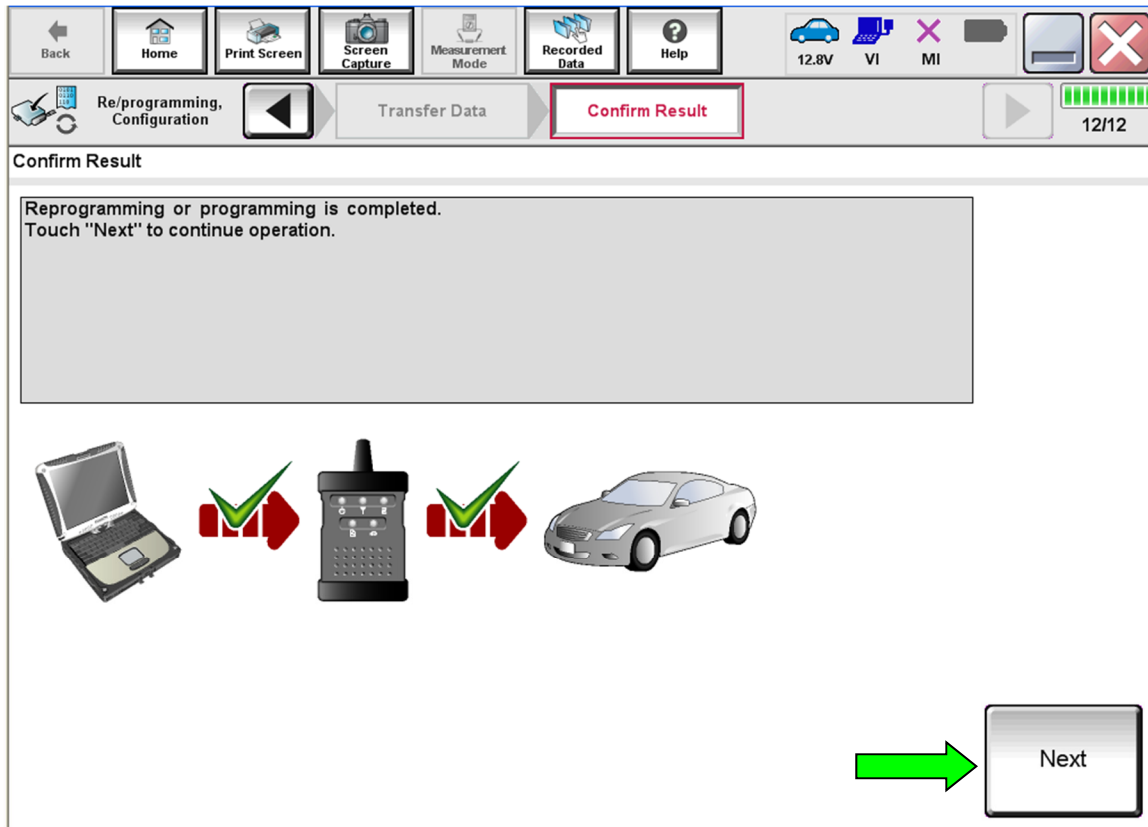
8. When the screen in Figure 4 displays, reprogramming is complete.

**NOTE:** If the screen in Figure 4 does not display (reprogramming does not complete), refer to the information on the next page.

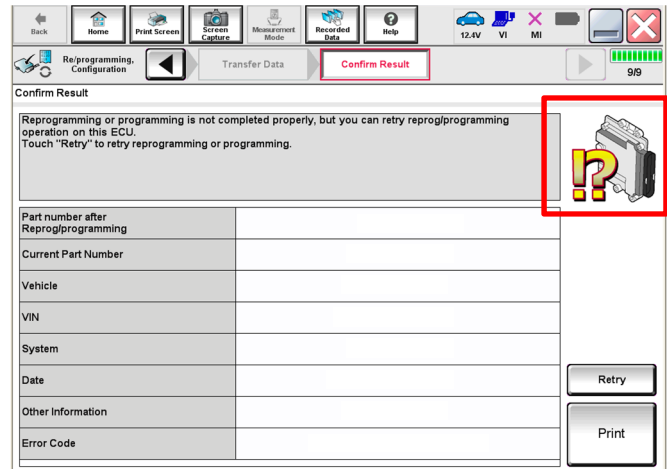
Figure 5

If reprogramming does not complete and the “!?” symbol displays, as shown in Figure 5:

- Check battery voltage (12.0 – 15.5V).
- Ignition is ON, engine is OFF.
- External Bluetooth® devices are OFF.
- All electrical loads are OFF.
- Select **Retry** and follow the on screen instructions.

**NOTE:** Retry may not go through on first attempt and can be selected more than once.

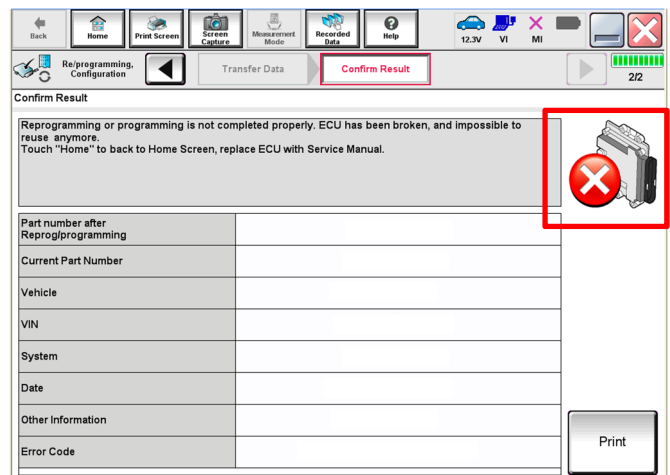
Figure 6

If reprogramming does not complete and the “X” symbol displays, as shown in Figure 6:

- Check battery voltage (12.0 – 15.5V).
- CONSULT A/C adapter is plugged in.
- Ignition is ON, Engine is OFF.
- Transmission in Park.
- All CONSULT / VI cables are securely connected.
- All CONSULT updates are installed.
- Select **Home**, and then restart the reprogram procedure from the beginning.

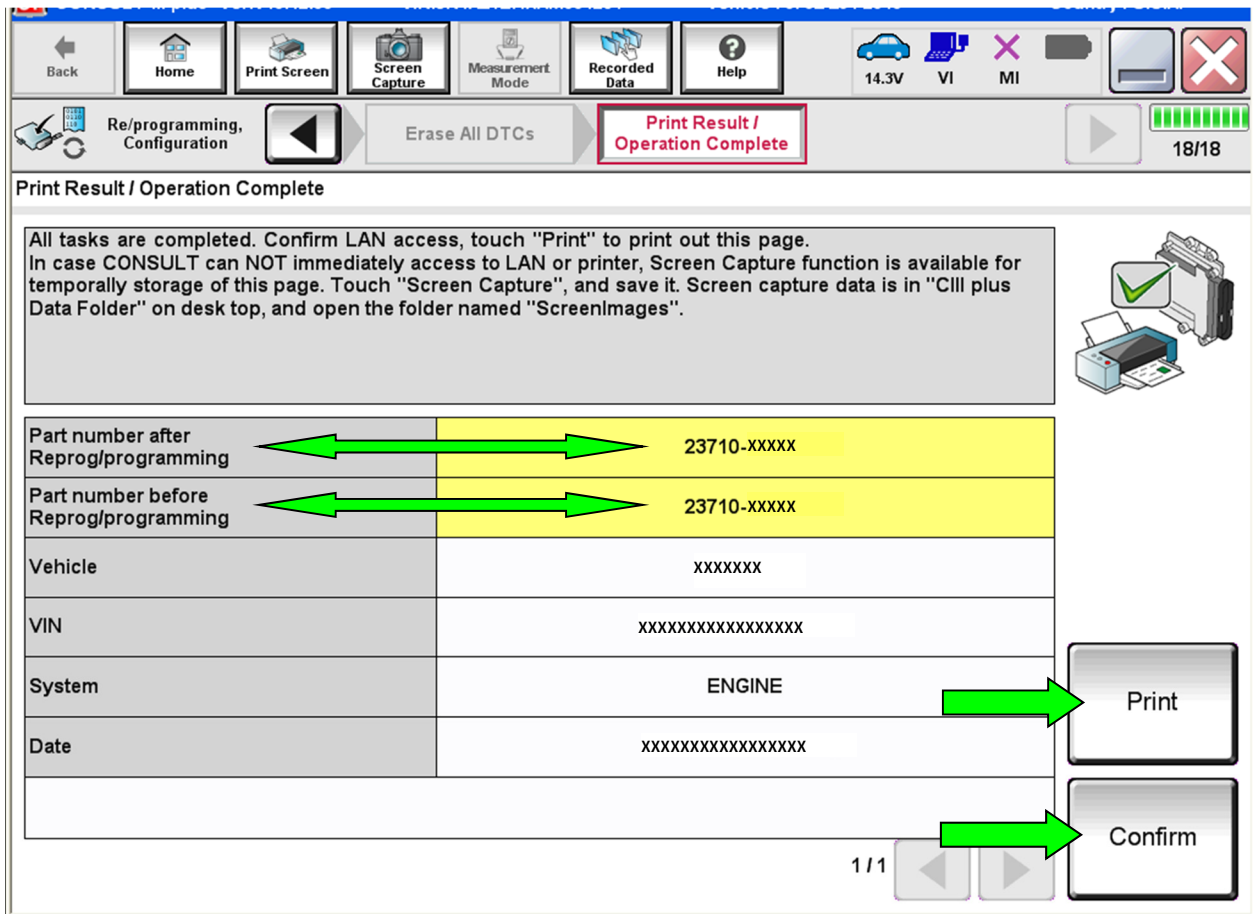
12. When the entire reprogramming process is complete, the screen in Figure 7 will display.
13. Verify the before and after part numbers are different.
14. Print a copy of this screen (Figure 7) and attach it to the repair order for warranty documentation.
15. Select **Confirm**.
