# SERVICE BULLETIN

Classification: TF16-001D	Reference: NTB17-003D	Date: March 1, 2022
------------------------------	--------------------------	------------------------

## FLUID LEAK CAUSED BY TRANSFER ASSEMBLY RIGHT SIDE DRIVE SHAFT OIL SEAL

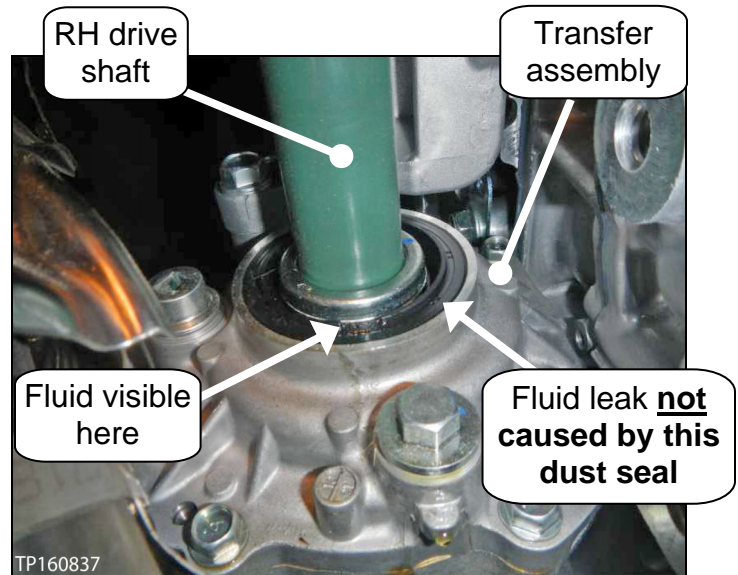
Figure 1

If fluid is leaking from the front passenger (RH) side of the transfer assembly, refer to the information in this bulletin.

**NOTE:** The fluid leak is NOT caused by the dust seal shown in Figure 1.

1. **DO NOT REPLACE** the transfer assembly.
2. Replace the drive shaft oil seal and the dust seal.
  - The drive shaft oil seal and the dust seal can be replaced without removing the transfer assembly from the vehicle.
  - It is not necessary to remove the transfer cover to replace the drive shaft oil seal and the dust seal.
  - Refer to NTB21-094 for drive shaft oil seal and dust seal replacement.

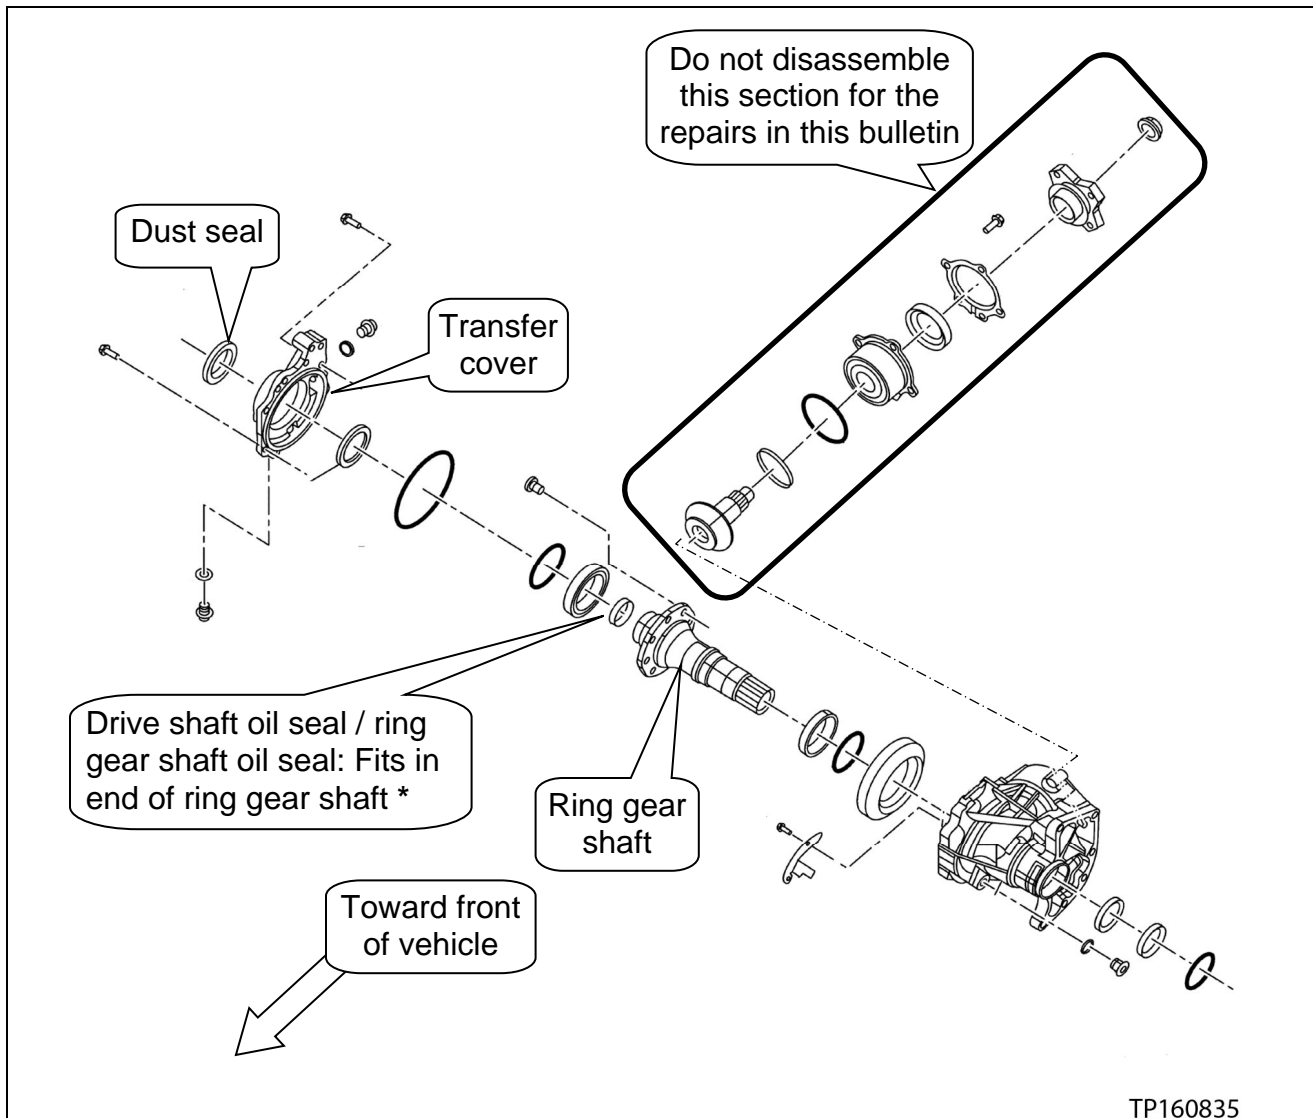
Figure 6

\* The seal causing the leak is called "Drive shaft oil seal" in the ESM for all applied models except Rogue, Rogue Hybrid, Rogue Sport, and Altima. For these vehicles, it is called "Ring gear shaft oil seal".
