SERVICE BULLETIN

Classification: AN20-009E	Reference: NTB20-029E	Date: March 3, 2022
------------------------------	--------------------------	------------------------

TELEMATICS (IVC) SERVICE INFORMATION

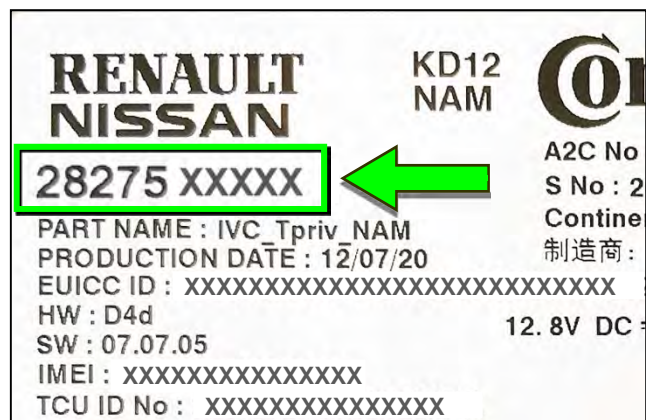
Figure 7

12. Write down the part number listed on the new / replacement TCU (Figure 7).

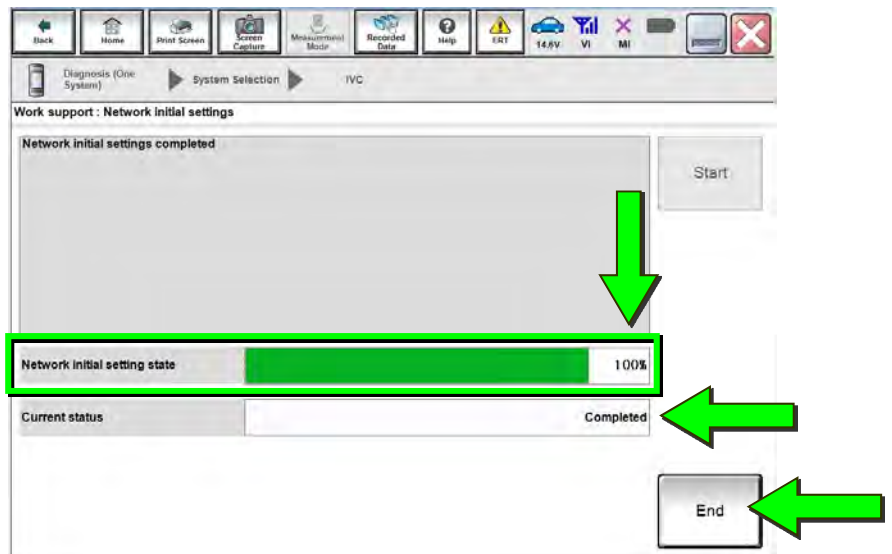
Figure 25

39. Check the **Network initial setting state** field (Figure 25).

- If the result is “100%”:
 - a. Confirm “Completed” displays in the **Current status** field.
 - b. Select **End**.
 - c. Skip to **Intelligent Key Registration** on page 18.

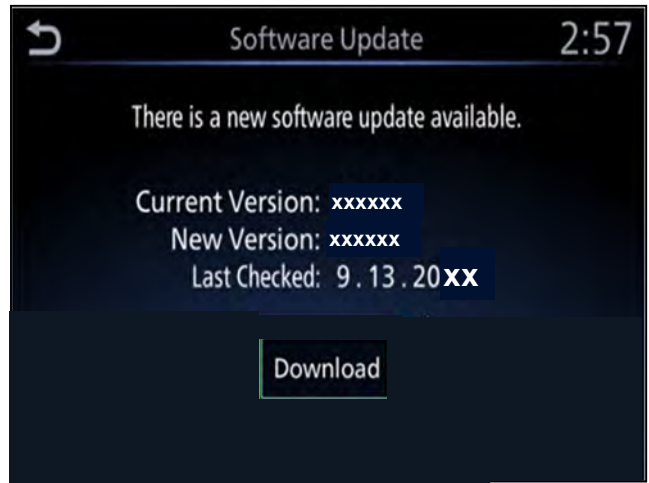
49. To confirm telematics functionality, ensure the screen in either Figure 32 or Figure 33, above, is displayed.

- If the screen matches Figure 32 or Figure 33, the procedure is complete.
