SERVICE BULLETIN

Classification: EM20-004A	Reference: NTB20-053A	Date: March 24, 2022
------------------------------	--------------------------	-------------------------

TITAN 4WD; VIBRATION WHILE DRIVING ABOVE 3,500 RPM

APPLIED VEHICLES: 2020-2022 Titan (A61)
APPLIED DRIVETRAINS: 4WD
NOTE: This bulletin does not apply to Titan XD

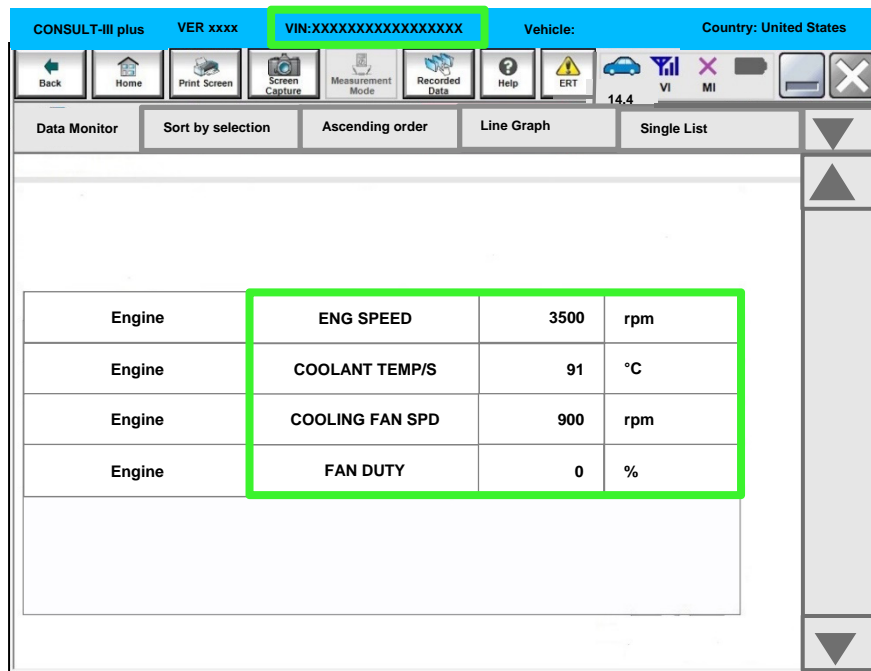
Figure 1

12. Obtain a screen shot, photo or video of **Data Monitor** (Figure 1) showing the following:

- **ENG SPEED** – 3,500 RPM or above
- **COOLANT TEMP/S** – 81-95 °C (**178-203 °F**)
- **COOLING FAN SPD** – 900 RPM or above
- **FAN DUTY** – 0 %
- **VIN**
