SERVICE BULLETIN

Classification: HA21-002B	Reference: NTB21-071B	Date: March 24, 2022
------------------------------	--------------------------	-------------------------

AUTO HVAC CENTER VENT TEMPERATURE DIFFERENCE GREATER THAN 5°C

- APPLIED VEHICLES:** 2021 Rogue (T33)
- APPLIED DATES:** VIN starting with 5N1 – built before March 25, 2021
VIN starting with JN8 – built before April 22, 2021
- APPLIED ENGINES:** PR25DD ONLY

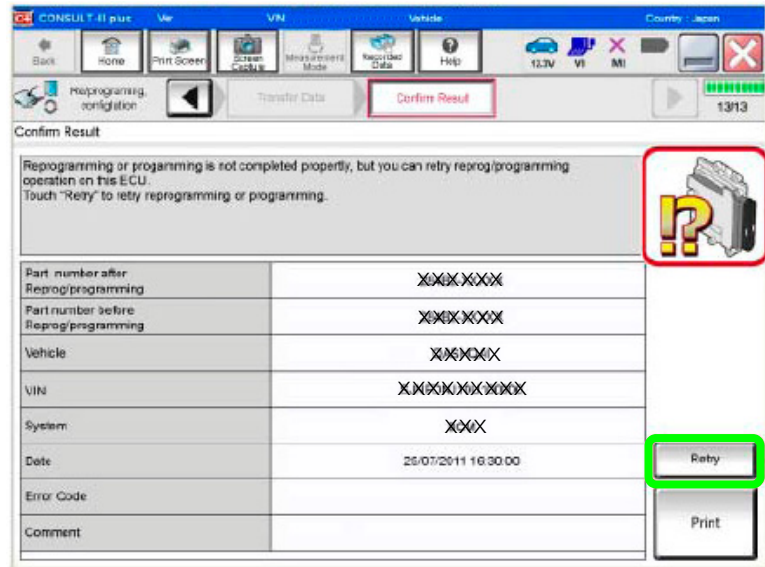
Figure 14

If reprogramming does not complete and the “!?” icon displays, as shown in Figure 14:

- Check battery voltage (12.0 V – 15.5 V).
- Ignition is ON, engine is OFF.
- External Bluetooth® devices are OFF.
- All electrical loads are OFF.
- Select retry and follow the on screen instructions.
- “Retry” may not go through on first attempt and can be selected more than once.

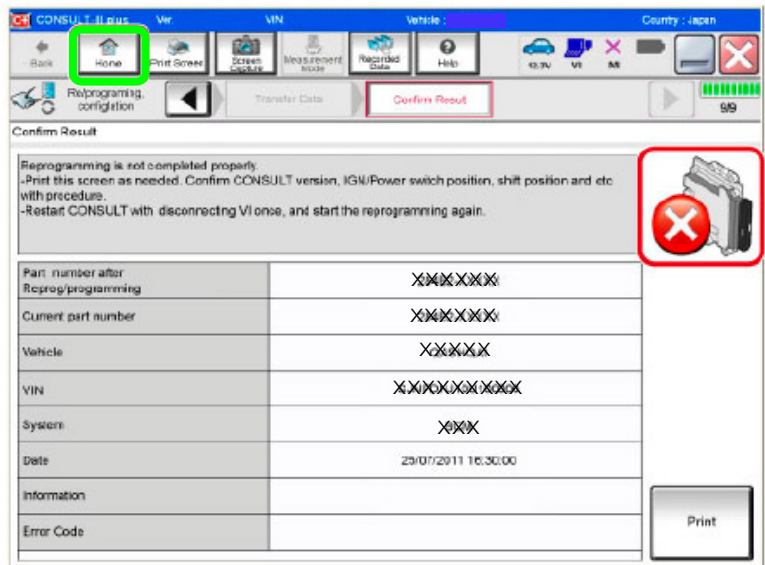
Figure 15

If reprogramming does not complete and the “X” icon displays, as shown in Figure 15:

- Check battery voltage (12.0 V – 15.5 V).
- CONSULT A/C adapter is plugged in.
- Ignition is ON, engine is OFF.
- Transmission is in Park.
- All C-III plus / VI cables are securely connected.
- All C-III plus updates are installed.
- Select Home, and restart the reprogram procedure from the beginning.
