SERVICE BULLETIN

EL21-019
 NTB22-016
 March 9, 2022

WIRELESS CHARGING PAD IS INOPERATIVE

APPLIED VEHICLES: 2021 Rogue (T33)
APPLIED VINS: VINs starting with JN8
APPLIED DATES: Built before May 26, 2021

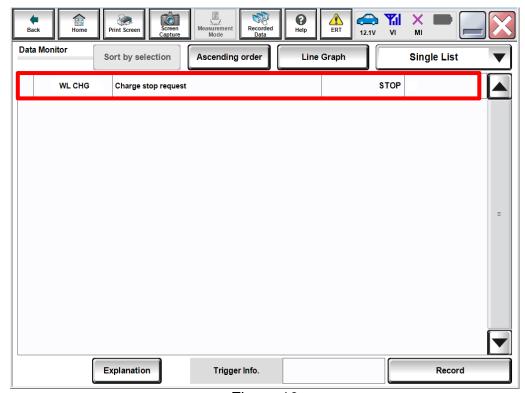
Figure 10

- 13. Confirm if the **WL CHG** status shows the **Charge stop request** as "STOP" (Figure 10).
 - If the **Charge stop request** status is "STOP", proceed to step 14.
 - If the **Charge stop request** status is "No", this bulletin does not apply. Refer to the ESM for further diagnostic information.

- 14. Replace the Intelligent Key Unit with one listed in **PARTS INFORMATION**.
 - Refer to the ESM: BODY EXTERIOR, DOORS, ROOF & VEHICLE SECURITY > DOOR & LOCK > REMOVAL AND INSTALLATION > INTELLIGENT KEY UNIT
- 15. Perform ADDITIONAL SERVICE WHEN REPLACING INTELLIGENT KEY UNIT.
 - Refer to the ESM: BODY EXTERIOR, DOORS, ROOF & VEHICLE SECURITY > DOOR & LOCK > BASIC INSPECTION > ADDITIONAL SERVICE WHEN REPLACING INTELLIGENT KEY UNIT
