SERVICE BULLETIN

Classification: BT22-001	Reference: NTB22-019	Date: March 14, 2022
-----------------------------	-------------------------	-------------------------

RATTLE NOISE FROM INSTRUMENT PANEL AREA AT IDLE AND/OR ON ACCELERATION

APPLIED VEHICLES: 2021 Rogue (T33)
APPLIED VINS: 11th character of VIN is **C**

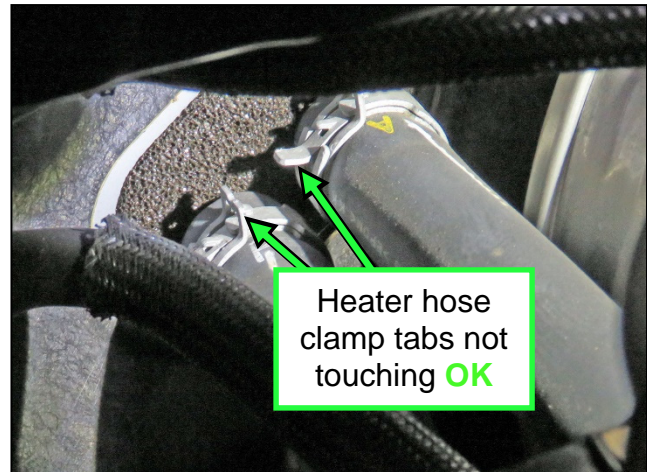
Figure 1

1. Open the hood.
2. Inspect the orientation of the heater hose clamps (Figure 1 and Figure 2).
 - If the tabs on the heater hose clamps are not touching each other, continue to step 3.

- If the tabs on the heater hose clamps are touching each other, rotate the hose clamps as needed to prevent contact between the clamps.
 - Retest for the rattle.

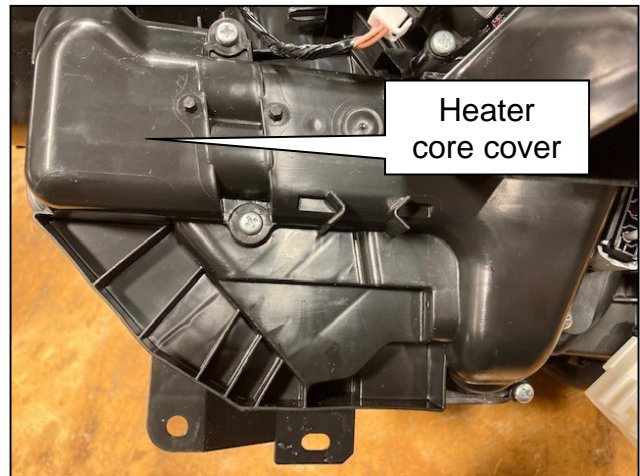
Figure 4

4. Lightly press on the heater core cover while duplicating the conditions needed for the rattle to occur.
 - If the rattle is not present when lightly pressing on the heater core cover, continue to step 5.
 - If the rattle is still present when lightly pressing on the heater core cover, this bulletin does not apply. Refer to the ESM for further diagnostic and repair information.

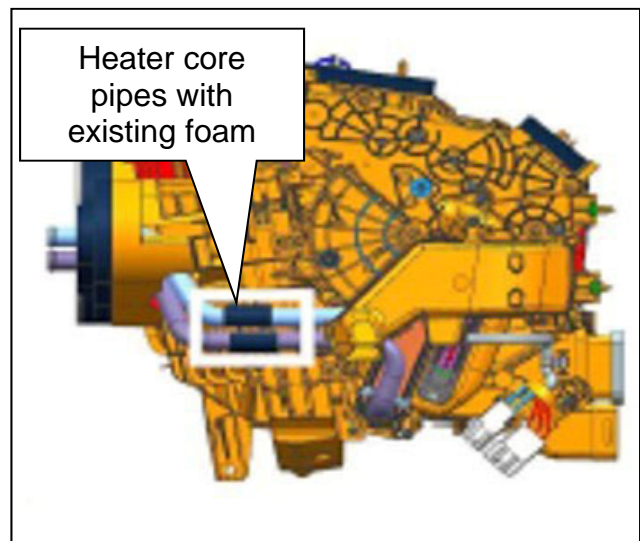
Figure 6

HINT:
Some foam may already be present on the heater core pipes (Figure 6).
