SERVICE BULLETIN

Classification: HA22-003	Reference: NTB22-023	Date: March 22, 2022
-----------------------------	-------------------------	-------------------------

BLOWER MOTOR MAKES CLICKING NOISE DUE TO SNOW INTRUSION

APPLIED VEHICLES: 2021 Rogue (T33)

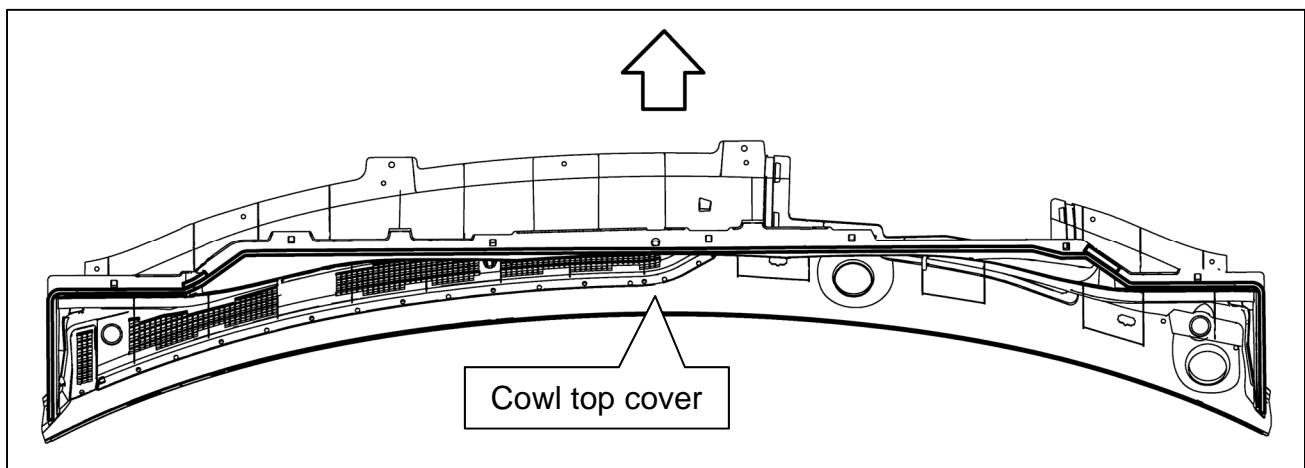
Figure 1

A clicking noise is heard coming from the HVAC case while the blower is operating,

Snow and/or ice is found in the HVAC blower motor case.

Replace the cowl top cover with one from the **PARTS INFORMATION**.

- Refer to the ESM: **BODY EXTERIOR, DOORS, ROOF & VEHICLE SECURITY > EXTERIOR > REMOVAL AND INSTALLATION > COWL TOP > Removal and Installation**
