Classification:
 RS19-005B

Reference:
 ITB19-024B

DTC B00A0-00 STORED

| APPLIED VEHICLES: 2009-2013 FX (S51) 2013 JX35 (L50) 2014-2022 Q50 (V37) 2014-2018 Q50 Hybrid (HV37) 2017-2022 Q60 (CV37) 2019-2022 QX50 (J55) 2022 QX55 (FJ55) | 2011-2013 QX56 (Z62) 2014-2020 QX60 (L50) 2022 QX60 (L51) 2014-2017 QX60 Hybrid (L50H) 2014-2017 QX70 (S51) 2014-2022 QX80 (Z62) |

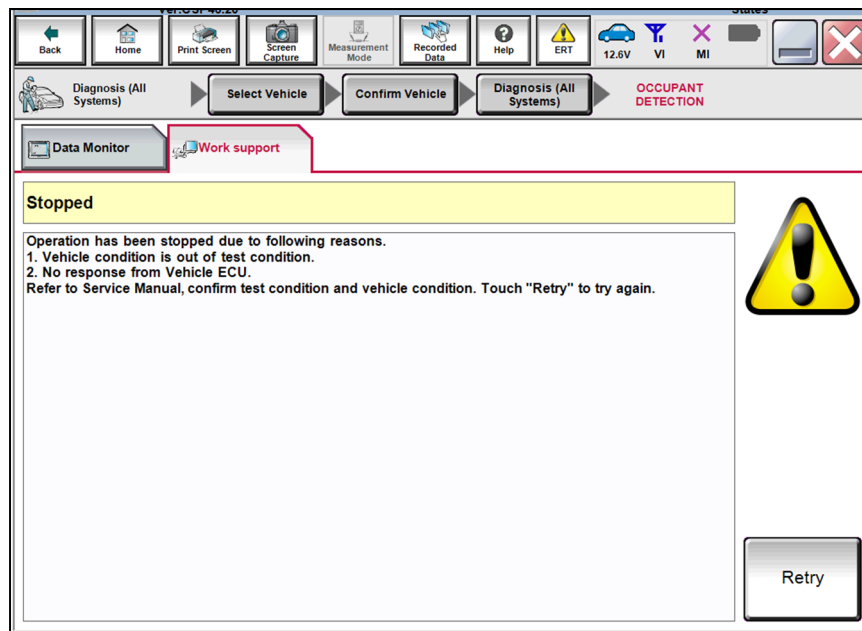
Figure 1

DTC B00A0-00 (OCCUPANT DETECTION SENSOR UNIT) is stored,

OCS zero point reset cannot be performed,

The following screen will display:

1. Check the Occupant Classification System (OCS) control unit using the ODS Analysis tool software.
 - Refer to **SERVICE PROCEDURE** on the next page.

2. Perform "75-Zero RESET".

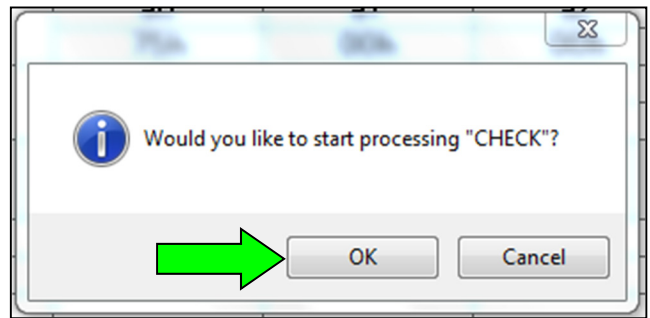
Figure 5

11. Check for code 75h to show under CURRENT FAILURE CODE.

- If code 75h shows under CURRENT FAILURE CODE, go to step 12.
- If code 75h does NOT show under CURRENT FAILURE CODE, STOP HERE.
This bulletin does not apply. Refer to ASIST and the ESM for further diagnostic assistance.

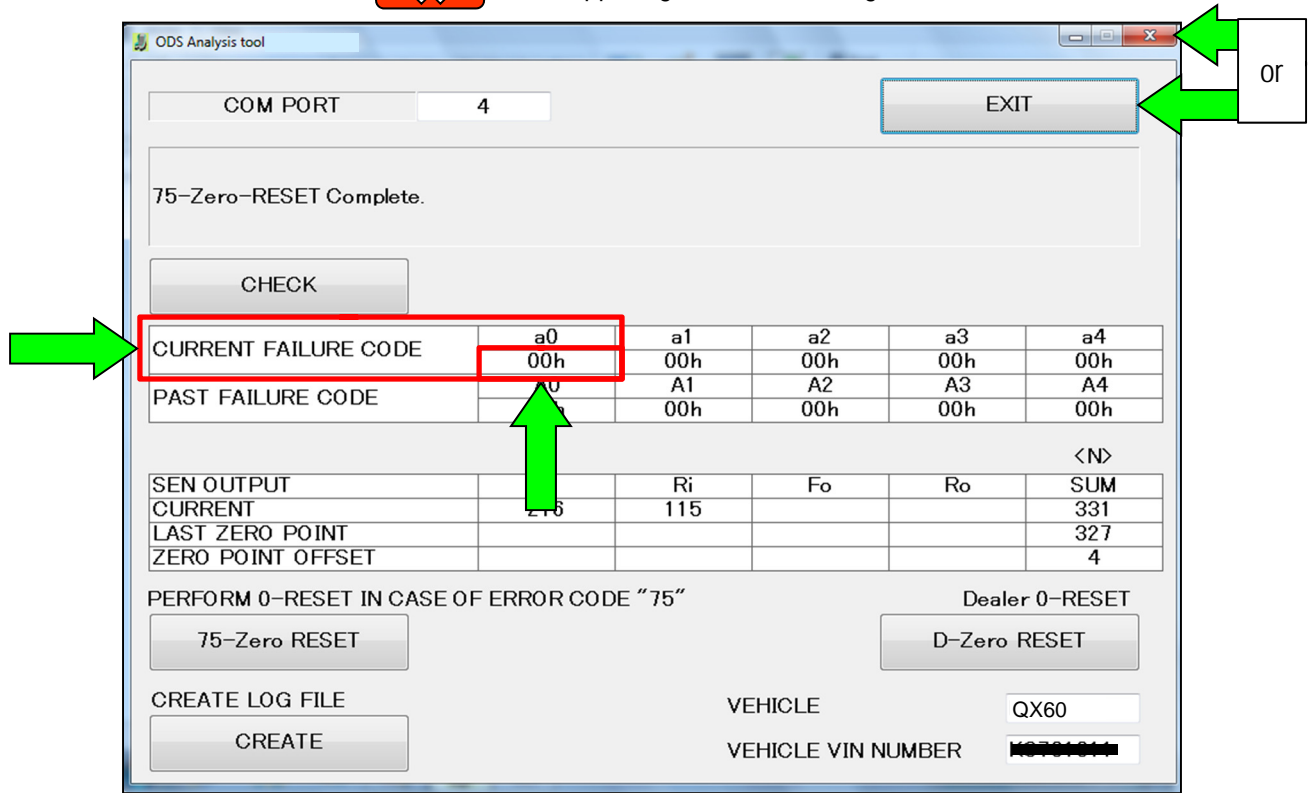
16. When the screen in Figure 9 displays, the 75-Zero reset process is complete.
 - Verify code 75h is not displayed under **CURRENT FAILURE CODE**.
17. Select either **EXIT** or the
