Technical Service Bulletin

90 Head-up display: Navigation directions are not displayed

90 22 63 2067174/1 May 25, 2022.

Model(s)	Year	VIN Range	Vehicle-Specific Equipment
e-tron GT, and RS e-tron GT	2022	All	Head Up Display

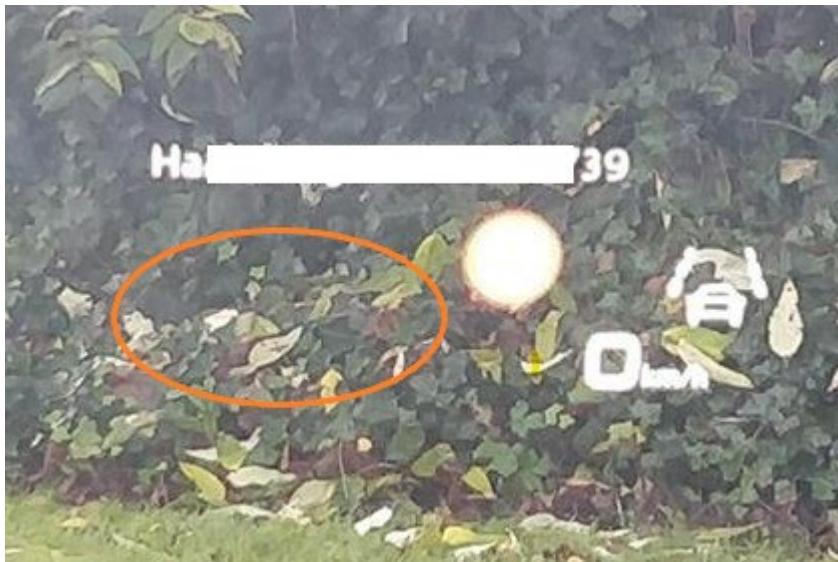
- No navigation map or directions are displayed on the heads-up display (HUD) (Figure 1).
- All other information is displayed properly.

Figure 1. Heads-up display without navigation information displayed.

A software-related malfunction in the HUD can cause the navigation information not to be displayed.

1. Follow all instructions in TSB 2011732: *00 Software Version Management (SVM), operating instructions.*
2. Update the HUD (diag. addr. 0082) using the SVM action code as listed in the table below, if necessary:
