# Technical Service Bulletin

## PSS 91 MIB3: lower display is flickering or distorted

91 22 02 2066224/3 May 25, 2022. Supersedes Technical Service Bulletin Group 91 number 22-96 dated April 25, 2022, for reasons listed below.

| Model(s) | Year | VIN Range | Vehicle-Specific Equipment |
|---|---|---|---|
| A6 and S6 | 2021 – 2022 | All | Not Applicable |

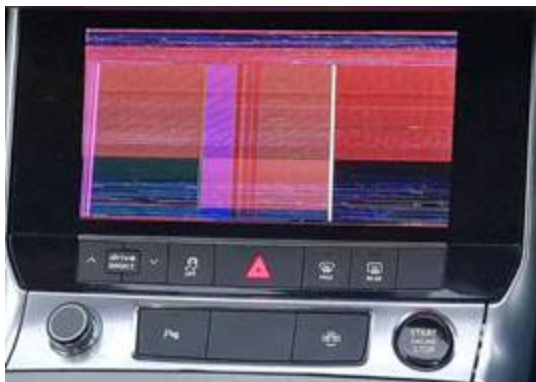
- The lower display flickers intermittently or the display seems to be distorted.

**Figure 1:** Display distorted

A software malfunction may cause the lower display to flicker or be distorted.

1. Explain to the customer that a solution is expected by the end of the 4<sup>th</sup> quarter of 2022 (subject to change) and that no repairs are necessary at this point. Do not replace any components for this condition since this will not resolve the customer's concern.
2. Create a PSS record in the PSS application through the Pending Service Solutions (PSS) link in AccessAudi (under *Related Links* >> *Service*), or through the Technical Assistance page in Elsa.

1. Reboot the MMI (refer to "Restarting the MMI" in the owner's manual)
  - a. Push and hold the volume/power button for at least ten seconds until you see the upper MMI screen boot back up.

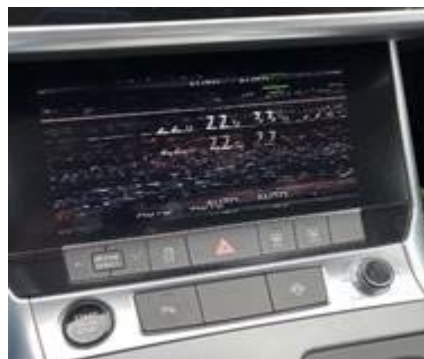
**Figure 2:** Display flickering
