NUMBER: 23-022-21

GROUP: 23 - Body

External AC Power Outlet Detaches From the Bezel

This bulletin involves inspecting if the external AC power outlet is loose in the frame and repairing if needed

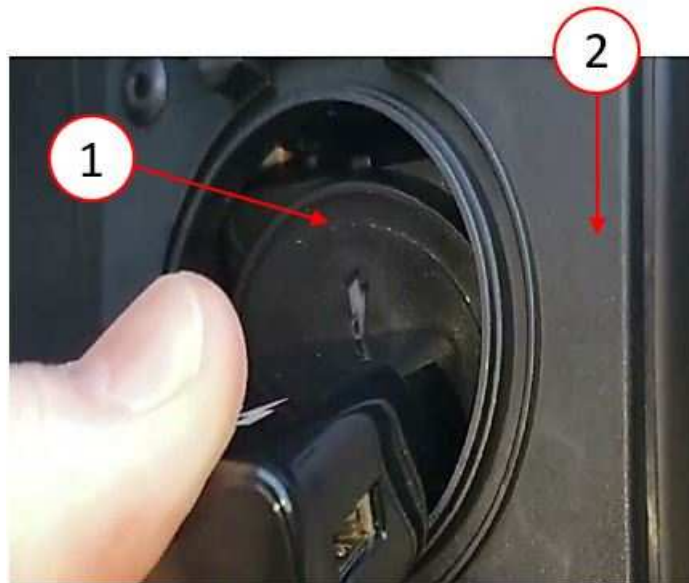
Fig. 1

- The external AC power outlet is loose in the frame (Fig. 1) .

AC power outlet Detached From Frame/Bezel

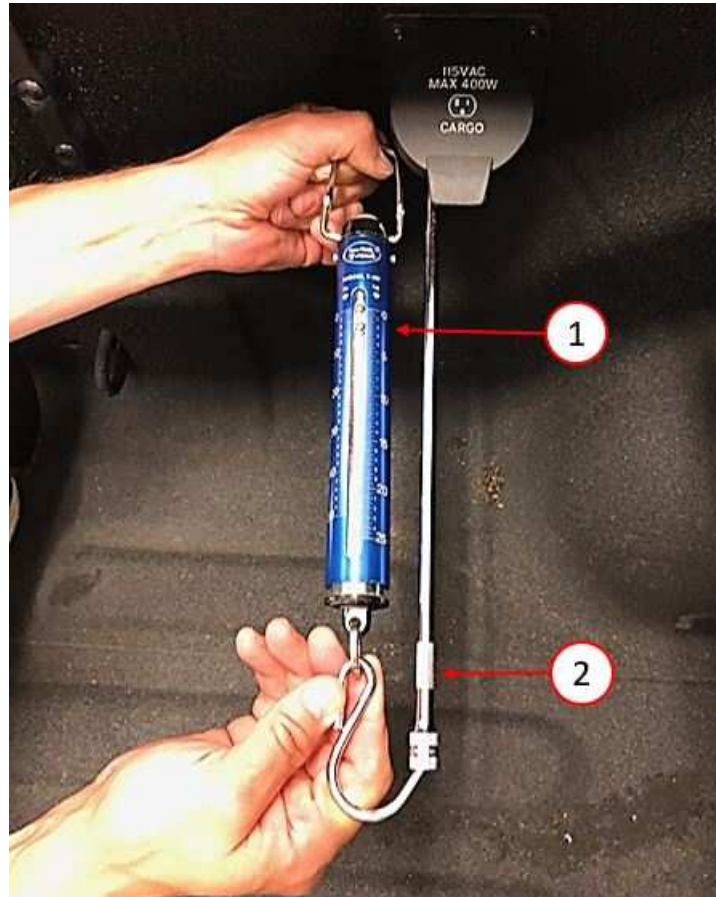
Fig. 2
Pull Gauge Used on AC power outlet

- Using a Pull Gauge (8828B) and 1/4 inch extension, 14 inches long. Put the large hook of the pull gauge into the into the ratchet end of the extension. Place the socket end of the extension on the outlet. Pull on the gauge, applying 80 N (18 lbf) of pressure on all four corners of the AC power outlet (Fig. 2) and (Fig. 3) .
