# Technical Service Bulletin

<b>Technical Service Bulletin:</b> TSB210254	<b>Released Date:</b> 05-Jan-2022
<b>Corroded Ignition Control Module Ground Pins</b>

## Corroded Ignition Control Module Ground Pins

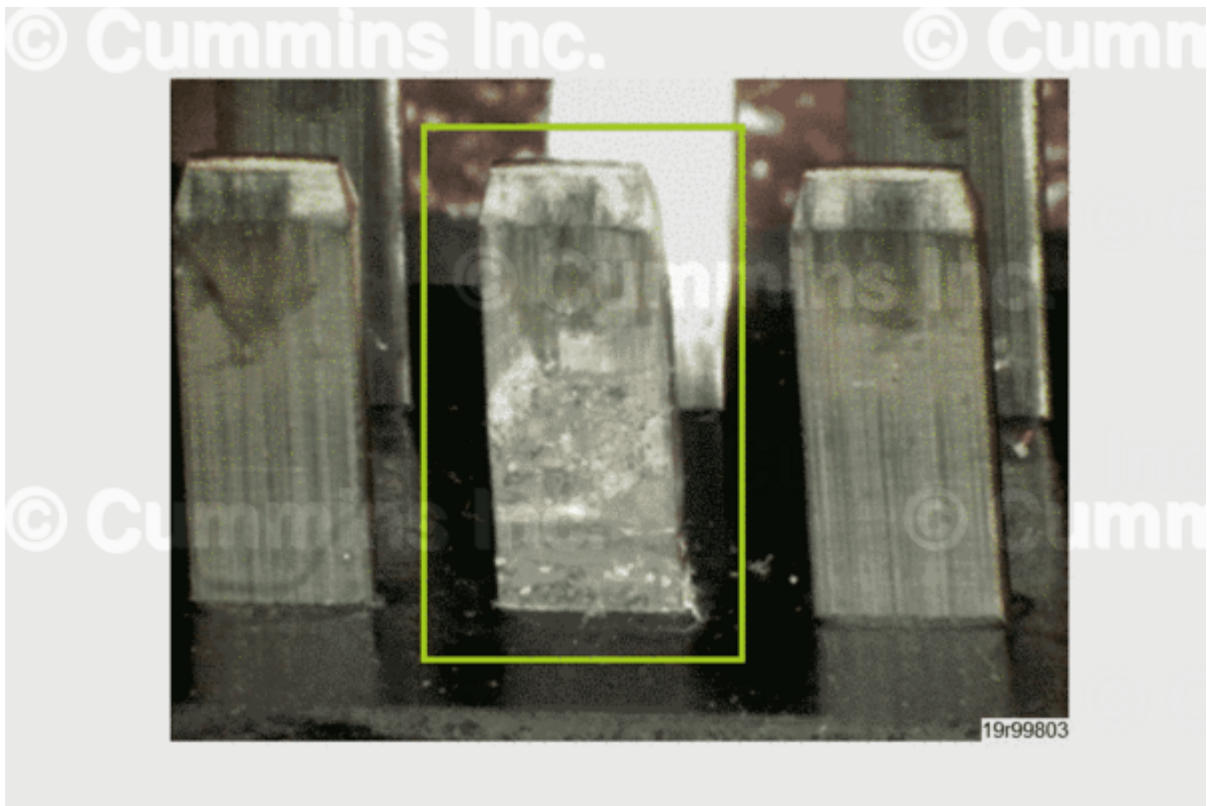
- Water migration along the wire caused by insufficient seal

Figure 1, (Center) Ignition Control Module Pin 2 of C1, Ground, Shows Signs of Corrosion; (Right) Pin 3 Shows No Corrosion.

- Clean the ignition control module pins with a brass brush.
- Use terminal with part number 4918361 by cutting off the crimp splice and add a solder splice, Part Number 5299281, from the kit, Part Number 5299279.

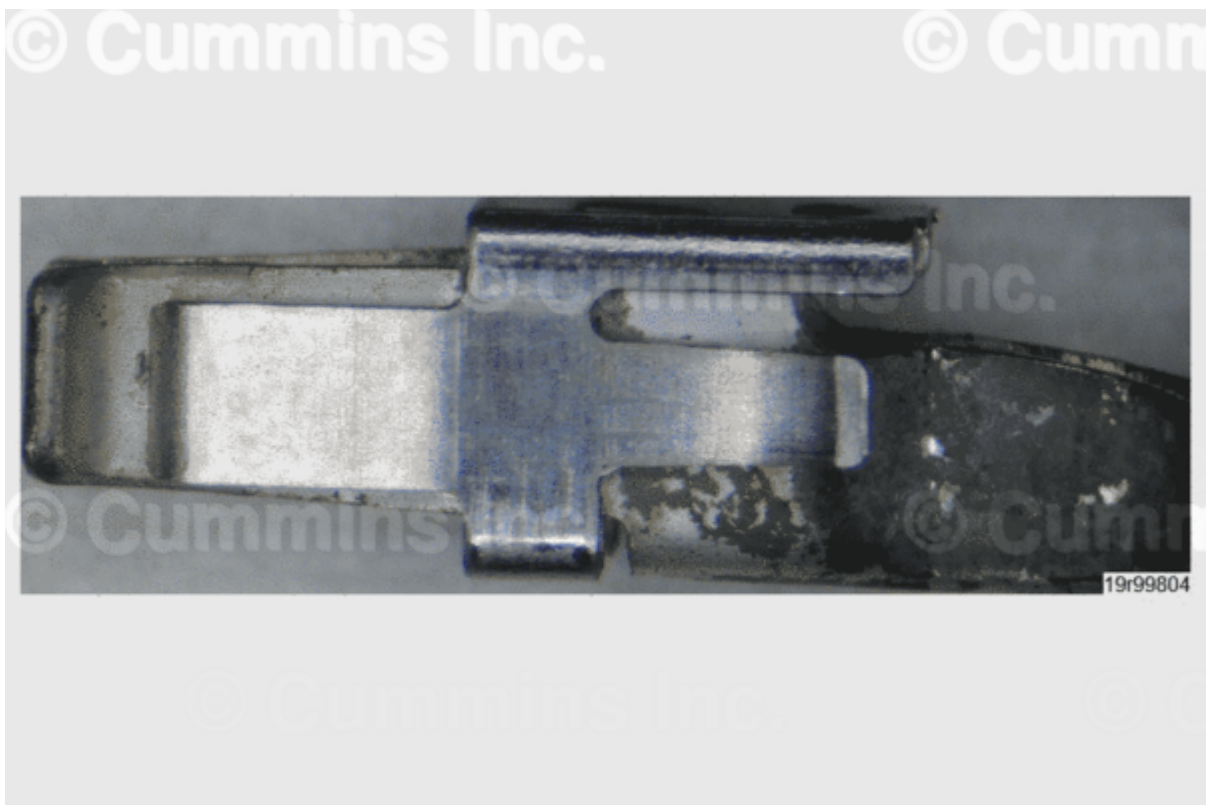
Figure 2, Ground terminal With Corrosion Along Mating Surface.

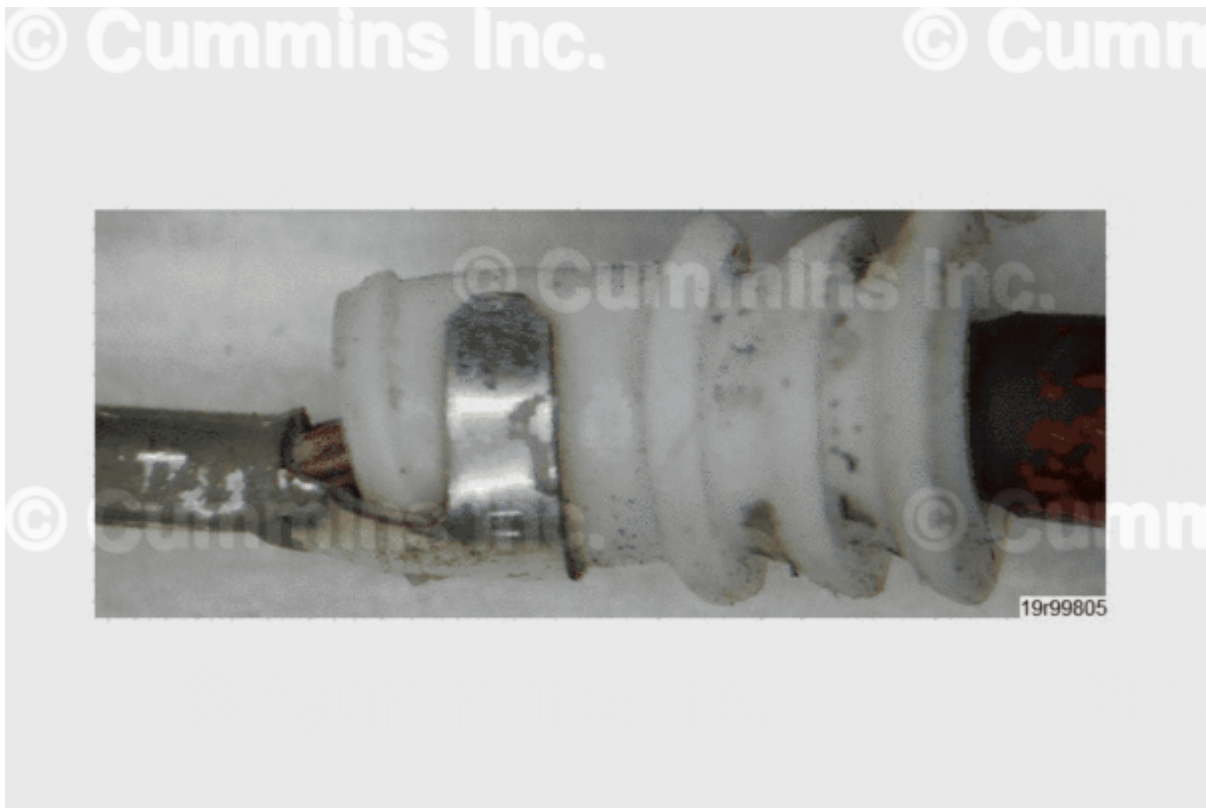
Figure 3, Copper Wire Strands Within the Ground Terminal Showing Signs of Corrosion.
