Service Bulletin

Bulletin No.: 20-NA-166

Subject: Information on Malfunction Indicator Lamp (MIL) Illuminated – DTCs P050D and/or P0300 Setting on a Cold Start and/or Engine Runs Rough when Warm with No Codes

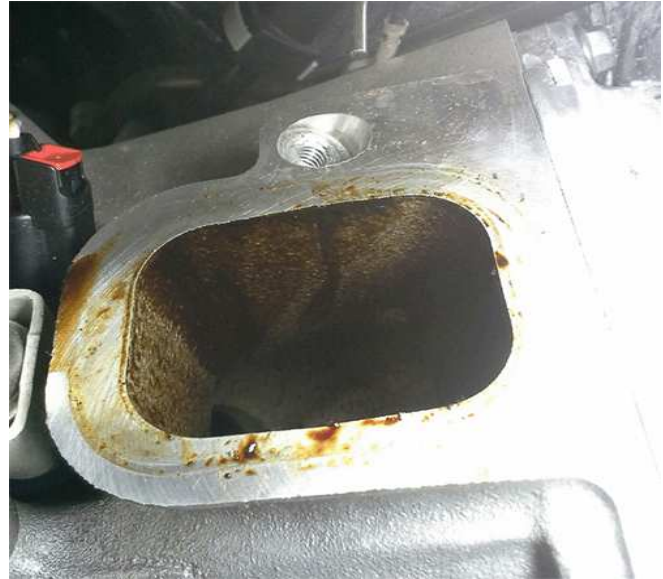
4806659

If the head casting line is the concern, the intake port will be wet with a coolant oil mix.

The location of where the coolant is running down in the port will also look washed down.

If this is found, the cylinder head will need to be replaced.

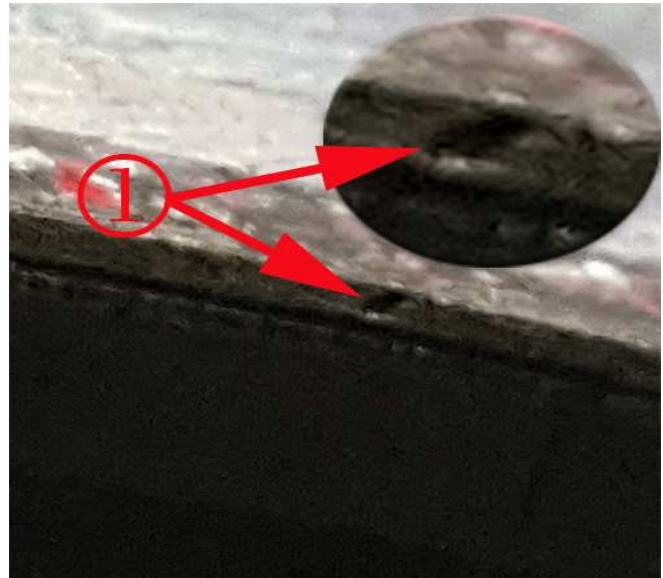
4806657

It is also possible to have coolant entry at the liner to deck face casting of the cylinder bore. It is hard to see the actual source (pin hole), but it usually streams down the liner so that you can see it with a borescope. (Sometimes) The top of the piston will be steam cleaned.

Do not confuse residual fuel on the piston crown / surface as coolant. Some fuel residue may be present and can be mistaken as coolant (reason for the cooling system Dye to be added). Use a black light to confirm the liquid is coolant. If this concern is present, do not replace the cylinder head because that will not repair this concern. Call the Product Quality Center (PQC) per Service Bulletins 20-NA-138 (U.S.) or 16-NA-338 (Canada), if required, reference this bulletin and replace the engine.
