# Service Bulletin

Bulletin No.: 20-NA-197

**Subject:** Malfunction Indicator Lamp (MIL) Illuminated - DTC P0087, P0089, P0191, P026D, P1089, P163A, P163B, P2293, P228A, P228B, P228C, and/or P228D Set

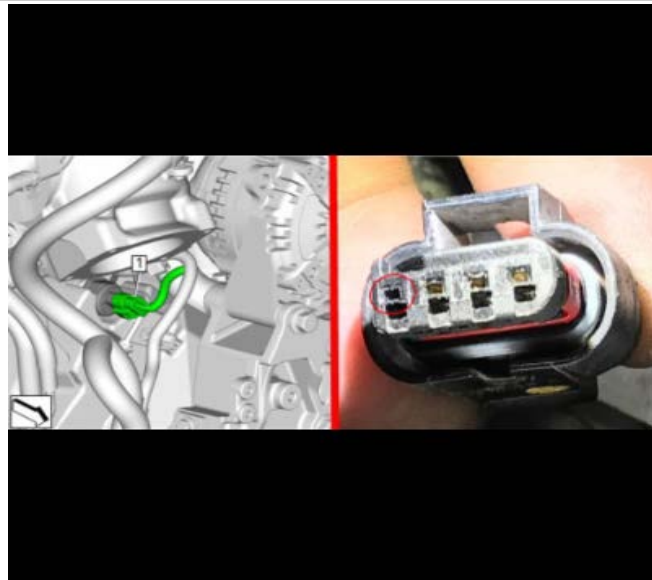
5652222

<b>Cause</b>	This condition may be caused by corrosion or damaged at the fuel pressure sensor electrical connector.

Inspect the fuel pressure sensor electrical connector for corrosion or damage.

⇒ It may be necessary to use a generous enough amount of dielectric grease in the connector to reach the entire terminal and use J-35616-16 (LT GN) terminal test tool and drag the tool up to 10 times to find/identify corrosion or fretting.
