Service Bulletin

Bulletin No.: 17-NA-221

Subject: Poor Engine Performance in Extremely Cold Weather Conditions for LE2 Engines, Charge Air Cooler Icing - Malfunction Indicator Lamp (MIL) Illuminated, DTC P0299, P0234, P0236, P2227, P00C7 Set

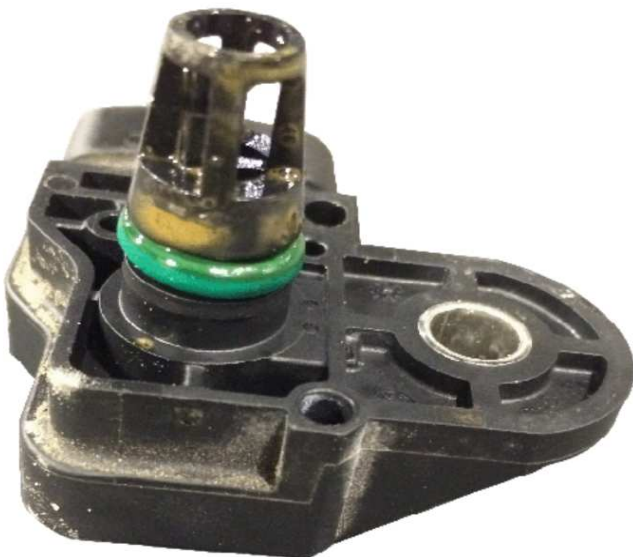
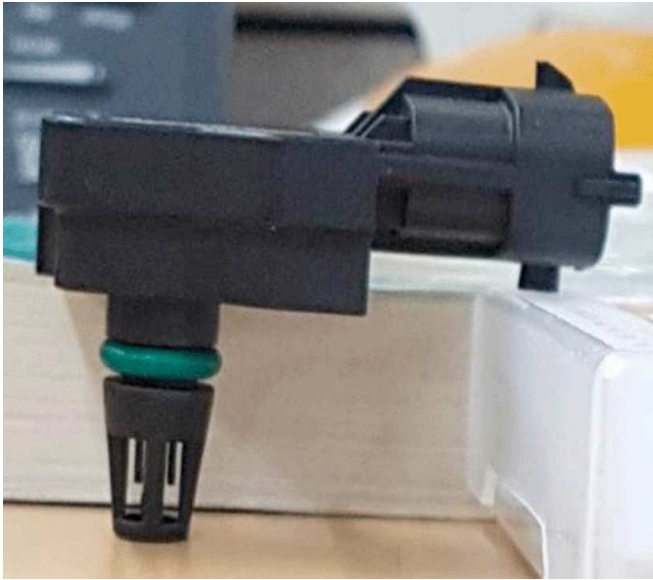
5020216

2. Inspect the sensor for any contaminants.

3. Allow time for any ice build-up to melt by placing the sensor port down.
4. Clean the sensor with a clean towel.
5. Install the sensor.

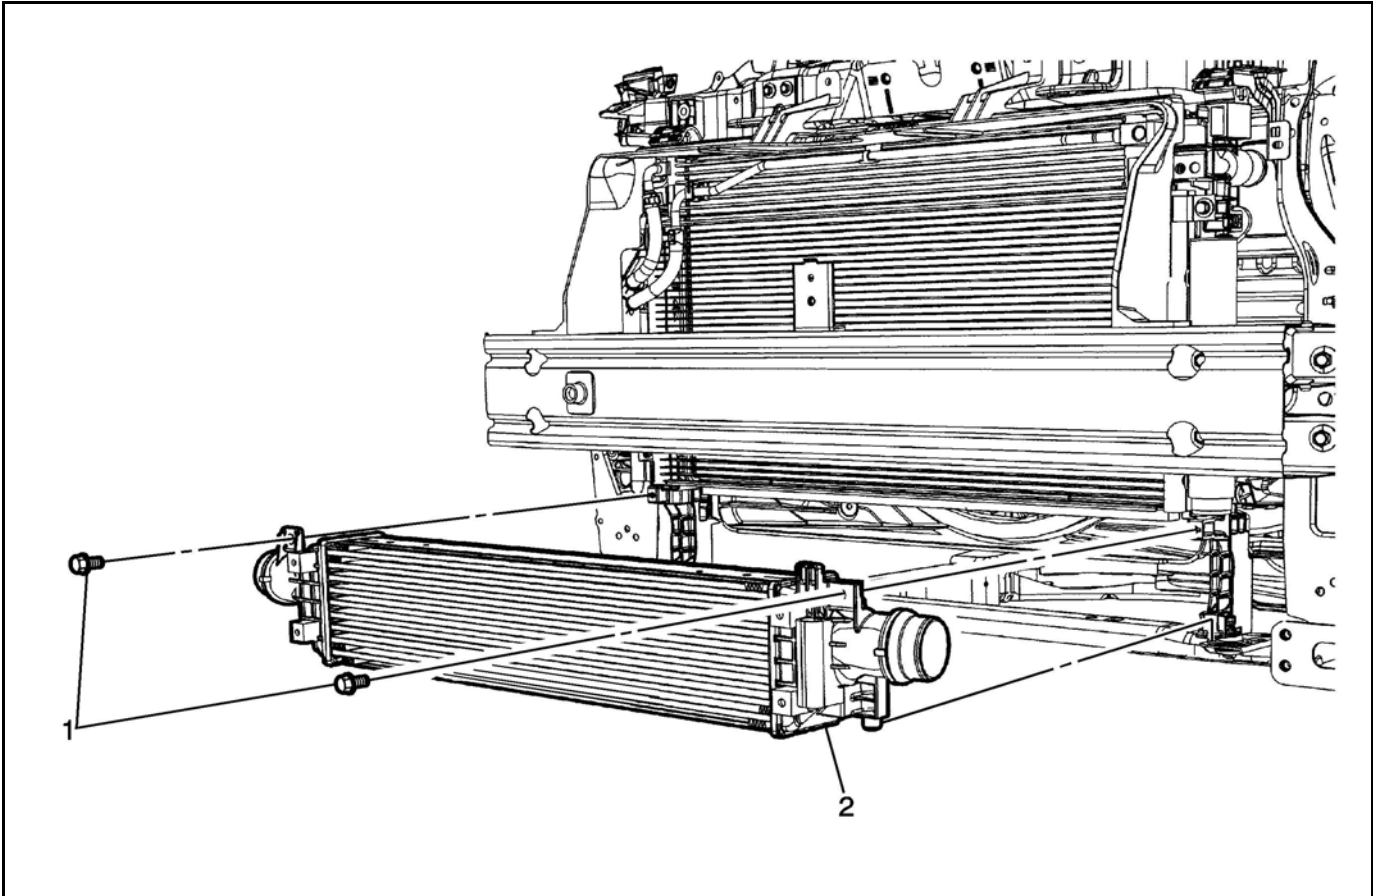
Cause	This condition may be caused by ice accumulation in the charge air cooler (CAC), restricting air flow to the throttle body.

1. Install the CAC (2). Refer to *Charge Air Cooler Replacement* in SI.
