Service Bulletin

Bulletin No.: 19-NA-187

Subject: Diagnostic Tip to Identify Engine Misfiring and/or Malfunction Indicator Lamp (MIL) Illuminated - DTC P0300 Setting

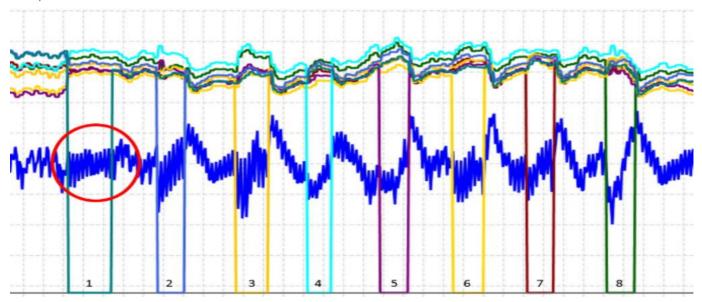
Note that cylinder #1 does not drop the RPM when canceled, when compared to the other cylinders.

- ⇒ RPM recovery is limited after the cancellation has ended.
- ⇒ Other cylinders do not have as much of a RPM drop when they are canceled, however the RPM does jump after the cancellation has ended.

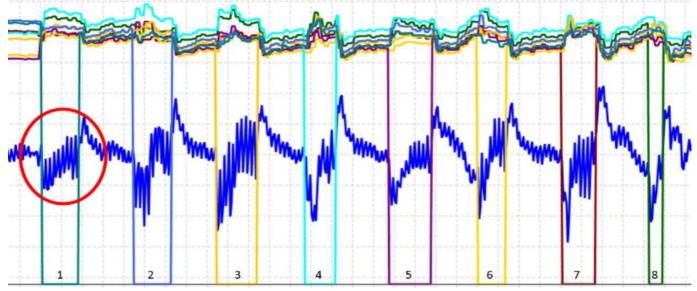
During this second balance test, it appears like cylinder #1 is contributing, however it is less than any of the other cylinders.

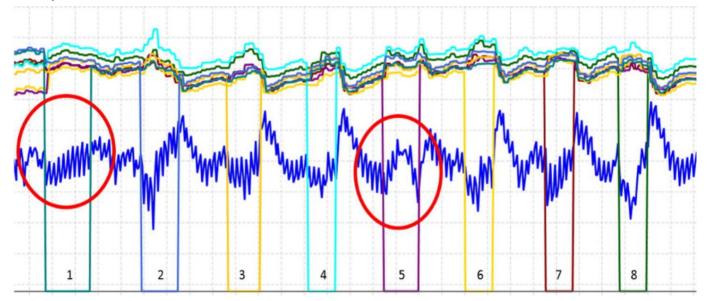
5394869

During this final test, it appears that cylinder #5 is not contributing as well as #1. This is one of the main reasons that we must repeat the test to find consistency.

⇒ This vehicle was repaired by replacing #1 fuel injector.
