Service Bulletin

Bulletin No.: 22-NA-015

Subject: Diagnostic Tip on Shake and/or Shudder During Light Throttle Acceleration Between 25 and 80 MPH (40 and 128 KM/H) at Steady Speed

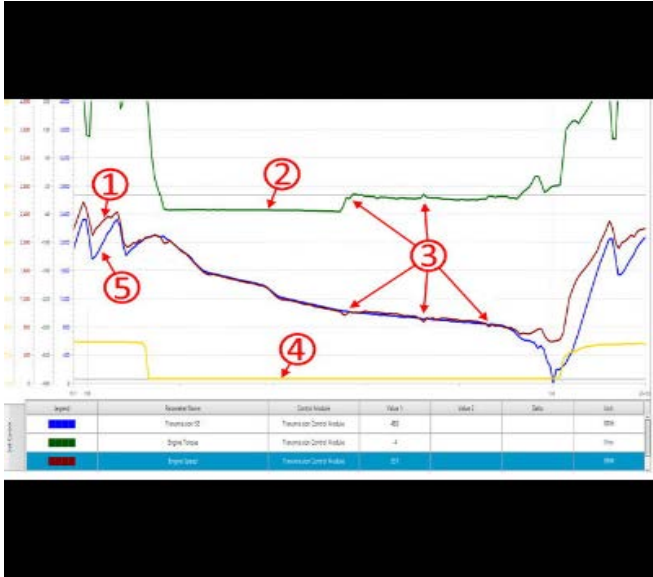
5975000

Diagnostic Tip Closed Throttle Shudder – TSB 21-NA-207: 2021 Silverado Sierra 5.3 (L84) 10 Speed (MQB) only.

The condition is only present at 0% throttle during a coast event at approximately 15 mph (24 km/h). Note the engine RPM and torque oscillations at engine refuel points.

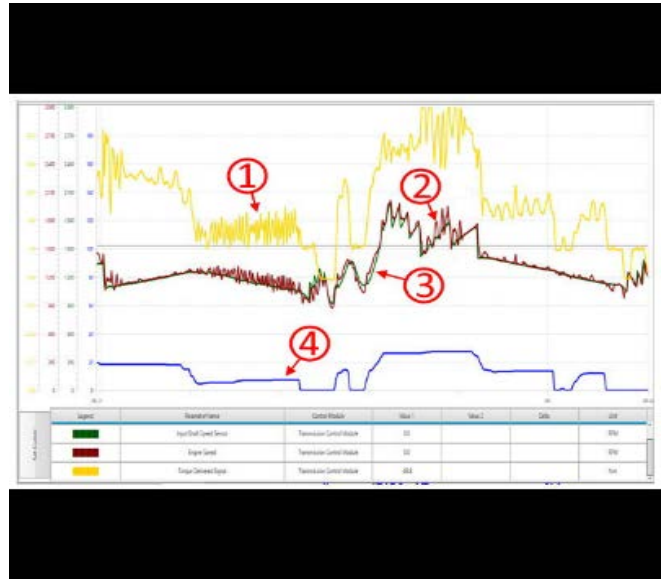
5975002

Diagnostic Tip Engine Related Shudder – PIP5794B Camshaft Actuator

Record a GDS session log and monitor engine speed, transmission input speed and engine torque. If engine torque is larger than +/- 25 Nm while no gear shift is active, and throttle is relatively constant the issue most likely lies within the engine.

Observe the large variation in engine torque while engine speed and turbine speed follow each other more closely. Although this feels like shudder to the customer it is most likely an engine related concern.

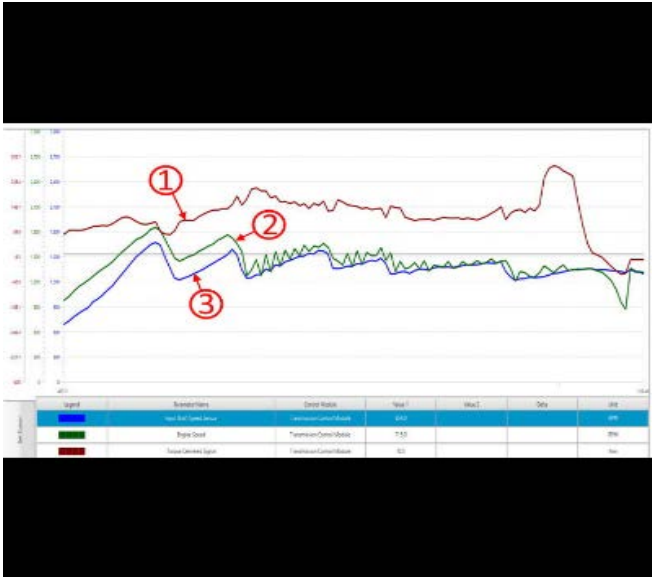
5975003

Diagnostic Tips TCC Solenoid – Valve Body

1. Torque
2. Engine Speed
3. Turbine Speed
 - The shudder condition is present both in Drive “D” or Manual “L9”.
 - Typically occurs at less than 15,000 miles (24,000 km)
 - Turbine speed follows engine speed
 - Relatively consistent engine torque. <+/- 25 Nm

Engine torque remains relatively flat while engine speed rises and falls. The valve body should be replaced.

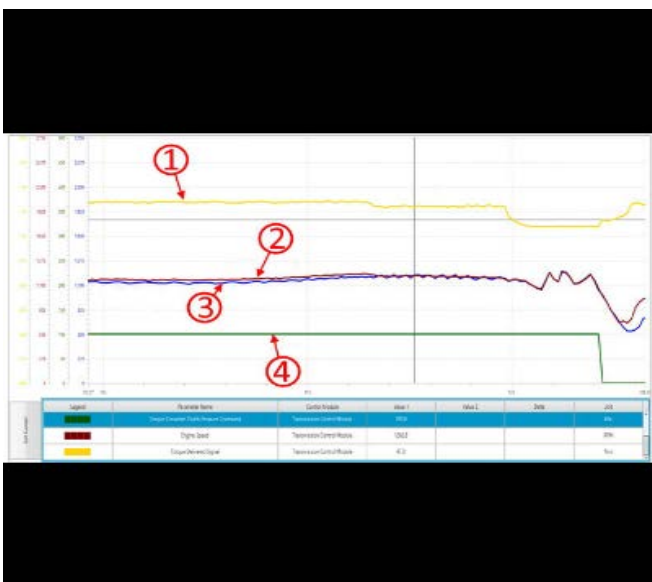
5975005

Diagnostic Tip TCC Solenoid (Drift) – Valve Body

3. Turbine Speed
4. TCC Pressure
 - Shudder condition is present in Drive “D” but NOT present in Manual “L9”
 - Throttle would typically be less than 10% and engine torque less than 100 Nm
 - TCC slip speed will be 0 or near 0
 - TCC pressure command will remain at 100 kPa

The valve body should be replaced.

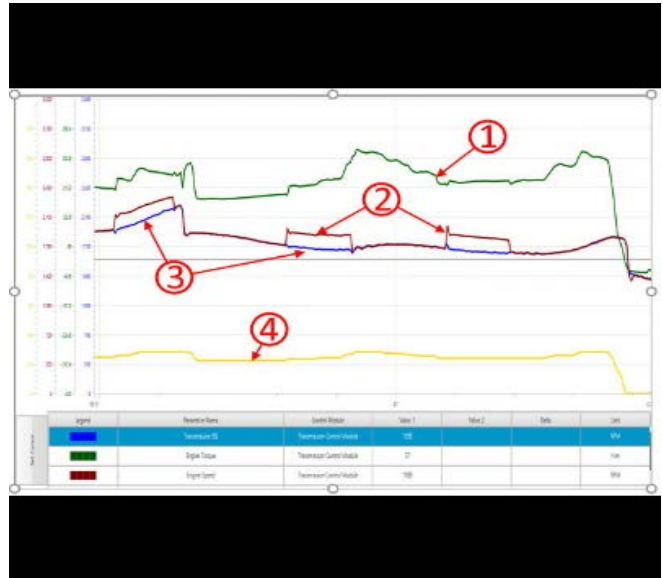
5975007

Diagnostic Tip TCC Shudder – Torque Converter

1. Torque
2. Engine Speed
3. Turbine Speed
4. Pedal
 - TCC pressure control is steady
 - TCC slip is elevated
 - Engine RPM will increase at the shudder point while turbine speed remains steady
 - Engine torque remains relatively steady during the shudder event
 - Throttle angle remains steady during the shudder event

The torque converter should be replaced.
